### 1) a. Cranberry Creek

## CRANBERRY CREEK CATCHMENT

### LOWER RIDEAU RIVER SUBWATERSHED REPORT 2012

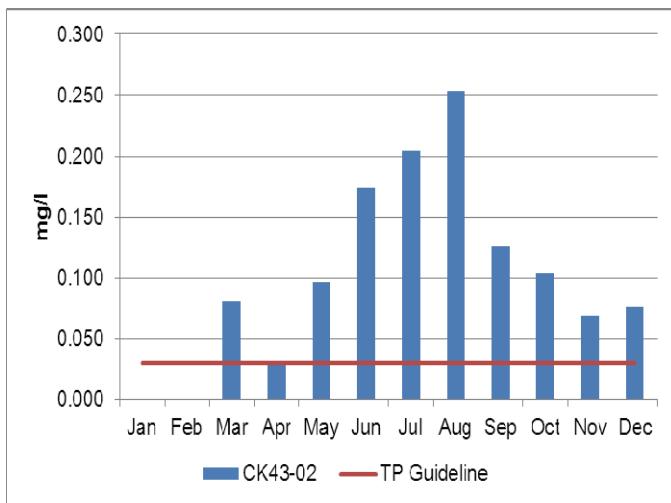
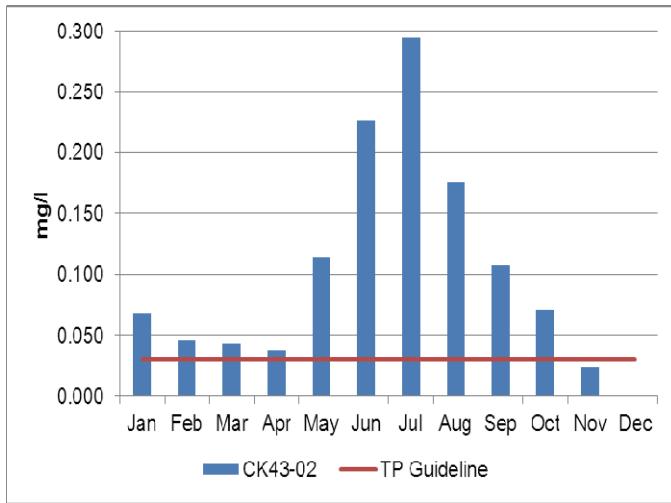
The majority of samples at site CK43-02 were above the TP guideline of 0.030mg/l for both time periods (Fig. 2a, 2000-2005 and 2b, 2006-2011), only 8 percent of samples were below the guideline in the 2000-2005

period. This improved to eighteen percent of samples in the 2006-2011 period. The average TP concentration remained fairly constant, slightly decreasing from 0.124 mg/l (2000-2005) to 0.121 mg/l (2006-2011). The target of a TP concentration of 0.030mg/l at the 85<sup>th</sup> percentile has not been achieved at this site and the concentration at the 85<sup>th</sup> percentile increased from 0.210 mg/l (2000-2005, Fig. 3a) to 0.229 mg/l (2006-2011, Fig. 3b).

Overall the data suggests that nutrient loading is a significant problem at this site; efforts should be made to reduce nutrient inputs to the creek.

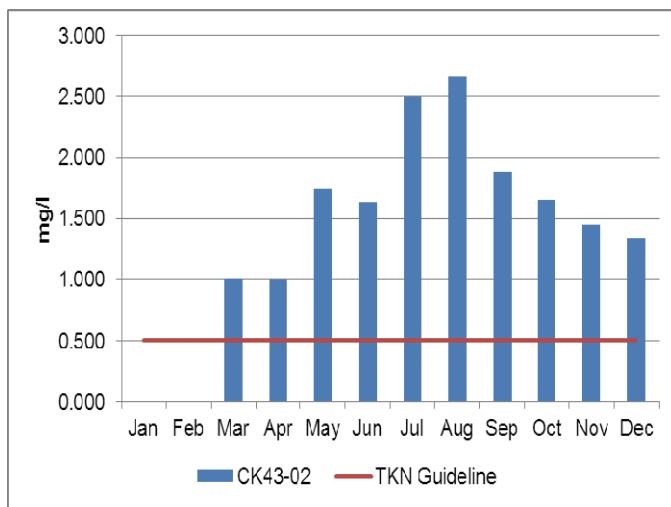
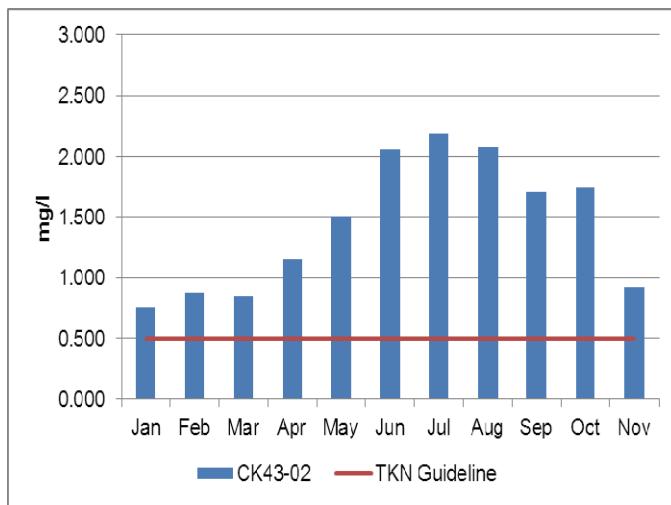
Total Kjeldahl nitrogen is used as a secondary indicator of nutrient enrichment. Figures 4a and 4b show that all results exceeded the TKN guideline of 0.500 mg/l in both periods of interest. The average concentration decreased slightly from 1.740 mg/l to 1.560 mg/l, far exceeding the guideline.

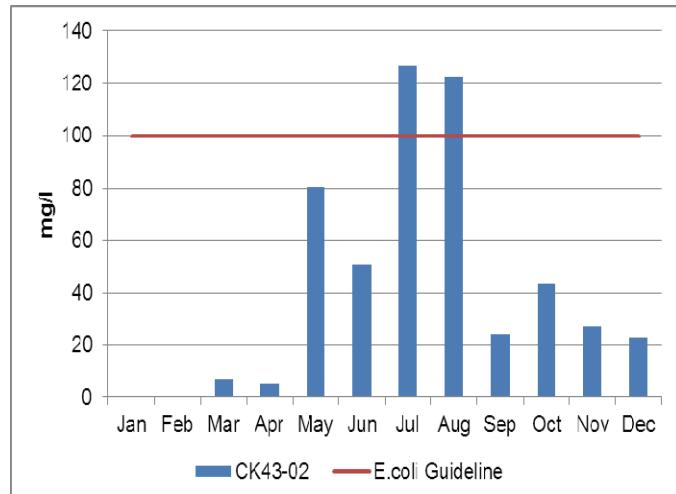
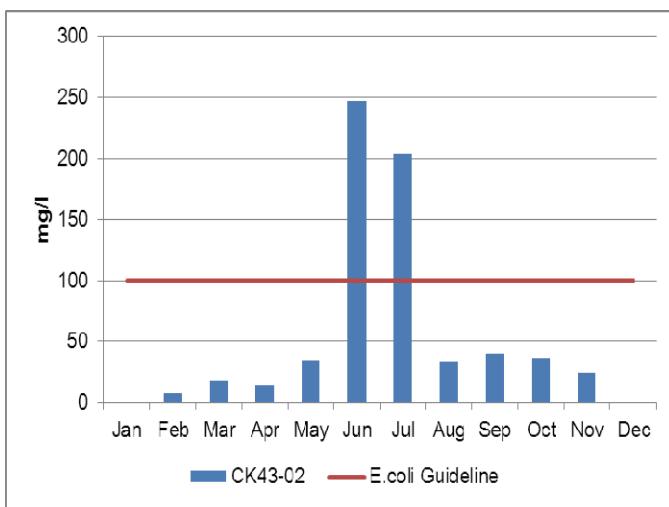
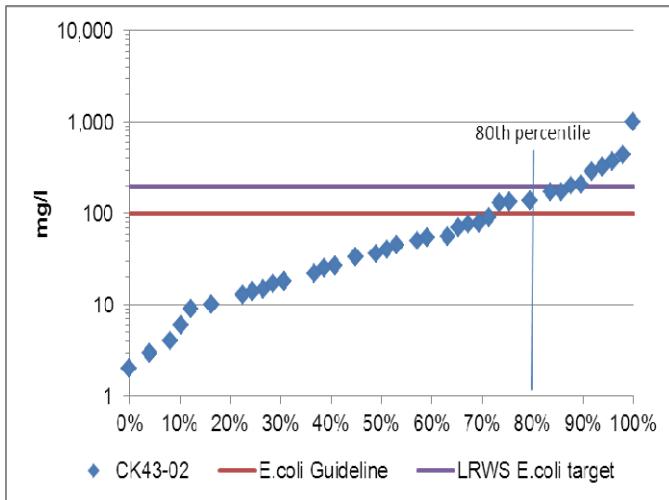
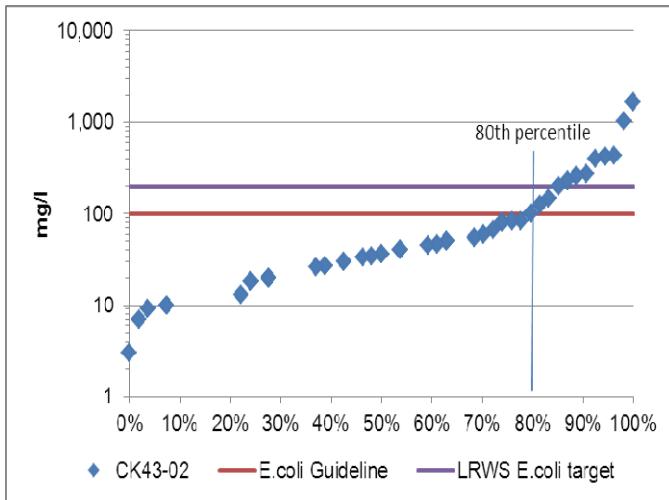
E. coli counts above the guideline of 100 colony forming units per 100 mL (CFU/100mL) occasionally occurred at site CK43-02 on Cranberry Creek. In comparing the two time periods at site CK43-02, the proportion of samples below the guideline increased from seventy-two percent (Fig. 5a) to seventy-eight percent (Fig. 5b). The count at the geometric mean increased slightly from 38 CFU/100 ml to 41 CFU/100 ml. Percentile plots of E. coli data at site CK43-02 are shown for both periods. Figures 6a and 6b show that this target was achieved in both time periods; the E. coli count at the 80<sup>th</sup> percentile decreased from 136 CFU/100 ml to 105 CFU/100 ml.

These statistics indicated that bacterial counts are typically below guidelines, efforts should be made to prevent additional sources of contamination to the creek to protect overall water quality and aquatic life.

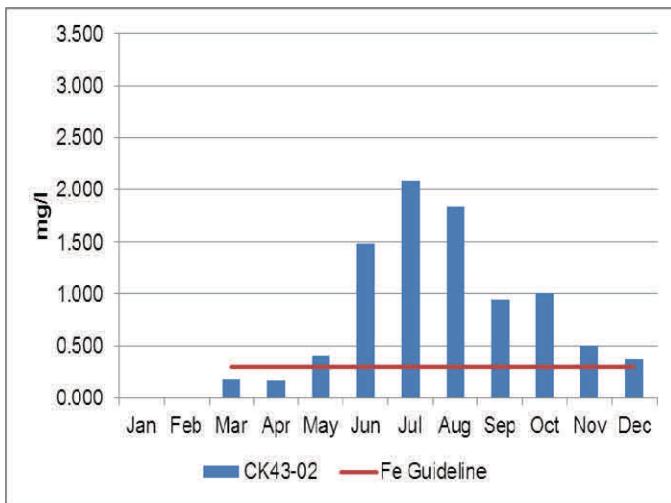
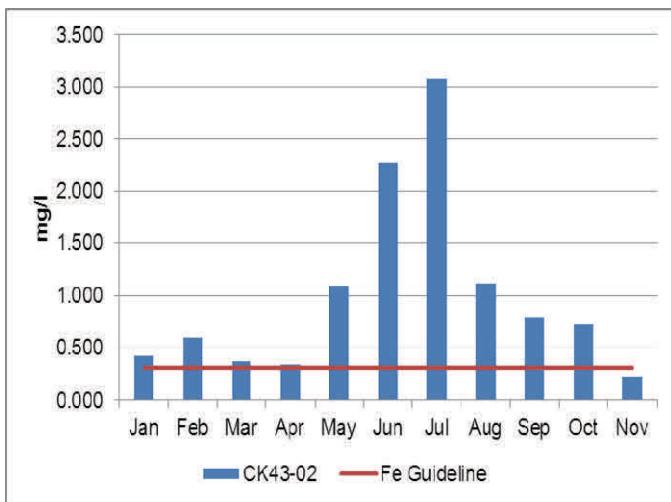
Figures 7a and 7b show that the Fe results often exceed the guideline of 0.300 mg/l and there was an overall increase in concentrations over the periods of interest. Thirty-three percent of samples were below the guideline in 2000-2005 and decreased slightly to twenty-eight percent in the 2006-2011 period. The average concentration increased from 0.928 mg/l to 1.08 mg/l, exceeding the guideline.

Overall the data shows that metal pollution is a problem in the creek and efforts should be made to reduce concentrations wherever possible.

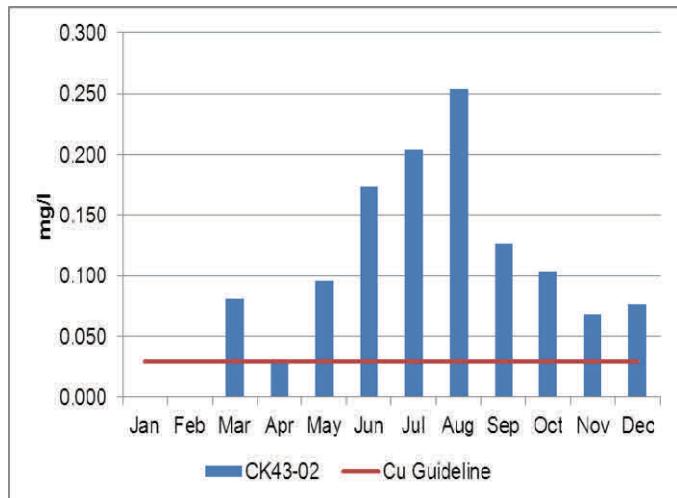
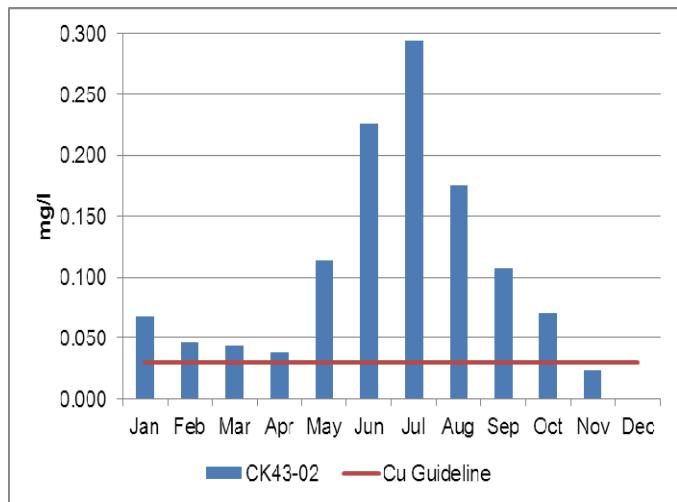
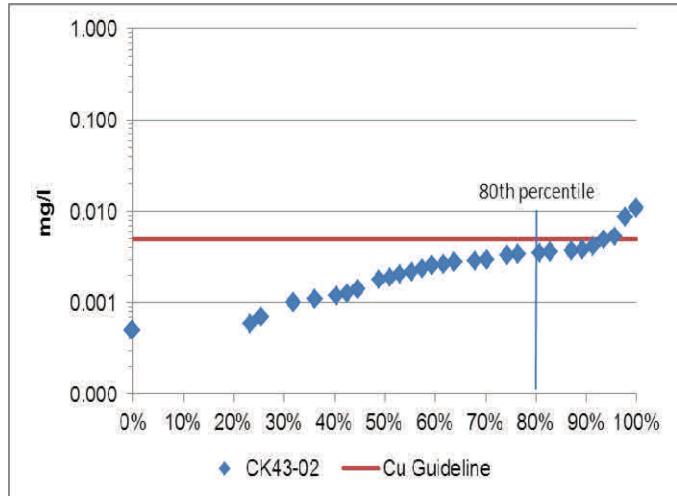
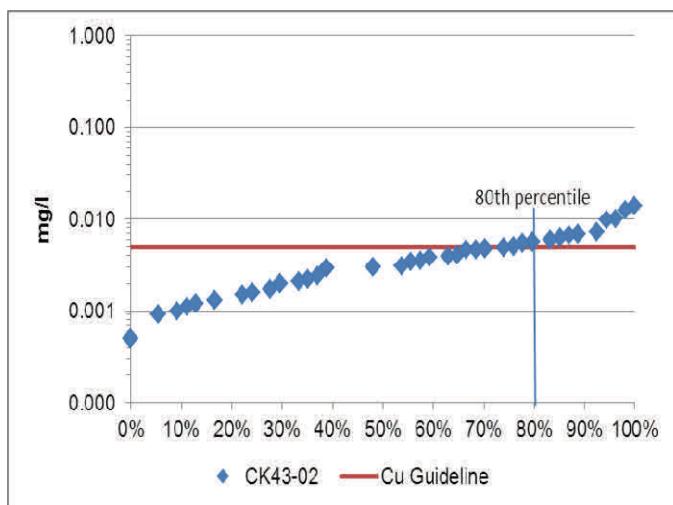
Results for Cu concentrations were also occasionally above the guideline of 0.005 mg/l. The proportion of samples below the guideline decreased slightly from ninety-four percent (Fig. 8a, 2000-2005) to seventy-five percent (Fig. 8b, 2006-2011), the average concentration remained increased from 0.003 mg/l to 0.004 mg/l. The target of a Cu concentration of 0.005 mg/l at the 80<sup>th</sup> percentile was not achieved at this site in the 2006-2011 period, the concentration at the 80<sup>th</sup> percentile increased from 0.003 mg/l (2000-2005, Fig 9a) to 0.006 mg/l (2006-2011, Fig 9b).

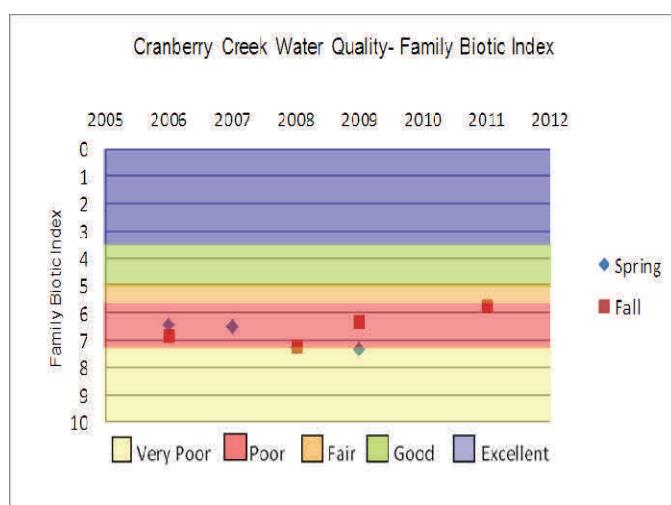
Figure 10. Surface water quality conditions in Cranberry Creek based on the Family Biotic Index

FBI results for Cranberry Creek show that it has "Poor" water quality conditions for the period from 2006 to 2011 (Fig.10) and scores an overall "Poor" surface water quality rating using a grading scheme developed by Conservation Authorities in Ontario for benthic invertebrates.

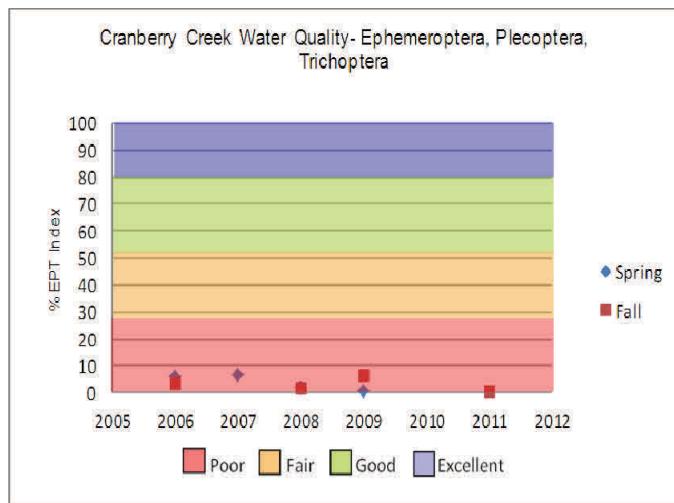
Figure 12. Surface water quality conditions in Cranberry Creek using the EPT Index

With the EPT indicator, Cranberry Creek is reported to have "Poor" water quality (Fig.12) from 2006 to 2011.

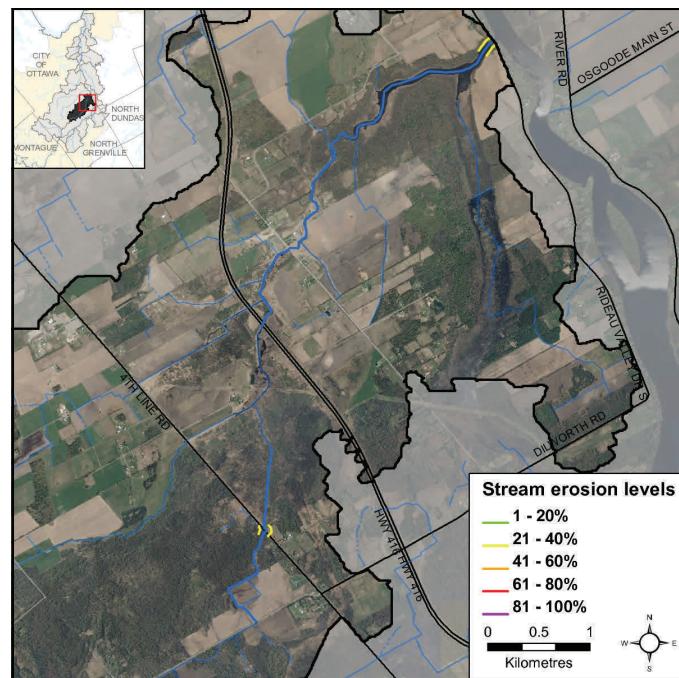
Figure 15. Erosion along Cranberry Creek

Erosion is a normal, important stream process and may not affect actual bank stability; however, excessive erosion and deposition of sediment within a stream can have a detrimental effect on important fish and wildlife habitat. Bank stability indicates how much soil has eroded from the bank into the stream. Poor bank stability can greatly contribute to the amount of sediment carried in a waterbody as well as loss of bank vegetation due to bank failure, resulting in trees falling into the stream and the potential to impact instream migration. Figure 15 shows the bank stability of the left and right bank along Cranberry Creek.

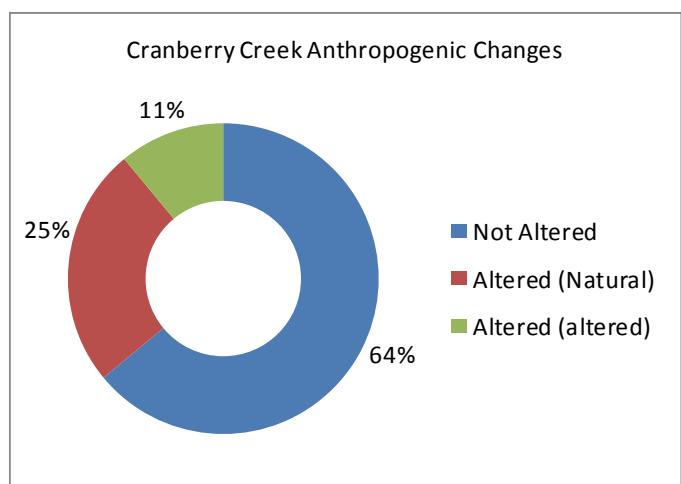
Figure 18. Alterations to Cranberry Creek

Figure 18 shows that 64 percent of Cranberry Creek remains "unaltered." Sections considered "natural" with some human changes account for 25 percent of sections, with the remaining 11 percent of sections sampled being considered "altered" (e.g., with road crossings and little or no buffer). No areas were recorded as being "highly altered" along Cranberry Creek.

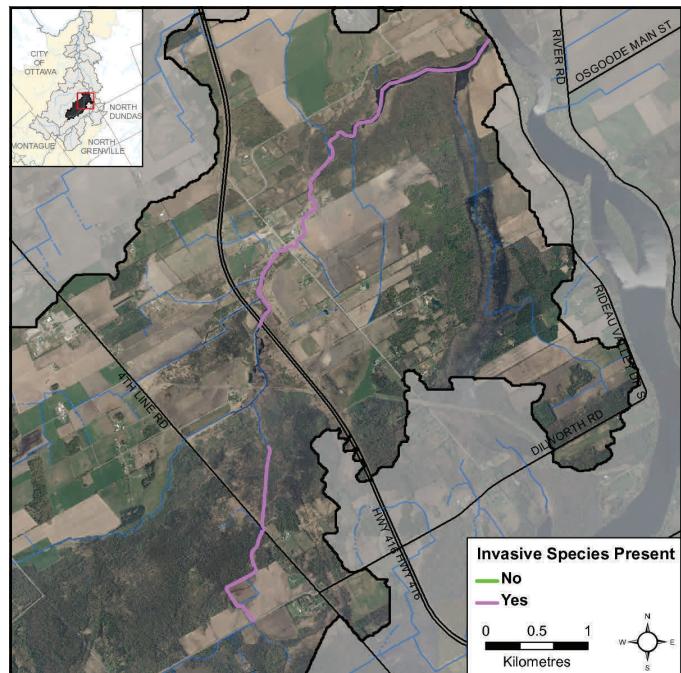
Figure 24. Invasive species along Cranberry Creek

Invasive species can have major implications on streams and species diversity. Invasive species are one of the largest threats to ecosystems throughout Ontario and can outcompete native species, having negative effects on local wildlife, fish and plant populations. One hundred percent of the sections surveyed along Cranberry Creek had invasive species (Figure 24). The species observed in Cranberry Creek were purple loosestrife and European frogbit.
