# ARCAND DRAIN CATCHMENT

## LOWER RIDEAU RIVER SUBWATERSHED REPORT 2012

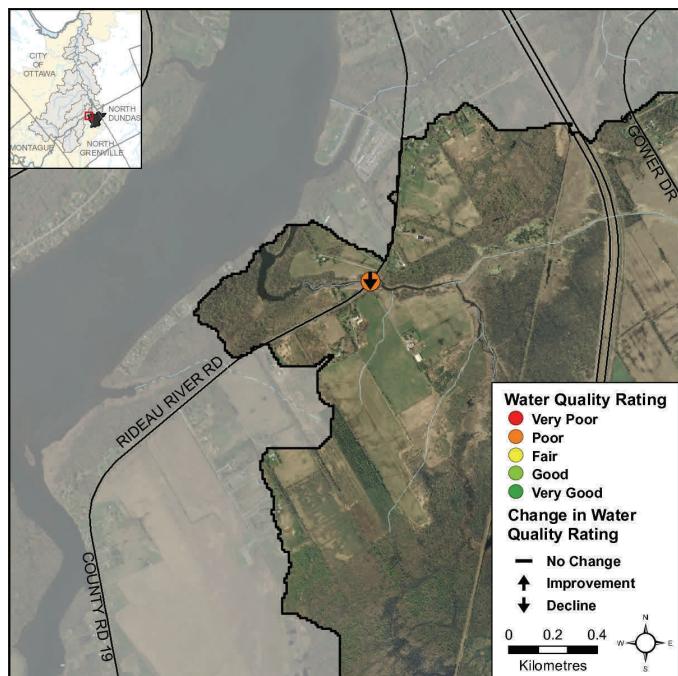
Figure 1. Sampling site in Arcand Drain

Surface water quality conditions in Arcand Drain are monitored through the RVCA's Baseline Water Quality Program (at County Road 19 crossing, see Fig.1 for the location).

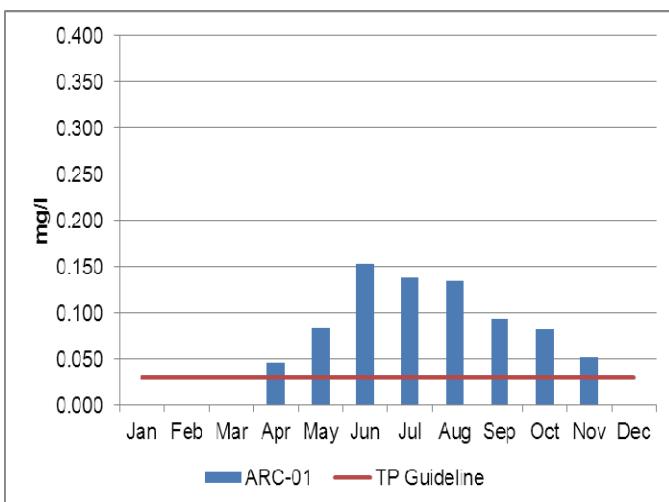
*Figure 2a. Total phosphorous concentrations in Arcand Drain from 2000-2005*

The majority of samples were above the TP guideline for both time periods (Fig. 2a, 2000-2005 and 2b, 2006-

2011), and there has been an increase in average TP concentration from 0.109 mg/l (2000-2005) to 0.166 mg/l (2006-2011). The LRWS has not been achieved at this site. The concentration at the 85<sup>th</sup> percentile has increased from 0.192 mg/l (2000-2005, Fig. 3a) to 0.240 mg/l (2006-2011, Fig. 3b).

Total phosphorus (TP) is used as a primary indicator of excessive nutrient loading and may contribute to abundant aquatic vegetation growth and depleted dissolved oxygen levels. The Provincial Water Quality Objectives (PWQO) of 0.030mg/l is used as the TP Guideline. Concentrations greater than 0.030 mg/l indicate an excessive amount of TP. Arcand Drain TP results are shown in Figures 2a and 2b. In addition to the TP guideline, the LRWS set the target for TP concentration of 0.030 mg/l (PWQO) at the 85th percentile for tributaries of the Rideau River, such as Arcand Drain. Percentile plots for this data are shown in Figures 3a and 3b. Any point to the left of the 85th percentile line (vertical) and above the guideline (horizontal line) have failed to reach the LRWS target.

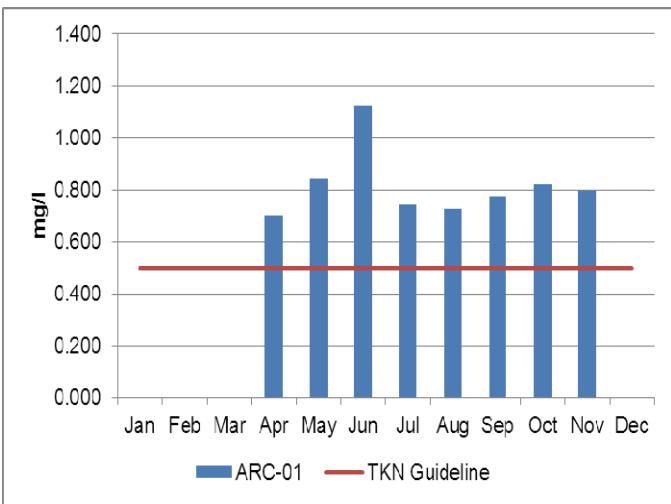
Figure 4a. Total Kjeldahl nitrogen concentrations in Arcand Drain from 2000-2005

Table 3 shows that the majority of results exceeded the TKN guideline of 0.500 mg/l. The average concentration also increased from 0.863 mg/l (Fig. 4a) to 1.08 mg/l (Fig. 4b), far exceeding the guideline.

Total Kjeldahl nitrogen (TKN) is used as a secondary indicator of nutrient loading; RVCA uses a guideline of 0.500 mg/l (TKN Guideline) to assess TKN concentrations. Arcand Drain TKN results are shown in Figures 4a and 4b.

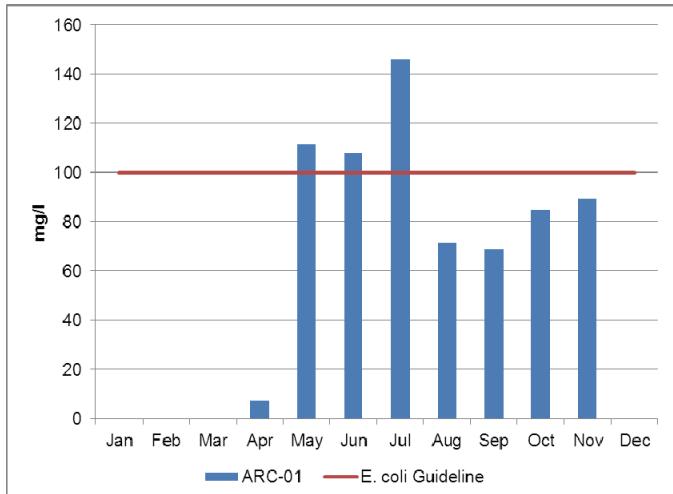
Figure 5a. E.coli counts in Arcand Drain from 2000-2005

The proportion of samples below the E. coli guideline decreased from sixty-five percent (Fig.5a) to fifty-six percent (Fig. 5b), however the count at the geometric mean decreased from 76 CFU/100 ml to 63 CFU/100 ml. In comparing the two time periods, E. coli counts at the 80<sup>th</sup> percentile increased slightly from 171 CFU/100 ml (2000-2005, Fig. 6a) to 176 CFU/100 ml (2006-2011, Fig. 6b) but did remain below the target set by the LRWS.

Figure 5 shows the results of the geometric mean with respect to the guideline for the two periods 2000-2005 (Fig. 5a) and 2006-2011 (Fig. 5b). Figures 6a and 6b show percentile plots of the data for the two time periods of interest 2000-2005 (Fig. 6a) and 2006-2011 (Fig. 6b). Any point to the left of the 80<sup>th</sup> percentile line (vertical) and above the guideline (horizontal line) have failed to reach the LRWS target

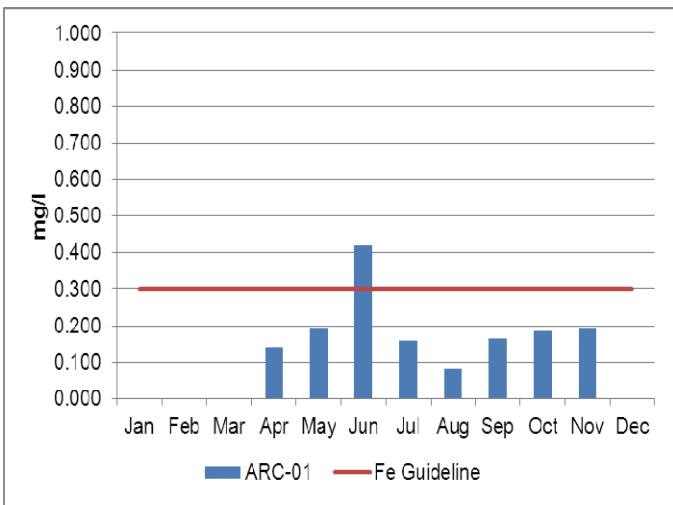
Figure 7a. Iron concentrations in Arcand Drain from 2000-2005

Iron concentrations increased and often exceeded the guideline of 0.300 mg/l at this site, data from 2000-2005 (Fig.7a) show eighty-five percent of samples were below the guideline and this dropped to sixty-seven percent of samples in 2006-2011 (Fig.7b). Average Fe concentrations also increased in this same time period from 0.223 mg/l to 0.419 mg/l.

Figures 7 and 8, show the results for site ARC-01 with respect to guidelines for the two periods 2000-2005 (figures 7a and 8a) and 2006-2011 (figures 7b and 8b). The guidelines for each metal as stated by the PWQO are Cu 0.005 mg/l and Fe 0.300 mg/l. The Lower Rideau Watershed Strategy (2005) also set a target for Cu concentration of 0.005 mg/l at the 80<sup>th</sup> percentile. Figure 9 shows percentile plots of the data for the two time periods of interest (Fig. 9a, 2000-2005) (Fig. 9b, 2006-2011). Any point to the left of the 80<sup>th</sup> percentile line (vertical) and above the guideline (horizontal) have failed to reach the LRWS target

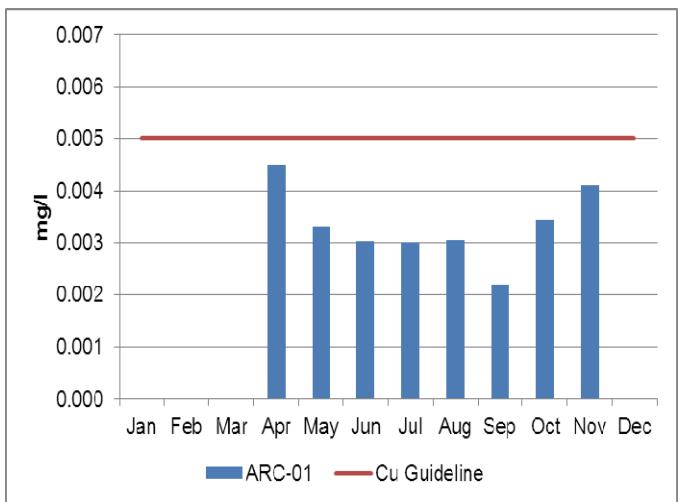
Figure 8a. Copper concentrations in Arcand Drain from 2006-2011

The proportion of Copper samples below the guideline decrease from ninety-four percent (Fig.8a) to sixty percent (Fig. 8b) between the two time periods. Similarly Cu concentrations had an overall increase from 0.002 mg/l to 0.004 mg/l. In comparing the two time periods Cu concentrations at the 80<sup>th</sup> percentile have increased from 0.003 mg/l (2000-2005, Fig.9a) to 0.007 mg/l (2006-2011, Fig.9b).

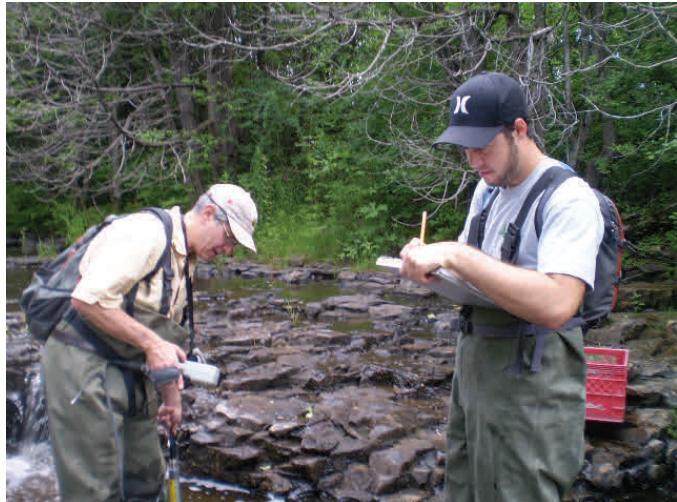
Using a YSI to collect water chemistry data

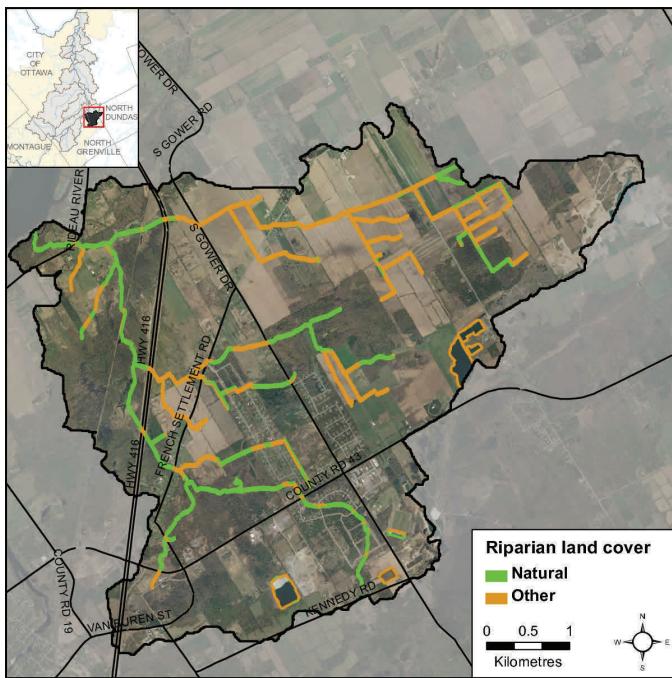
Figure 10. Catchment land cover in the riparian zone

Figure 10 shows the extent of the naturally vegetated riparian zone in the catchment, 30 metres on either side of all waterbodies and watercourses. Results from the RVCA's Land Cover Classification Program show that 41 percent of streams and creeks are buffered with woodland and wetland; the remaining 59 percent of the riparian buffer is occupied by settlement, crop and pastureland, transportation and aggregate sites.

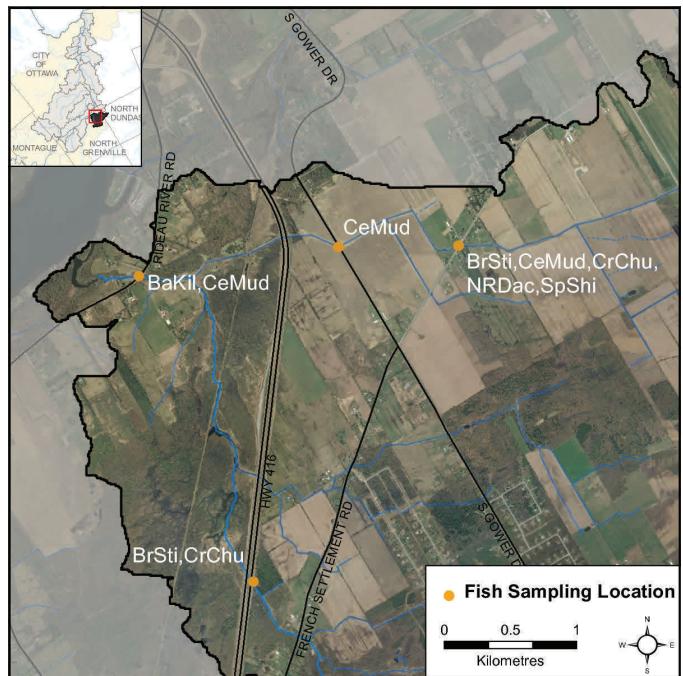
Figure 11. Fish species observed along Arcand Drain

Fish sampling sites located along the Arcand Drain are shown in Figure 11. The provincial fish codes shown on the following map are listed (in Table 5) beside the common name of those fish species identified in the Arcand Drain (Data source: RVCA and City of Ottawa).

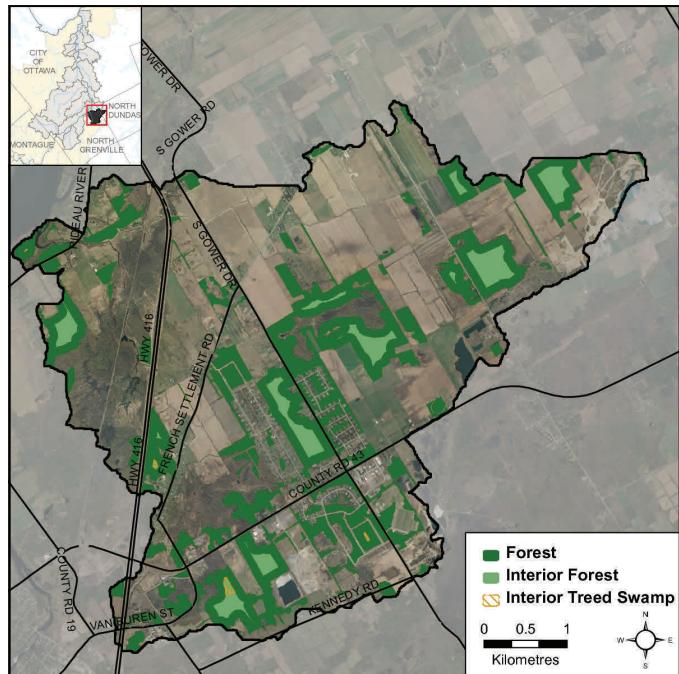
Figure 12. Catchment woodland cover and forest interior

The Arcand Drain catchment contains 591 hectares of woodland (Fig.12) that occupies 22 percent of the drainage area. This figure is less than the 30 percent of woodland area required to sustain forest birds, according to Environment Canada's Guideline: "How much habitat is enough?" When forest cover declines below 30 percent, forest birds tend to disappear as breeders across the landscape.

The same 69 woodlands contain 17 forest interior patches (Fig.12) that occupy three percent (76 ha.) of the catchment land area. This is below the ten percent

Most patches (14) have less than 10 hectares of interior forest, eight of which have small areas of interior forest habitat less than one hectare in size. Conversely, three patches have greater than 10 hectares of interior forest, containing 10, 14 and 16 hectares of interior forest habitat respectively.

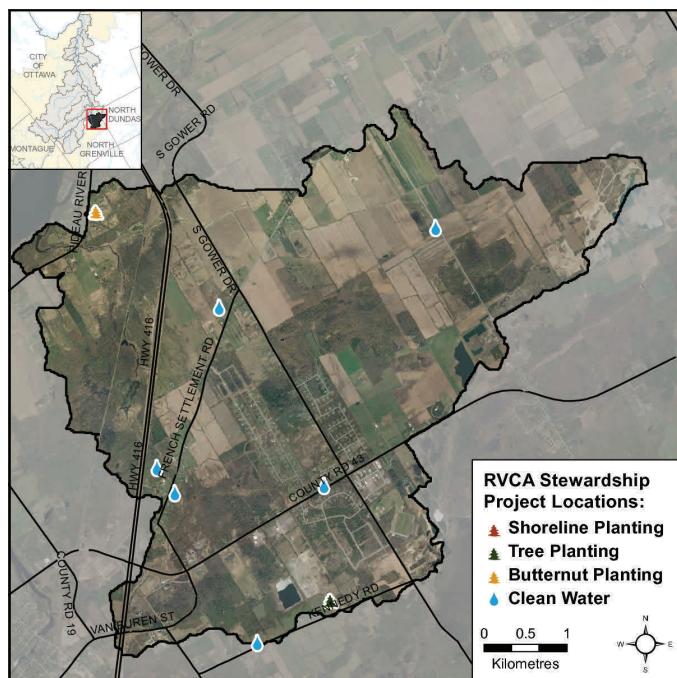
Figure 14. RVCA stewardship program project locations

Figure 14 shows the location of all Rural Clean Water Projects in the Arcand drainage area. From 2006 to 2011, landowners completed 3 projects including 1 septic system repair/replacement and 2 well upgrades. In total, RVCA contributed \$3,000 in grant dollars to projects valued at \$12,569.

The location of all tree planting and shoreline projects is also shown in Figure 14. From 2006 to 2011, no tree planting projects were completed.

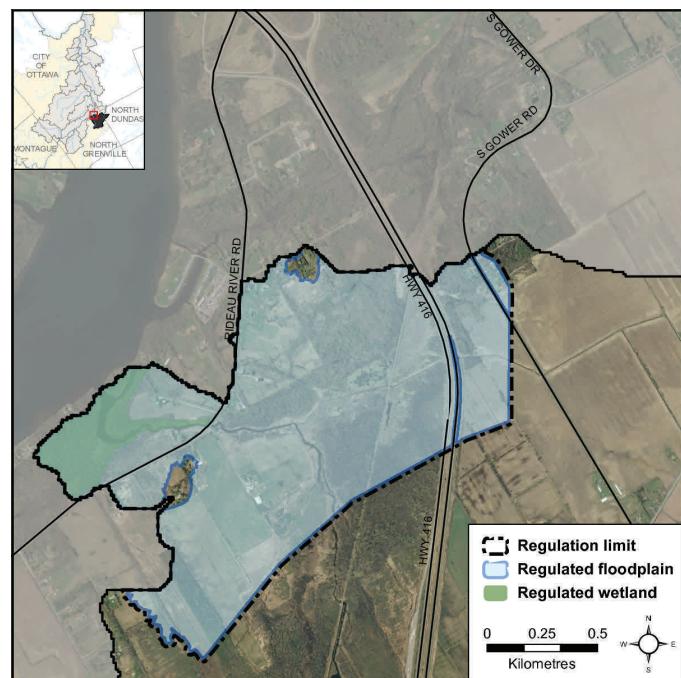
Figure 15. RVCA regulation limits

Two square kilometres or seven percent of the catchment drainage area is within the regulation limit of Ontario Regulation 174/06 (Fig.15), giving protection to wetland areas and river or stream valleys that are affected by flooding and erosion hazards.

Natural features within the regulation limit include 3.9 kilometres of streams (representing 11 percent of all streams in the catchment).
