The RVCA produces individual reports for 16 catchments in the Lower Rideau subwatershed. Using data collected and analysed by the RVCA through its watershed monitoring and land cover classification programs, surface water quality conditions are reported for McDermott Drain along with a summary of environmental conditions for the surrounding countryside every six years.

**1) a. McDermott Drain**

Surface water quality conditions in McDermott Drain are monitored through the RVCA's Baseline Water Quality Program (MCD-03 and MCD-02 off of Gabert Road, see figure 1 for their locations).

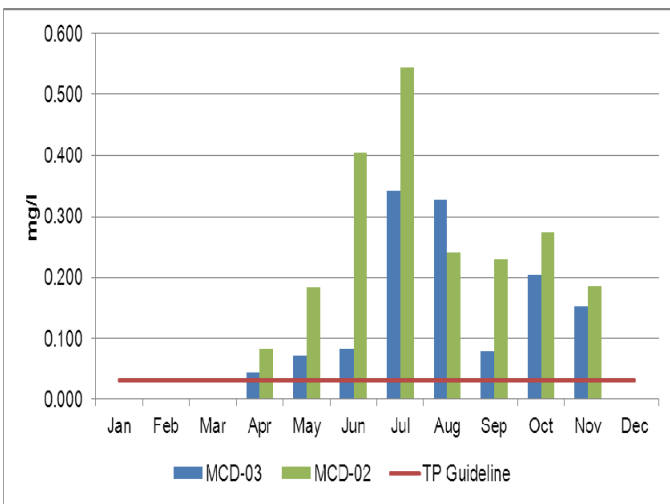
Figure 2a. Total phosphorous concentrations in McDermott Drain from 2000-2005

The majority of samples at site MCD-03 were above the TP guideline of 0.030mg/l for both time periods (figures 2a and 2b), only 5 percent of samples were below the

The majority of samples at site MCD-02 were also above the TP guideline of 0.030mg/l for both time periods (Figures 2a and 2b); there were no samples below the guideline in the 2000-2005 period; this improved to thirteen percent of samples in the 2006-2011 period. Average TP concentration increased from 0.288 mg/l (Fig. 2a, 2000-2005) to 0.391 mg/l (Fig. 2b, 2006-2011). Figures 3a and 3b show that the target set by the LRWS has not been achieved for site MCD-02. The concentration at the 85<sup>th</sup> percentile increased from 0.429 mg/l (2000-2005, Fig. 3a) to 0.707 mg/l (2006-2011, Fig. 3b).

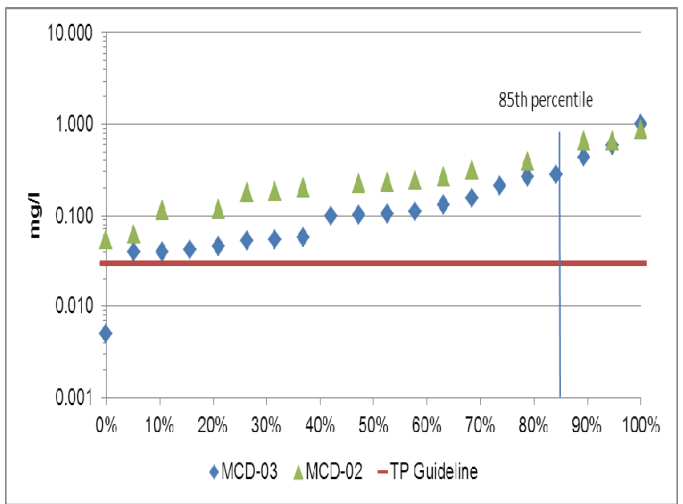
Figure 3a. Percentile plots of total phosphorous in McDermott Drain from 2000-2005

guideline in the 2000-2005 period; this improved to ten percent of samples in the 2006-2011 period. There was also a decrease in the average TP concentration from 0.190 mg/l (Fig. 2a, 2000-2005) to 0.096 mg/l (Fig. 2b, 2006-2011). The LRWS target of a TP concentration of 0.030mg/l at the 85<sup>th</sup> percentile has not been achieved at site MCD-03, though the concentration at the 85<sup>th</sup> percentile did decrease from 0.303 mg/l (2000-2005, Fig. 3a) to 0.130 mg/l (2006-2011, Fig. 3b).

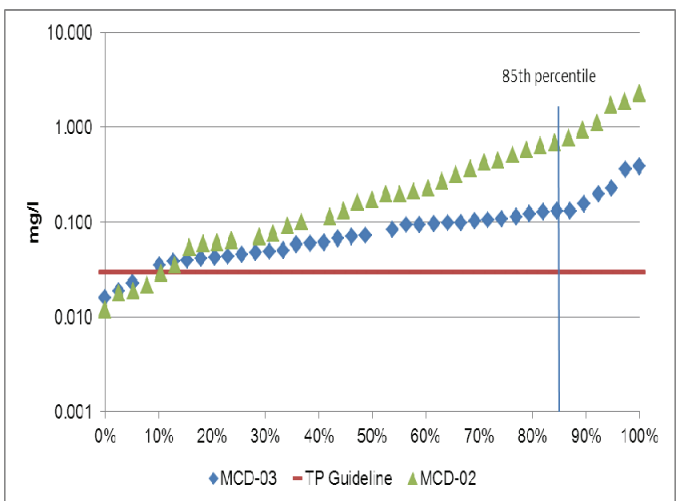
Figure 3b. Percentile plots of total phosphorous is McDermott Drain from 2006-2011

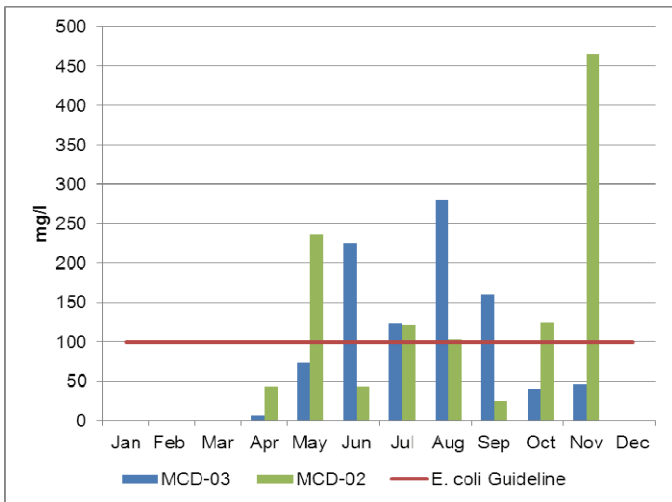
Figure 5a. *E. coli* counts in McDermott Drain from 2000-2005

Figure 5 shows the results of the geometric mean with respect to the guideline for the two periods 2000-2005 (Fig. 5a) and 2006-2011 (Fig 5b). Figures 6a and 6b show percentile plots of the data for the two time periods of interest 2000-2005 (Fig. 6a) and 2006-2011 (Fig. 6b). Any point to the left of the 80<sup>th</sup> percentile line (vertical) and above the guideline (horizontal) have failed to reach the LRWS target

from forty-two percent (Fig. 5a) to thirty-one percent (Fig. 5b), indicating higher counts occur more frequently. The count at the geometric mean increased from 87 CFU/100 ml to 144 CFU/100 ml. Percentile plots of *E. coli* data at site MCD-03 are shown for both periods. Figures 6a and 6b show that this target was exceeded in both time periods, the *E. coli* count at the 80<sup>th</sup> percentile increased from 222 CFU/100 ml to 644 CFU/100 ml.

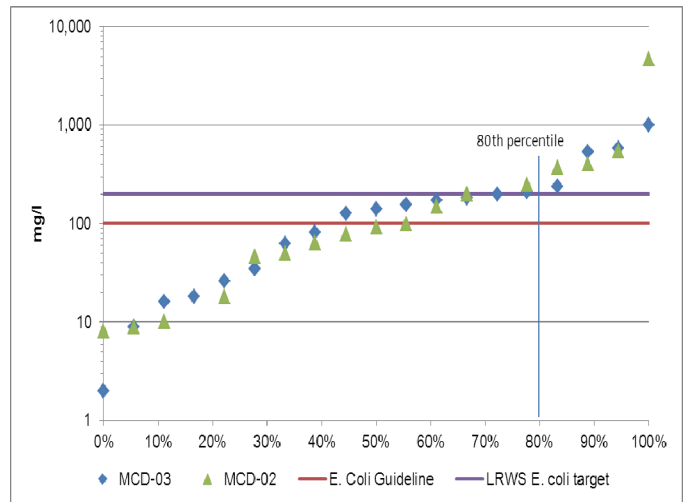
Figure 6a. Percentile plots of *E. coli* in McDermott Drain from 2000-2005

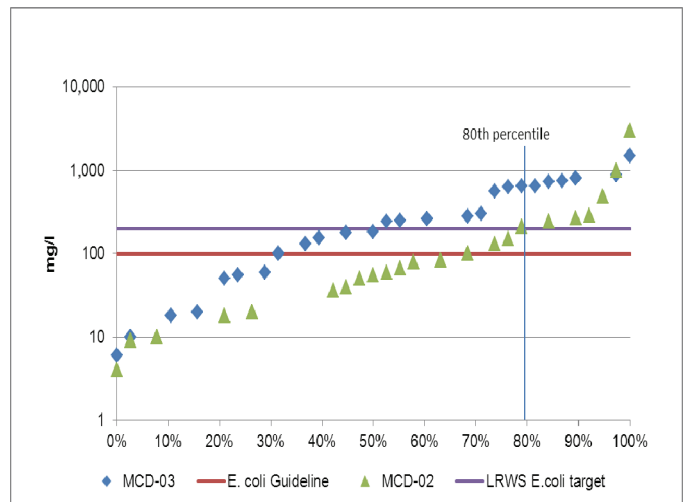
Figure 6b. Percentile plots of *E. coli* in McDermott Drain from 2006-2011

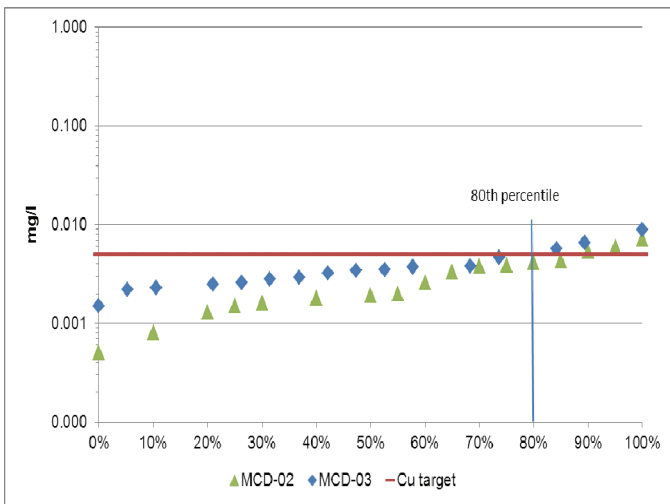
Figure 10a. Percentile plots of copper in McDermott Drain from 2000-2005

Results for Cu concentrations were also occasionally above the guideline of 0.005 mg/l. The proportion of samples below the guideline decreased slightly from eighty percent (Fig. 9a, 2000-2005) to seventy-two percent (Fig. 9b, 2006-2011); the average concentration remained constant at 0.004 mg/l. Percentile plots of Cu data are shown for the two time periods 2000-2005 (Fig. 10a) and 2006-2011 (Fig. 10b). The target of a Cu concentration of 0.005 mg/l at the 80<sup>th</sup> percentile has not been achieved at site MCD-03, the concentration at the 80<sup>th</sup> percentile increased from 0.005 mg/l (2000-2005, Fig. 10a) to 0.006 mg/l (2006-2011, Fig. 10b).

Results for Cu concentrations were also occasionally above the guideline of 0.005 mg/l. The proportion of samples below the guideline decreased slightly from eighty-six percent (Fig. 9a, 2000-2005) to eighty-three percent (Fig 9b, 2006-2011), the average concentration remained constant at 0.003 mg/l. Percentile plots of Cu data are shown for the two time periods 2000-2005 (Fig. 10a) and 2006-2011 (Fig. 10b). The target of a Cu concentration of 0.005 mg/l at the 80<sup>th</sup> percentile was achieved at site MCD-02, the concentration at the 80<sup>th</sup> percentile decreased from 0.004 mg/l (2000-2005, Fig. 10a) to 0.001 mg/l (2006-2011, Fig. 10b).

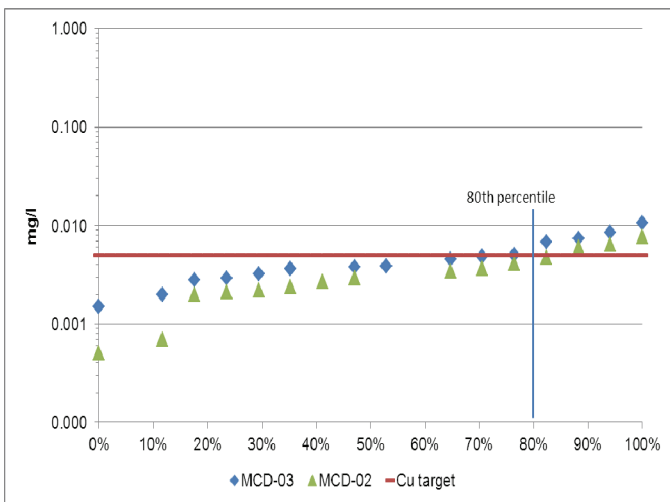
Figure 10b. Percentile plots of copper in McDermott Drain from 2006-2011
