The RVCA produces individual reports for 16 catchments in the Lower Rideau subwatershed. Using data collected and analysed by the RVCA through its watershed monitoring and land cover classification programs, surface water quality conditions are reported for Mud Creek along with a summary of environmental conditions for the surrounding countryside every six years.

Catchment Facts

1) Surface Water Quality

1) a. Mud Creek

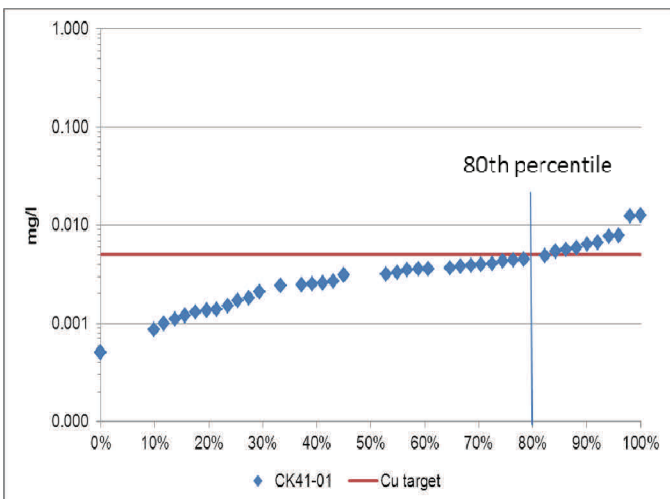
Figure 10a. Percentile plots of Copper in Mud Creek from 2000-2005

Results for Cu concentrations were also occasionally above the guideline of 0.005 mg/l. The proportion of samples below the guideline decreased slightly from eighty-three percent (Fig. 9a, 2000-2005) to sixty-two (Fig. 9b, 2006-2011); the average concentration increased from 0.003 mg/l to 0.006 mg/l to just exceed the guideline. Percentile plots of Cu data are shown for the two time periods 2000-2005 (Fig. 10a) and 2006-2011 (Fig. 10b). The target of a Cu concentration of 0.005 mg/l at the 80th percentile has not been achieved at this site, the concentration at the 80th percentile

increased from 0.005 mg/l (2000-2005, Fig. 10a) to 0.008 mg/l (2006-2011, Fig. 10b).

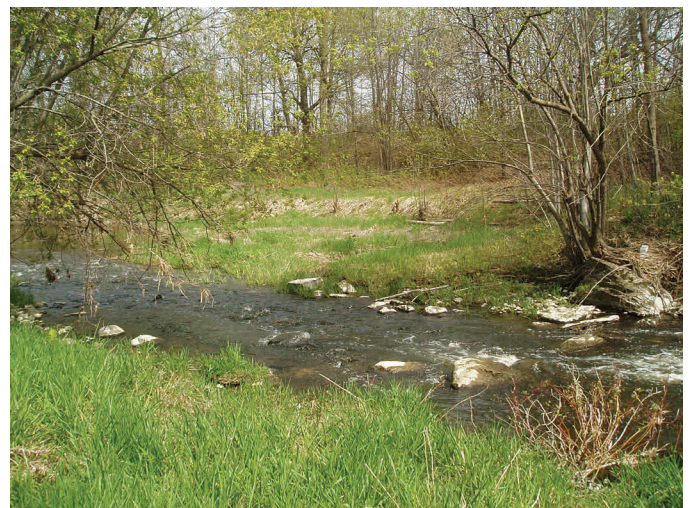
Benthic sampling site replicate one on Mud Creek at Bankfield in the City of Ottawa, this image was captured in the spring of 2008.

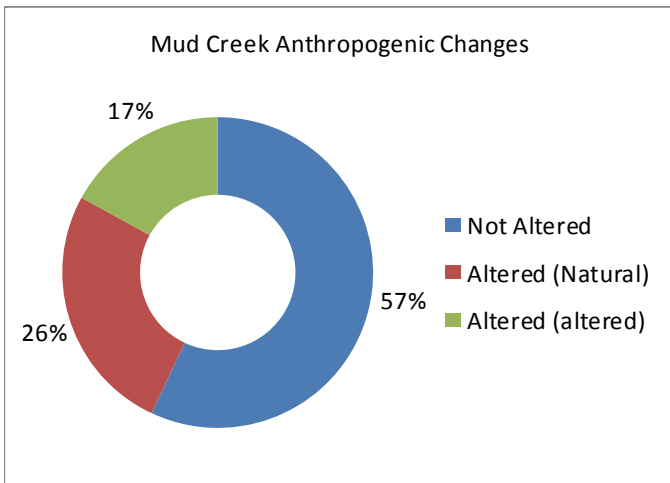
Figure 20. Alterations to Mud Creek

Figure 20 shows that 57 percent of Mud Creek remains “unaltered.” Sections considered “natural” with some human changes account for 26 percent of sections, with the remaining 17 percent of sections sampled being considered “altered” (e.g., with road crossings and little or no buffer). No areas were recorded as being “highly altered” along Mud Creek.

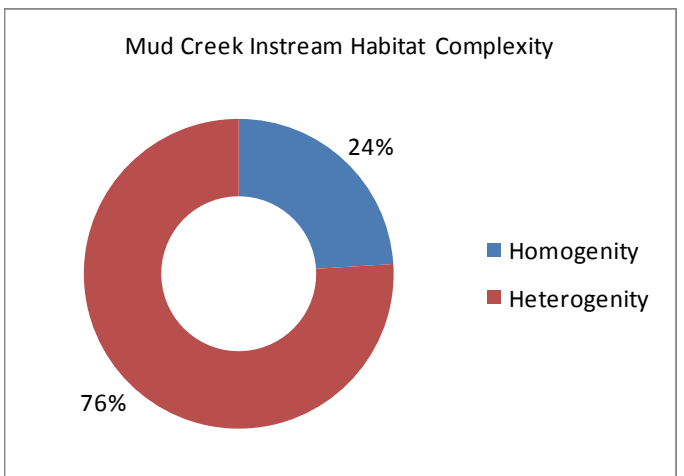
Figure 23. Instream habitat complexity in Mud Creek.

Streams are naturally meandering systems and move over time; there are varying degrees of habitat complexity, depending on the creek. A high percentage of habitat complexity (heterogeneity) typically increases the biodiversity of aquatic organisms within a system. Seventy-six percent of Mud Creek was considered heterogeneous, as shown in Figure 23.

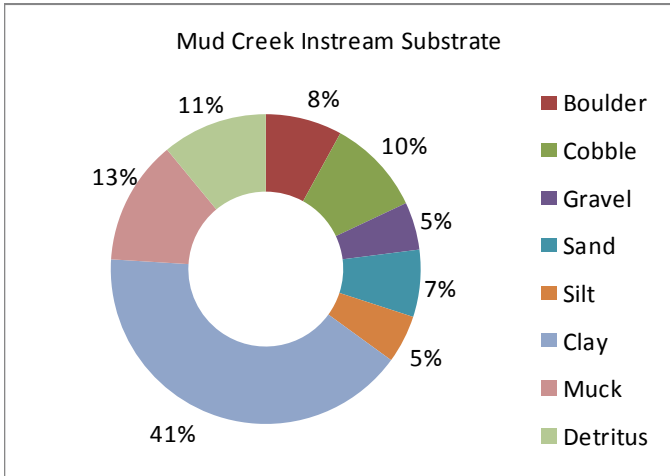
Figure 24. Instream substrate in Mud Creek

Diverse substrate is important for fish and benthic invertebrate habitat because some species have specific substrate requirements and for example will only reproduce on certain types of substrate. Figure 24 shows the diversity of substrate for Mud Creek.
