The RVCA produces individual reports for 16 catchments in the Lower Rideau subwatershed. Using data collected and analysed by the RVCA through its watershed monitoring and land cover classification programs, surface water quality conditions are reported for Murphy Drain along with a summary of environmental conditions for the surrounding countryside every six years.

1) a. Murphy Drain

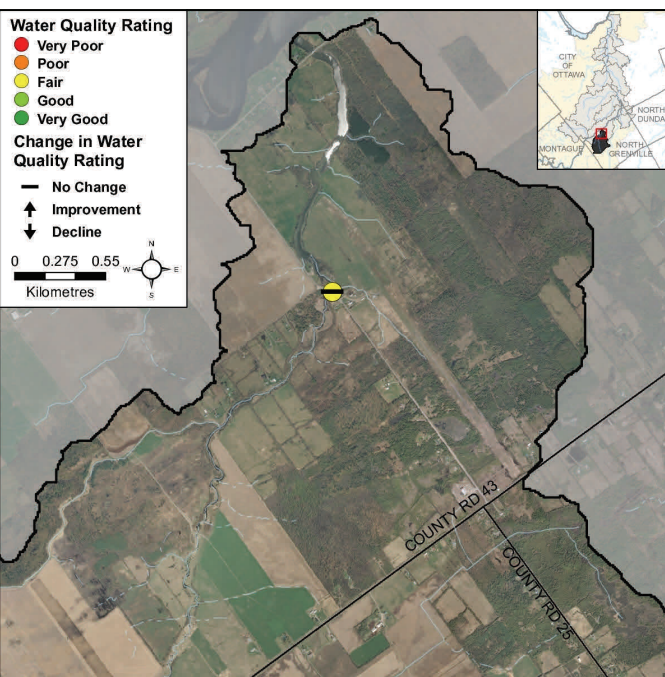
Figure 1. Sampling site in Murphy Drain

Surface water quality conditions in Murphy Drain are monitored through the RVCA's Surface Water Quality Program (at County Road 22 crossing, see Fig.1 for the location).

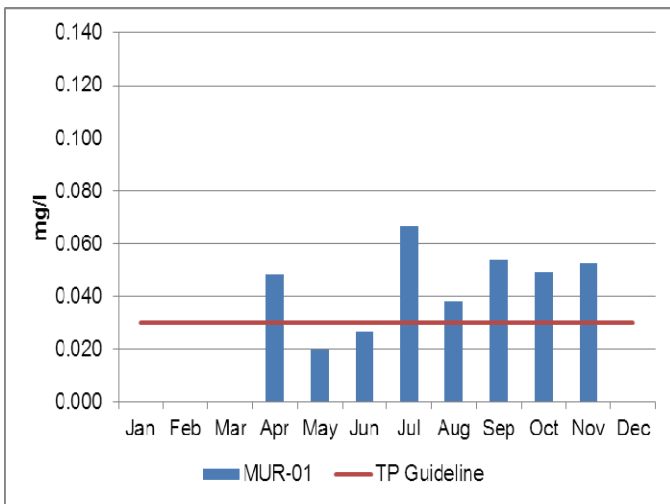
Figure 2a. Total phosphorous concentrations in Murphy Drain from 2000-2005

The proportion of samples below the TP guideline increased from thirty six percent to fifty five percent (Fig. 2a, 2000-2005 and 2b, 2006-2011). There was minimal change in the average TP concentration, a slight increase in average TP concentration was observed

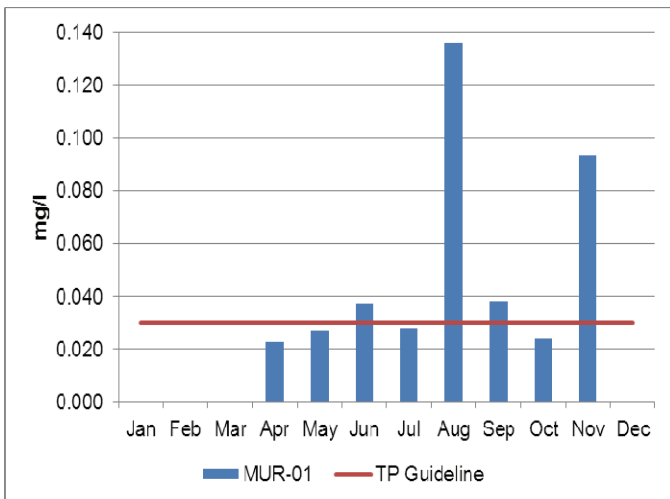
Figure 2b. Total phosphorous concentrations in Murphy Drain from 2006-2011

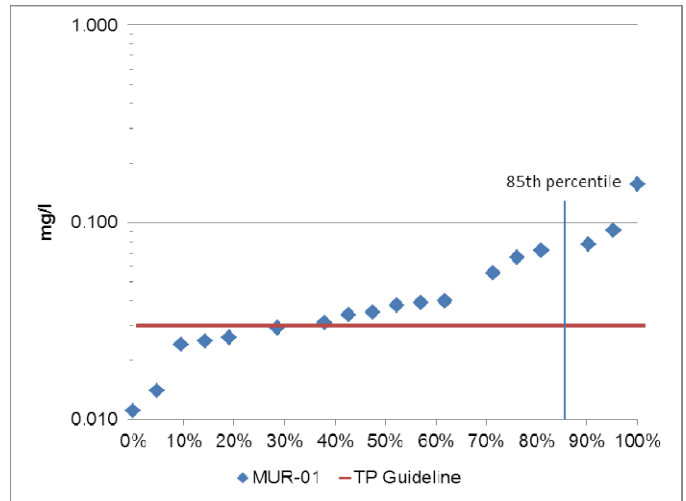
Figure 3a. Percentile plots of Total phosphorous in Murphy Drain from 2000-2005

from 0.047 mg/l (2000-2005) to 0.053 (2006-2011). The target of a TP concentration of 0.030 mg/l at the 85th percentile is not achieved at this site. Though the target is not achieved there has been a decrease in the concentration at the 85th percentile from 0.072 mg/l (2000-2005, Fig. 3a) to 0.052 mg/l (2006-2011, Fig. 3b).

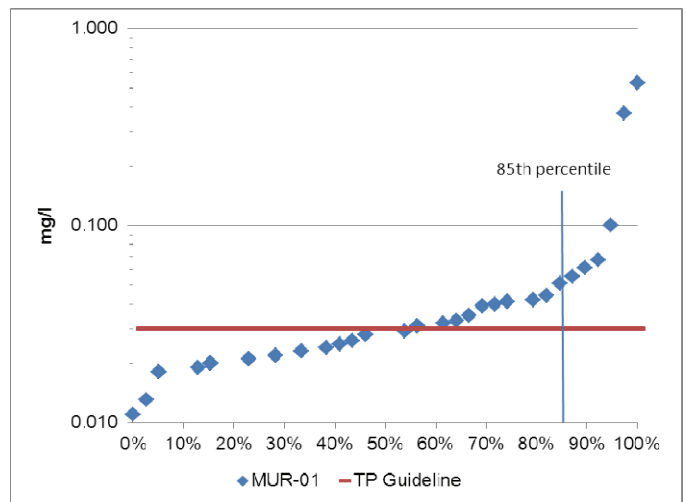
Figure 3b. Percentile plots of Total phosphorous in Murphy Drain from 2006-2011

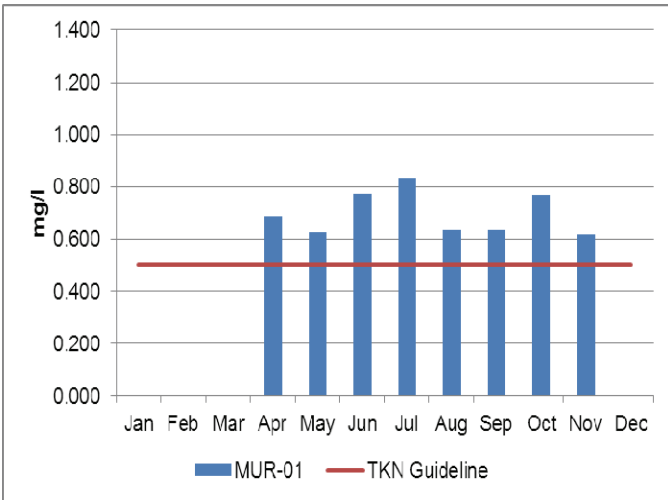
Figure 4a. Total Kjeldahl nitrogen concentrations in Murphy Drain from 2000-2005

TKN results remained fairly consistent. Exceedances above the guideline of 0.500 mg/l were common; the proportion of samples below the guideline increased from no samples to twenty percent. The mean concentration however increased slightly from 0.713 mg/l (Fig. 4a, 2000-2005) to 0.745 mg/l (Fig. 4b, 2006-2011), and just exceeded the guideline.

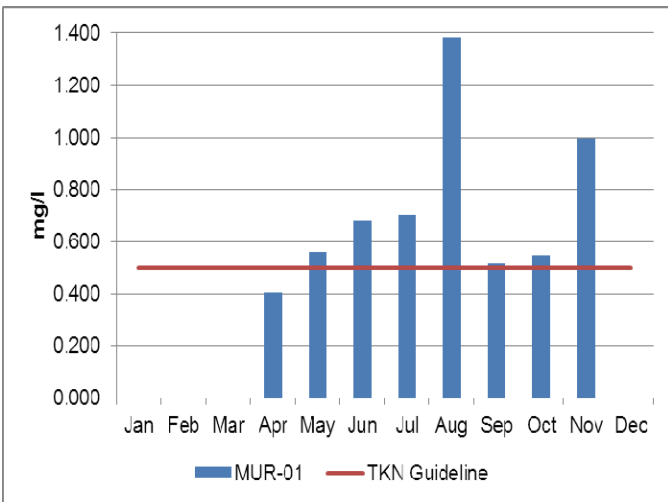
Figure 4b. Total Kjeldahl nitrogen concentrations in Murphy Drain from 2006-2011

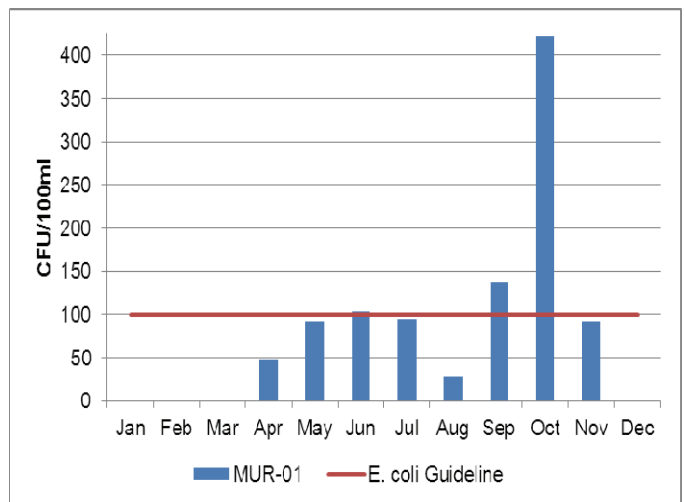
Figure 5a. E. coli concentrations in Murphy Drain from 2000-2005

Figure 5 shows the results of the geometric mean with respect to the guideline for the two periods 2000-2005

(Fig. 5a) and 2006-2011 (Fig 5b). Figures 6a and 6b show percentile plots of the data for the two time periods of interest 2000-2005 (Fig. 6a) and 2006-2011 (Fig. 6b). Any point to the left of the 80th percentile line (vertical) and above the guideline (horizontal line) have failed to reach the LRWS target

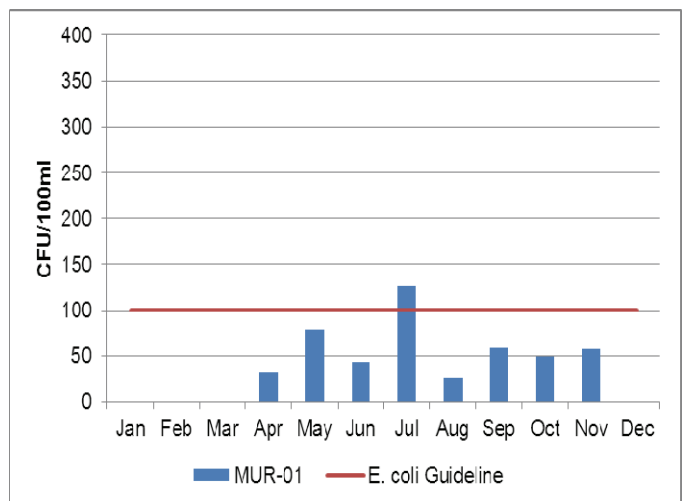
Figure 5b. E. coli concentrations in Murphy Drain from 2006-2011

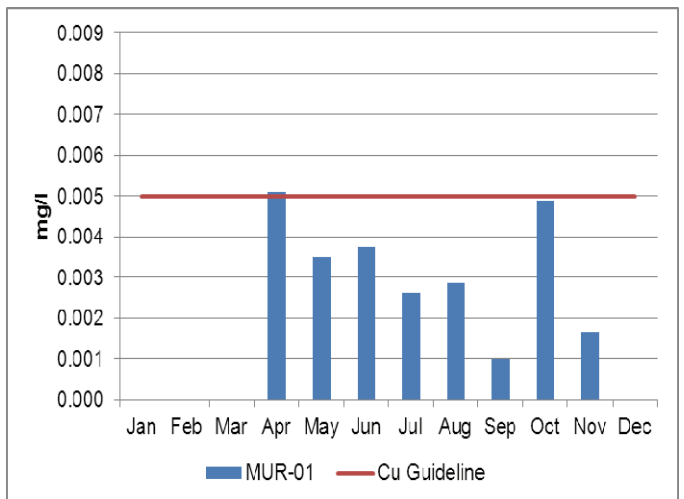
Figure 7a. Copper concentrations in Murphy Drain from 2000-2005

Figures 7a and b, show the results for each month with respect to guidelines for the two periods 2000-2005 (Fig.7a) and 2006-2011 (Fig.7b). The guideline for Cu as stated by the PWQO is 0.005 mg/l. The Lower Rideau Watershed Strategy (2005) also set a target for Cu concentration of 0.005mg/l at the 80th percentile. Figure 8 shows percentile plots of the data for the two time periods of interest (Fig. 8a, 2000-2005 and Fig. 8b, 2006-2011). Any point to the left of the 80th percentile line (vertical) and above the guideline (horizontal line) have failed to reach the LRWS target

The proportion of samples below the guideline decreased from eighty-two percent (Fig.7a) to sixty-five percent (Fig.7b) and the average concentration increased slightly from 0.003 mg/l to 0.004 mg/l.

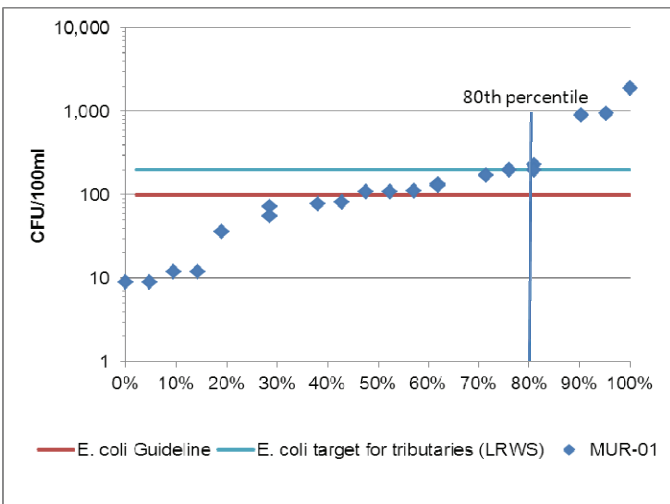
Figure 6a. E. coli concentrations in Murphy Drain from 2000-2005

The proportion of samples below the guideline also increased from only forty-five percent to seventy-eight percent and the geometric mean decreased from 93 CFU/100 ml to 52 CFU/100 ml. In comparing the two time periods E. coli counts at the 80th percentile have decreased from 200 CFU/100 ml (2000-2005, Fig. 6a) to 100 CFU/100 ml (2006-2011, Fig. 6b), to meet the target.

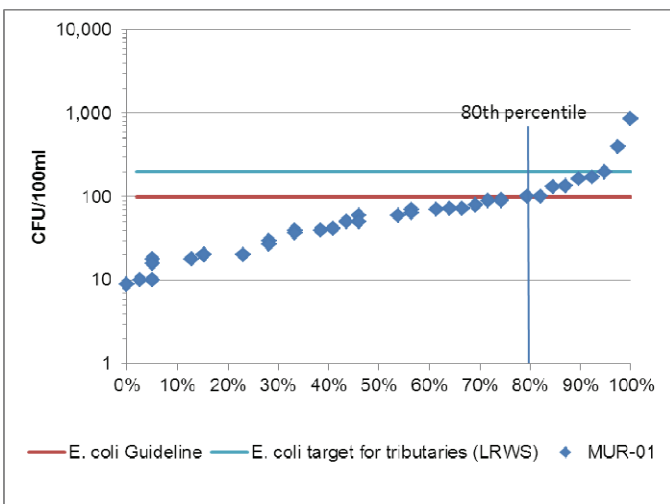
Figure 6b. E. coli concentrations in Murphy Drain from 2006-2011

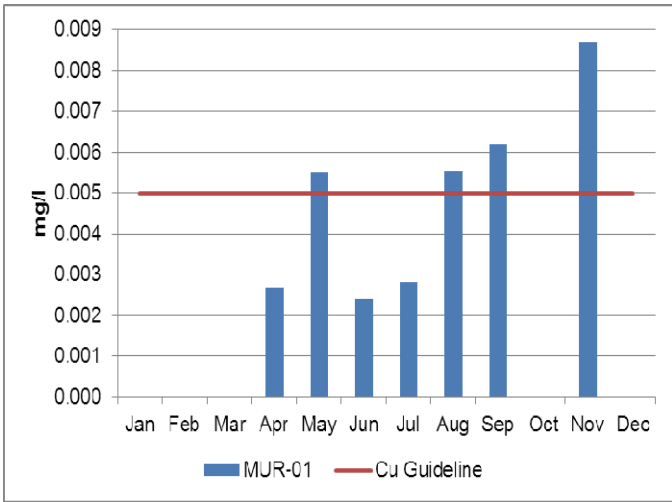
Figure 7b. Copper concentrations in Murphy Drain from 2006-2011

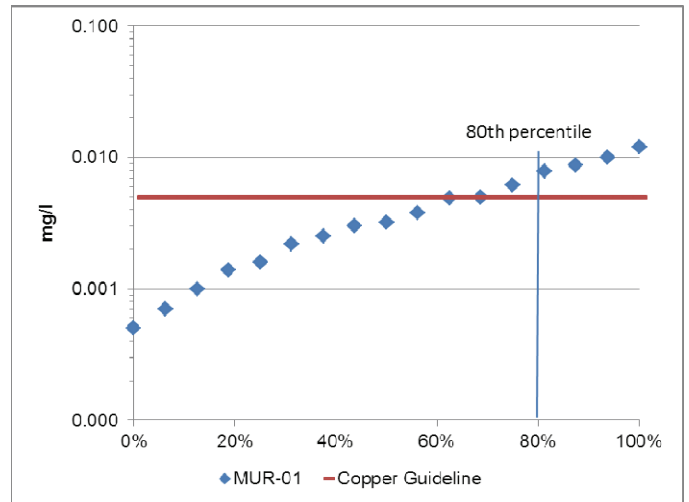
Figure 8b. Percentile plots of copper in Murphy Drain from 2006-2011

Of the three metals, copper (Cu) was the only metal that reported concentrations that exceeded the target of 0.005 mg/l at the 80th percentile. Figures 8a and 8b show that at the 80th percentile Cu concentrations have increased from 0.003 mg/l (Fig. 8a, 2000-2005) to exceed the target at 0.008 mg/l (Fig. 8b, 2006-2011).

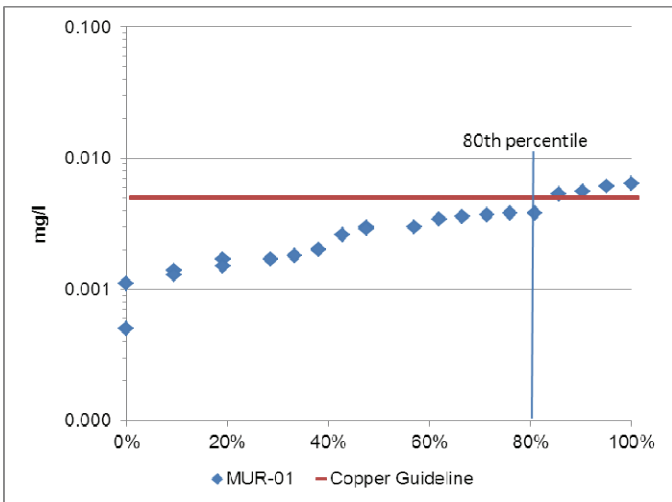
Figure 8a. Percentile plots of copper concentrations in Murphy Drain from 2000-2005

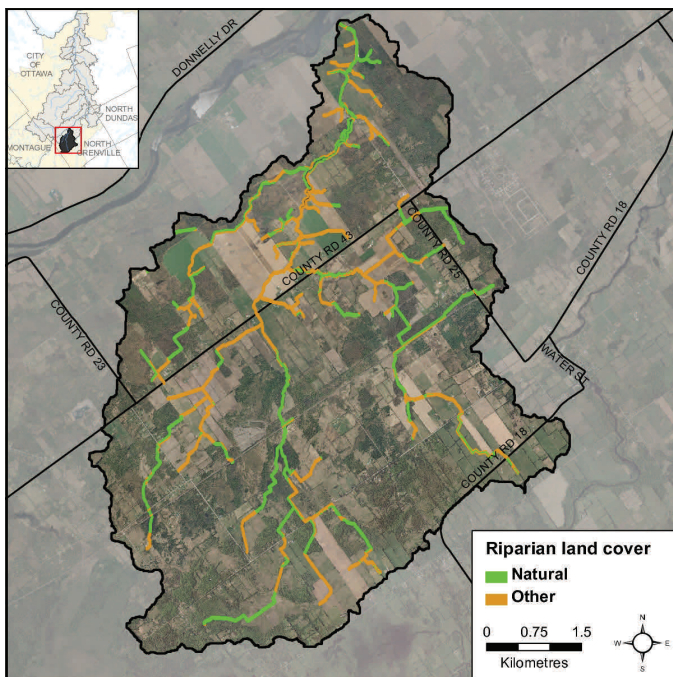
Figure 9. Catchment land cover in the riparian zone

Figure 9 shows the extent of the naturally vegetated riparian zone in the catchment, 30 metres on either side of all waterbodies and watercourses. Results from the RVCA’s Land Cover Classification Program show that 45 percent of streams, creeks and lakes are buffered with woodland, wetland and grassland; the remaining 55 percent of the riparian buffer is occupied by crop and pastureland, transportation and settlement.

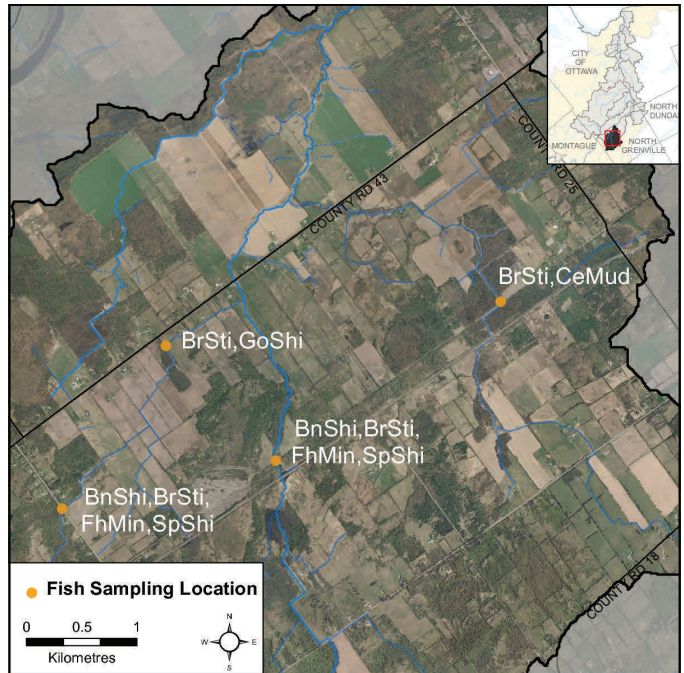
Figure 10. Fish species observed along Murphy Drain

Fish sampling sites located along Murphy Drain are shown in Figure 10. The provincial fish codes shown on the following map are listed (in Table 6) beside the common name of those fish species identified in Murphy Drain (Data source: RVCA and City of Ottawa).

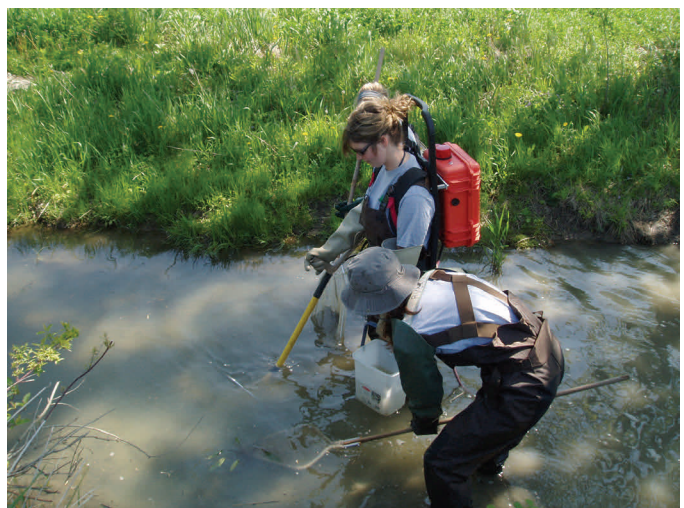
Electrofishing is a method used for fish community sampling

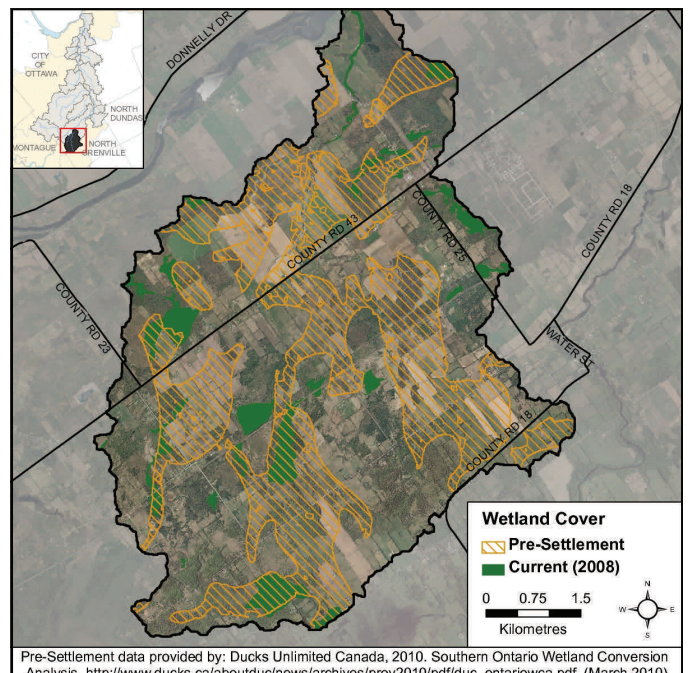
Figure 12. Pre-settlement and present day wetland cover

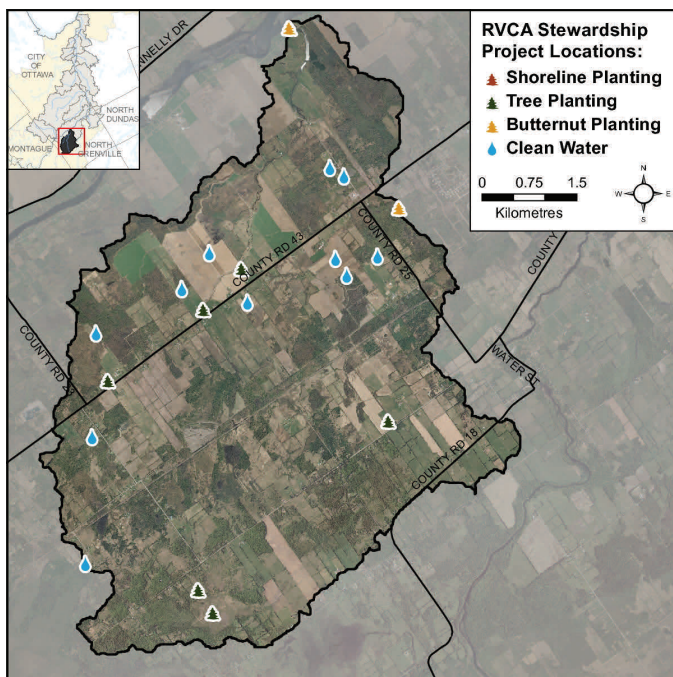
Figure 13. RVCA stewardship program project locations

Figure 13 shows the location of all Rural Clean Water Projects in the Murphy Drain area. From 2006 to 2011, landowners completed 4 projects including 2 septic system repair/replacements, 1 well upgrade and 1 well decommissioning. In total, RVCA contributed \$4,500 in grant dollars to projects valued at \$22,661.

The location of all tree planting and shoreline projects is also shown in Figure 13. From 2006 to 2011, 11,800 trees, valued at \$22,840, were planted on 3 sites through the RVCA Tree Planting Program.

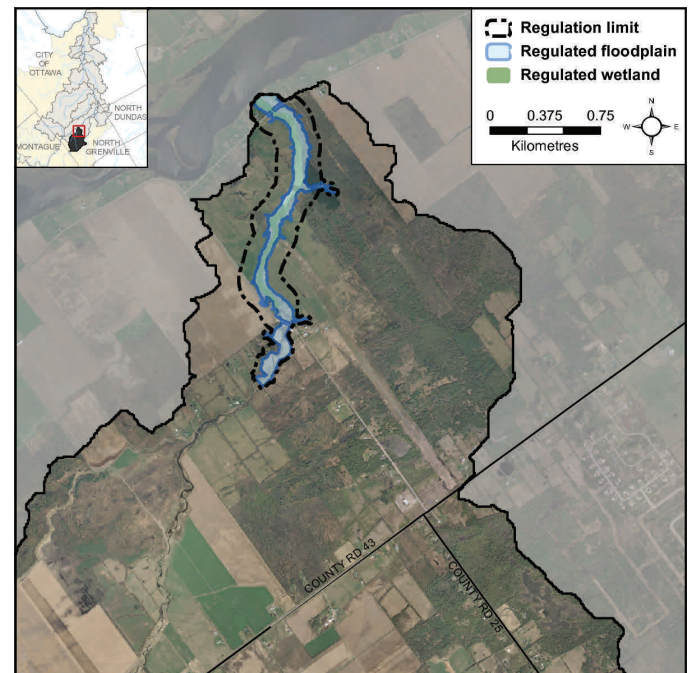
Figure 14. RVCA regulation limits

One square kilometre or one percent of the catchment drainage area is within the regulation limit of Ontario Regulation 174/06 (Fig.14), giving protection to wetland areas and river or stream valleys that are affected by flooding and erosion hazards.
