The RVCA produces individual reports for 16 catchments in the Lower Rideau subwatershed. Using data collected and analysed by the RVCA through its watershed monitoring and land cover classification programs, surface water quality conditions are reported for Nepean Creek along with a summary of environmental conditions for the surrounding countryside every six years.

1) a. Nepean Creek

Surface water quality conditions in Nepean Creek are monitored through the City of Ottawa's Baseline Water Quality Program (downstream of Fisher Glen stormwater treatment facility, see Fig. 1 for the location).

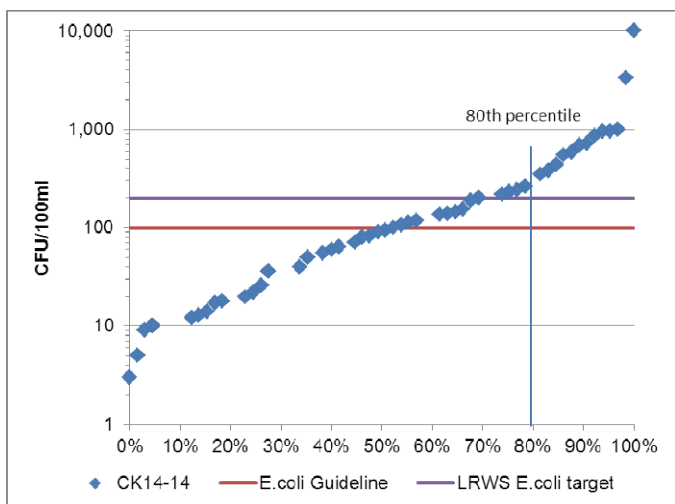
Figure 6a. Percentile plots of E. coli in Nepean Creek from 2000-2005

Figure 5 shows the results of the geometric mean with respect to the guideline for the two periods 2000-2005 (Fig. 5a) and 2006-2011 (Fig 5b). Figures 6a and 6b show percentile plots of the data for the two time periods of interest 2000-2005 (Fig. 6a) and 2006-2011 (Fig. 6b). Any point to the left of the 80th percentile line (vertical) and above the guideline (horizontal line) have failed to reach the LRWS target.

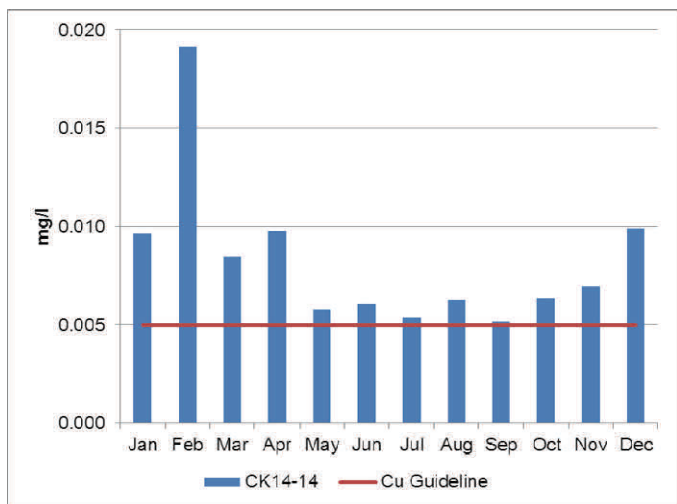
Figure 9b. Copper concentrations in Nepean Creek from 2006-2011

Results for Cu concentrations were also occasionally above the guideline of 0.005 mg/l. The proportion of samples below the guideline decreased from fifty-six percent (Fig. 9a, 2000-2005) to thirty-two percent (Fig. 8b, 2006-2011), the average concentration increased from 0.005 mg/l to 0.008 mg/l. Percentile plots of Cu data are shown for the two time periods 2000-2005 (Fig. 10a) and 2006-2011 (Fig. 10b). The target of a Cu concentration of 0.005 mg/l at the 80th percentile has not

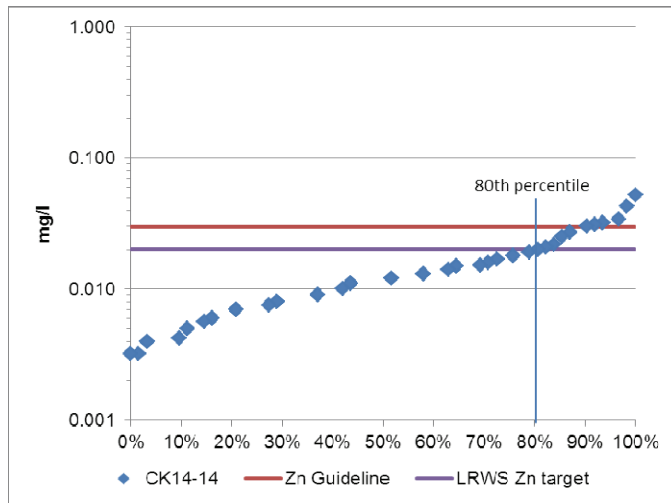
Figure 12b. Percentile plots of zinc in Nepean Creek from 2006-2011

Zn concentrations also exceeded the established guidelines on occasion. The majority of samples were below the guideline and the proportion increased slightly from eighty-six percent (Fig. 11a, 2000-2005) to eighty-nine percent (Fig. 11b, 2006-2011) and the average concentration decreased from 0.021 mg/l to 0.014 mg/l. Percentile plots of Zn data are shown for the two time periods 2000-2005 (Fig. 12a) and 2006-2011 (Fig. 12b). The target of a Zn concentration of 0.020 mg/l at the 80th percentile was not achieved in the 2000-2005 (Fig. 12a) as Zn results were 0.030 at the 80th percentile. The target was met in the 2006-2011 periods (Fig. 12b) as the concentration at the 80th percentile equals 0.020 mg/l.

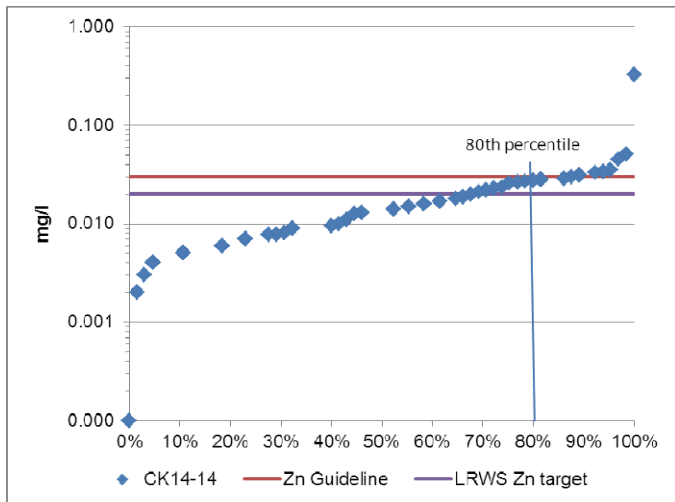
Figure 12a. Percentile plots of zinc in Nepean Creek from 2000-2005

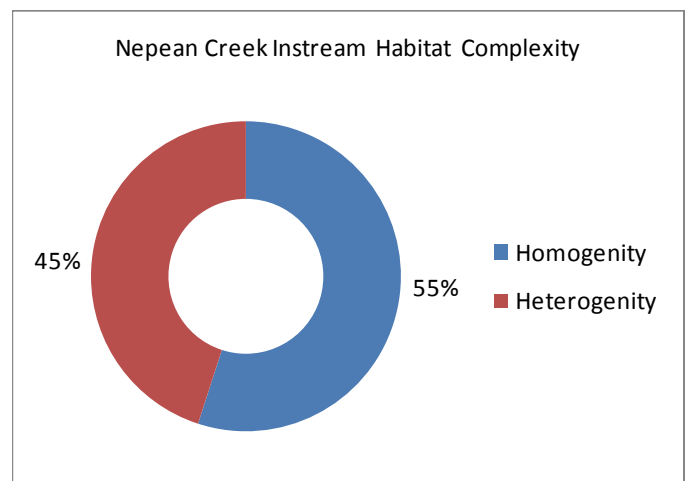
Figure 22. Instream habitat complexity in Nepean Creek.

Streams are naturally meandering systems and move over time, there are varying degrees of habitat complexity, depending on the creek. A high percentage of habitat complexity (heterogeneity) typically increases the biodiversity of aquatic organisms within a system. Forty-five percent of Nepean Creek was considered heterogeneous, as seen in Figure 22.

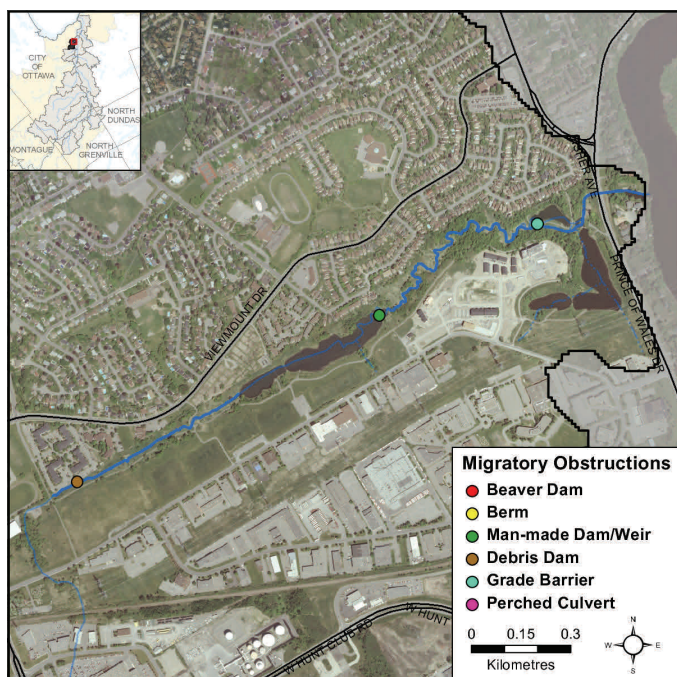
Figure 33. Migratory obstructions in Nepean Creek

It is important to know the locations of migratory obstructions because these can prevent fish from accessing important spawning and rearing habitat (Figure 33). Migratory obstructions can be natural or manmade, and they can be permanent or seasonal. There were three migratory obstructions within the Nepean Creek catchment at the time of the survey.

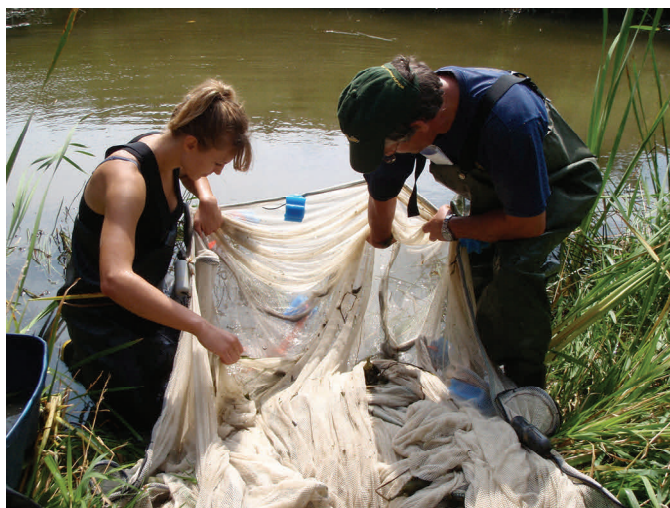
RVCA retrieving a seine net from Nepean Creek
