The RVCA produces individual reports for 16 catchments in the Lower Rideau subwatershed. Using data collected and analysed by the RVCA through its watershed monitoring and land cover classification programs, surface water quality conditions are reported for the Rideau River along with a summary of environmental conditions for the surrounding countryside every six years.

**1) a. Rideau River-Hogs Back**

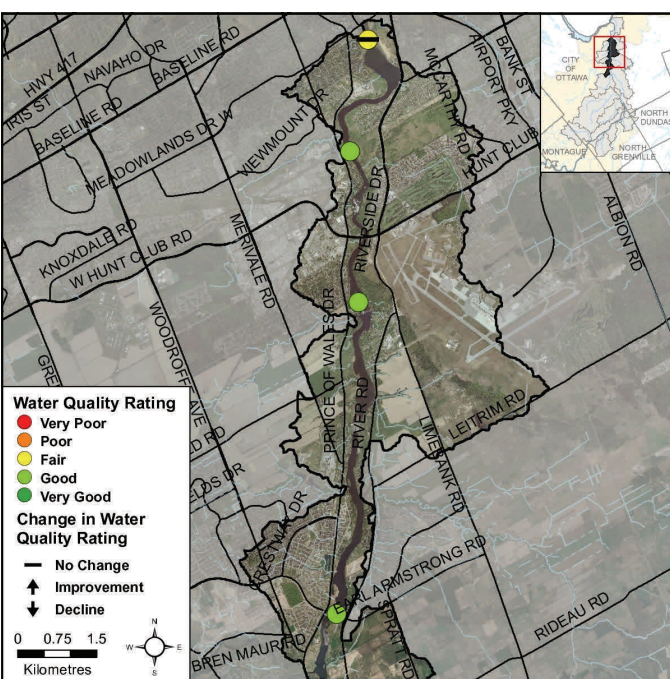
Figure 1. Sampling sites on Rideau River-Hogs Back

Surface water quality conditions in Rideau River-Hogs Back catchment are monitored through the City of Ottawa's Baseline Water Quality Program (RRS127 near Rideau Road and Earl Armstrong intersection, RRS117B Black Rapids lock station, RRS126 immediately downstream of the Hunt Club Creek outlet, RRS167B mid channel at Mooney's Bay) (See Fig. 1 for their locations).

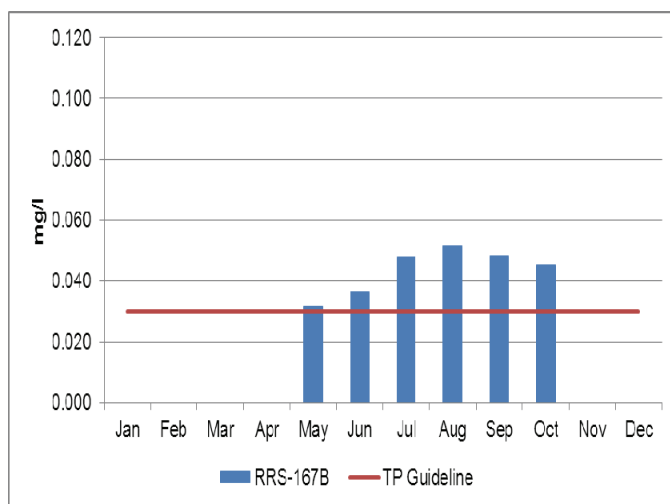
Figure 2a. Total phosphorous concentrations in Rideau River-Hogs Back from 2000-2005

The majority of samples at this site were above the TP guideline of 0.030mg/l for both time periods (Fig. 2a, 2000-2005 and 2b, 2006-2011). Thirteen percent of samples were below the guideline in the 2000-2005 period; this improved to twenty five percent of samples in the 2006-2011 period. Average TP concentration decreased from 0.044 mg/l (2000-2005) to 0.054mg/l (2006-2011). Percentile plots of TP data are shown for two time periods 2000-2005 (Fig. 3a) and 2006-2011 (Fig. 3b) and show that the target set by the LRWS has not been achieved. The concentration at the 85<sup>th</sup> percentile decreased from 0.059 mg/l (2000-2005, Fig. 3a) to 0.051 mg/l (2006-2011, Fig. 3b).

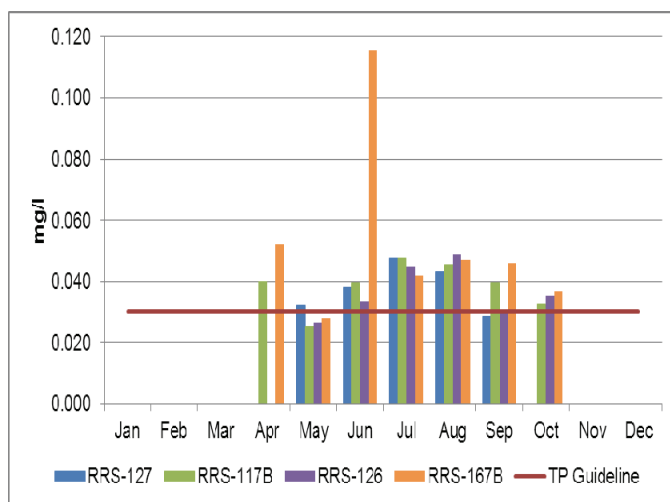
Figure 2b. Total phosphorous concentrations in Rideau River-Hogs Back from 2006-2011

At site RRS-127 only twenty percent of samples were below the guideline and the average TP concentration exceeded the guideline at 0.038 mg/l (Fig. 2b). Percentile plots of TP data show that the target set by the LRWS has not been achieved as the concentration at the 85<sup>th</sup> percentile is equal to 0.044 mg/l (Fig. 3b).

TP results at site RRS-117B were comparable to RRS-127, twenty-one percent of samples were below the guideline and the average TP concentration exceeded the guideline at 0.039 mg/l (Fig. 2b). Percentile plots of TP data show that the target set by the LRWS has not been achieved as the concentration at the 85<sup>th</sup> percentile is equal to 0.052 mg/l (Fig.3b).

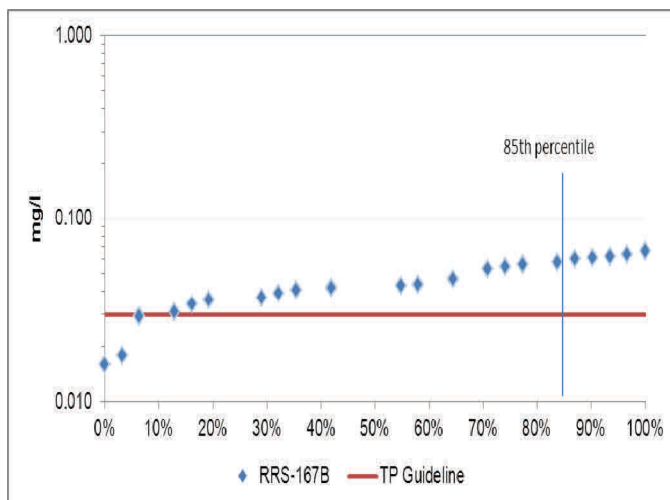
Figure 3a. Percentile plots of total phosphorous concentrations in Rideau River-Hogs Back from 2000-2005

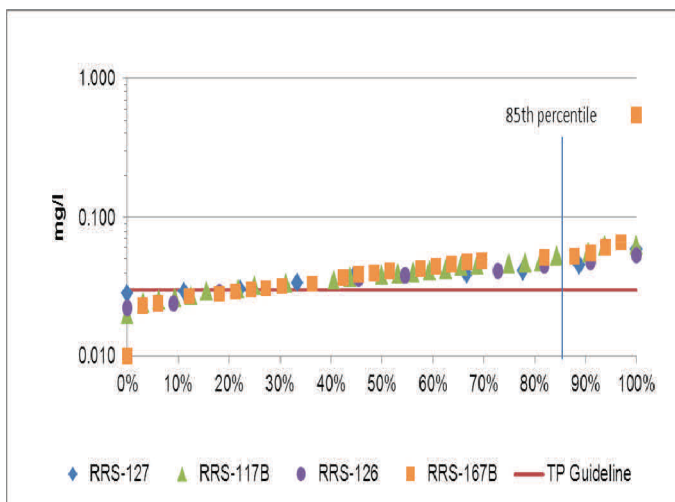
Figure 3b. Percentile plots of total phosphorous concentrations in Rideau-River-Hogs Back from 2006-2011

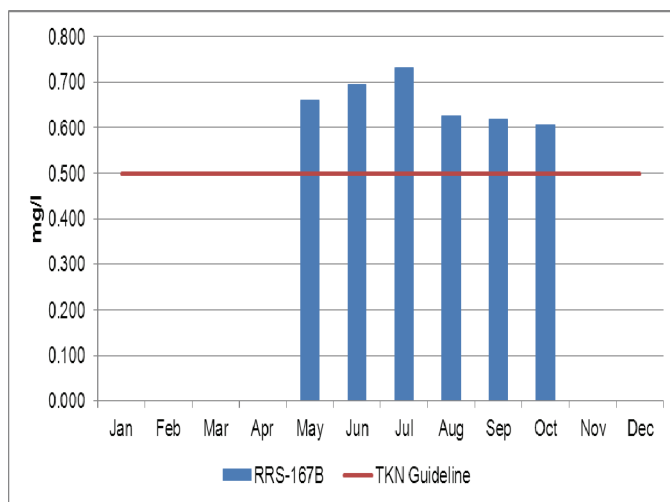
Figure 4a. Total Kjeldahl nitrogen concentrations in Rideau River-Hogs Back from 2000-2005

TKN results show that the majority of results exceeded the TKN guideline of 0.500 mg/l (Fig. 4a and 4b), there were no samples below the guideline in the 2000-2005 period and improved slightly to three percent in the 2006-2011 period. The average concentration decreased from 0.655 mg/l to 0.651 mg/l.

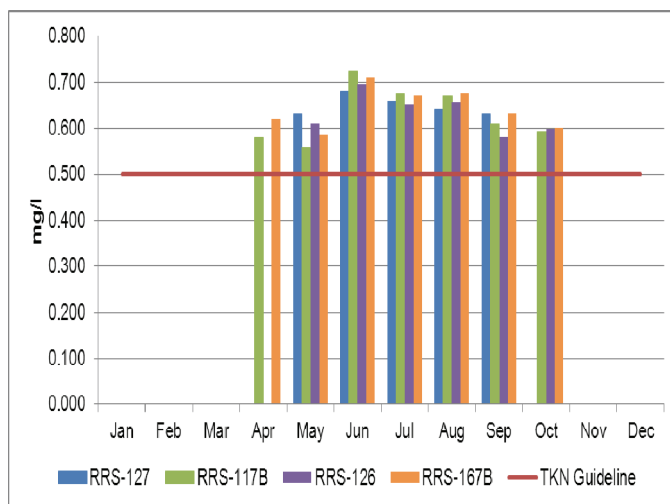
Figure 4b. Total Kjeldahl nitrogen concentrations in Rideau River-Hogs Back from 2006-2011

Total Kjeldahl nitrogen (TKN) is used as a secondary indicator of nutrient loading; RVCA uses a guideline of 0.500 mg/l (TKN Guideline) to assess TKN concentrations. Rideau River-Hogs Back TKN results are shown in Figures 4a and 4b.

TKN results show that all results exceeded the TKN guideline of 0.500 mg/l (Fig. 4b). The average concentration exceeded the guideline at 0.648 mg/l.

TKN results show that only three percent of samples were below the TKN guideline of 0.500 mg/l (Fig. 4b). The average concentration exceeded the guideline at 0.645 mg/l.

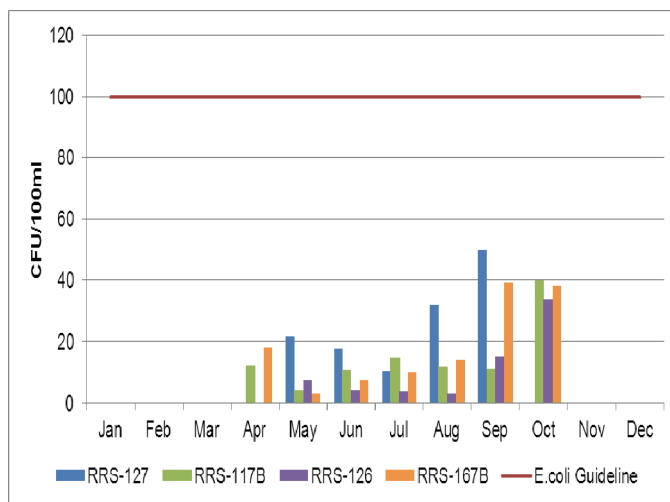
Figure 5b. E. coli counts in Rideau River-Hogs Back from 2006-2011

Figures 5a and 5b show the results of the geometric mean with respect to the guideline for the two periods 2000-2005 (Fig. 5a) and 2006-2011 (Fig. 5b). Figures 6a and 6b show percentile plots of the data for the two time periods of interest 2000-2005 (Fig. 6a) and 2006-2011 (Fig. 6b). Any point to the left of the 80<sup>th</sup> percentile line (vertical) and above the guideline (horizontal line) have failed to reach the LRWS target.

At site RRS-127, ninety percent of samples were below the guideline with a count at the geometric mean equal to 23 CFU/100ml (Fig. 5b).

At Site RRS-117B and RRS 126 all samples were below the guideline of 100 CFU/100ml with counts at the geometric mean of 12 CFU/100ml and 8 CFU/100ml respectively (5b).

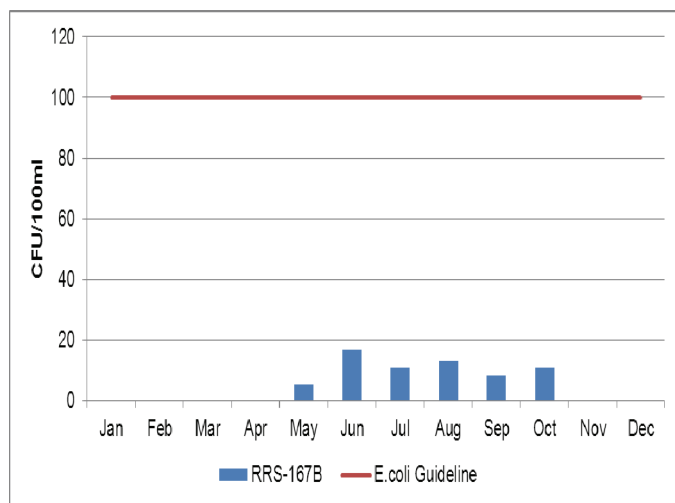
Figure 5a. E. coli counts in Rideau River-Hogs Back from 2000-2005

The furthest downstream site in this reach, RRS-167B showed a slight reduction in the proportion of samples below the guideline dropping from ninety-four percent (2000-2005, Fig. 5a) to ninety-one percent (2006-2011, Fig. 5b). The count at the geometric mean was quite low and increased from 11 CFU/100ml at 13 CFU/100ml during the two periods of interest. Figures 6a and 6b show that all samples results were below the maximum target of 500 CFU/100ml at all four sites.

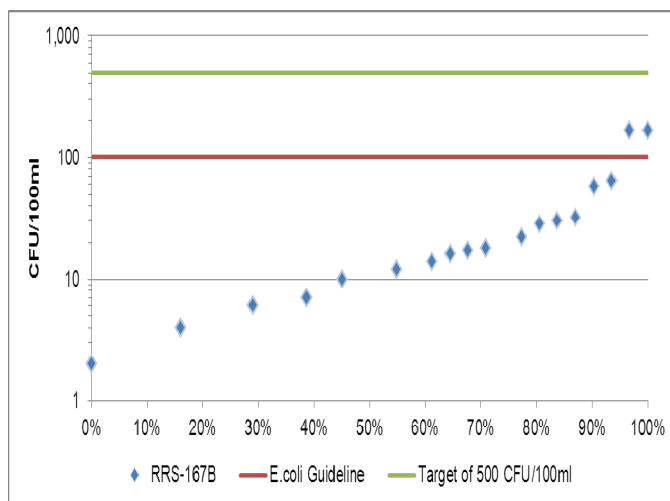
Figure 6a. Percentile plots of E. coli in Rideau River-Hogs Back from 2000-2005

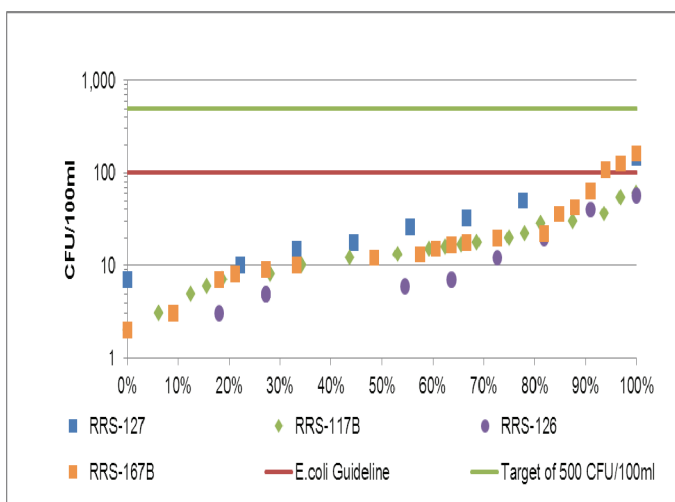
Figure 6b. Percentile plots of *E. coli* in Rideau river-Hogs Back from 2006-2011

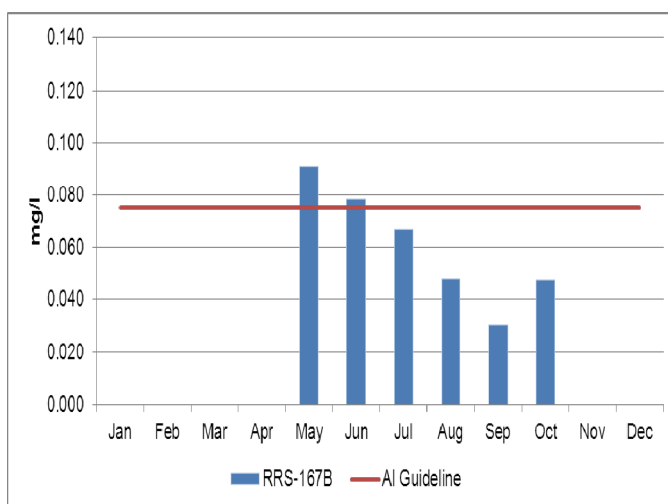
Figure 7a. Aluminum concentrations in Rideau River-Hogs Back from 2000-2005m

Figure 7 shows the results for each site with respect to guidelines for the two periods 2000-2005 (Fig. 7a) and 2006-2011 (Fig. 7b). The aluminum guideline as stated by the PWQO is Al 0.075 mg/l.

The furthest downstream site in this reach, RRS-167B showed an improvement from its nearest upstream site. In the 2000-2005 period seventy-seven percent of samples were below the guideline (Fig. 7a) and improved to eighty-two percent of samples in the 2006-2011 period (Fig. 7b). The average concentrations remained fairly constant between the two periods decreasing slightly from 0.059 mg/l to 0.057 mg/l.

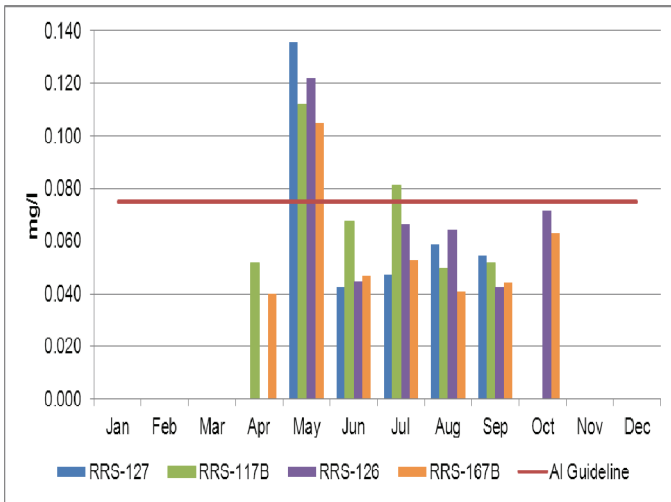
Figure 7b. Aluminum concentrations in Rideau river-Hogs Back from 2006-2011

At site RRS-127, ninety percent of samples were below the guideline with an average concentration of 0.068 mg/l (Fig. 7b).

Site RRS-117B had fewer samples below the guideline (seventy-three percent) but had a comparable average concentration of 0.067 mg/l (Fig. 7b).

Only fifty-eight percent of samples at site RRS -126 were less than the guideline, the average concentration was 0.069 mg/l (Fig. 7b).

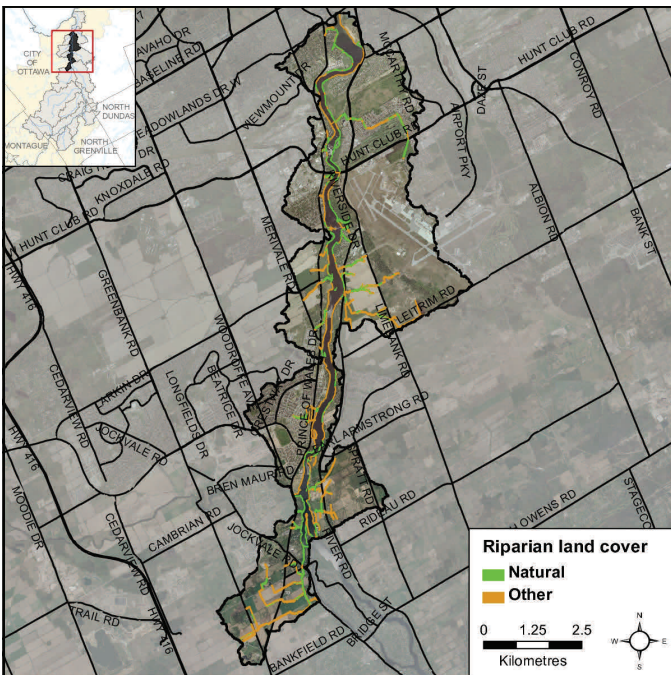
Figure 8. Catchment land cover in the riparian zone

Figure 8 shows the extent of the naturally vegetated riparian zone in the catchment, 30 metres on either side of all waterbodies and watercourses. Results from the RVCA’s Land Cover Classification Program show that 36 percent of streams, creeks and lakes are buffered with woodland, wetland and grassland; the remaining 66 percent of the riparian buffer is occupied by settlement, crop and pastureland and transportation.

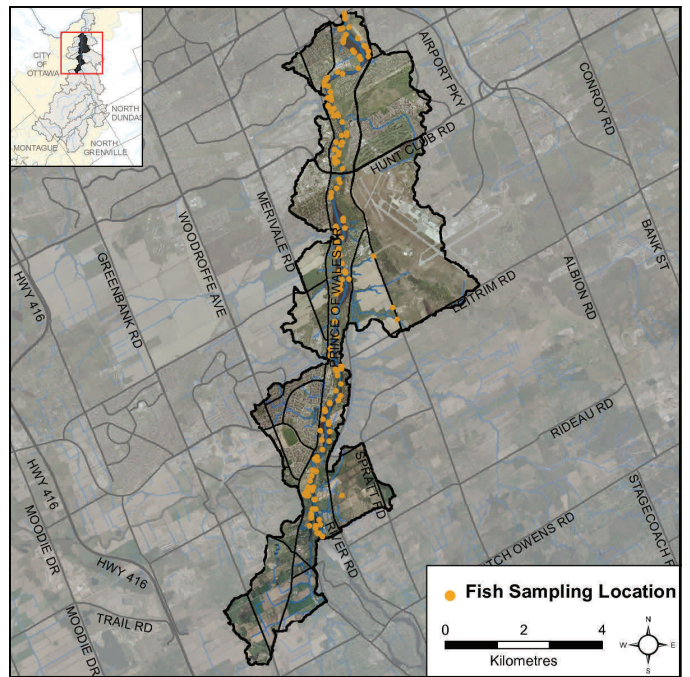
Figure 9. Fish sampling locations along the Hogs Back reach

Fish sampling sites located along the Hogs Back reach are shown in Figure 9. The provincial fish codes shown on the following map are listed (in Table 6) beside the common name of those fish species identified in the Hogs Back reach of the Rideau River.

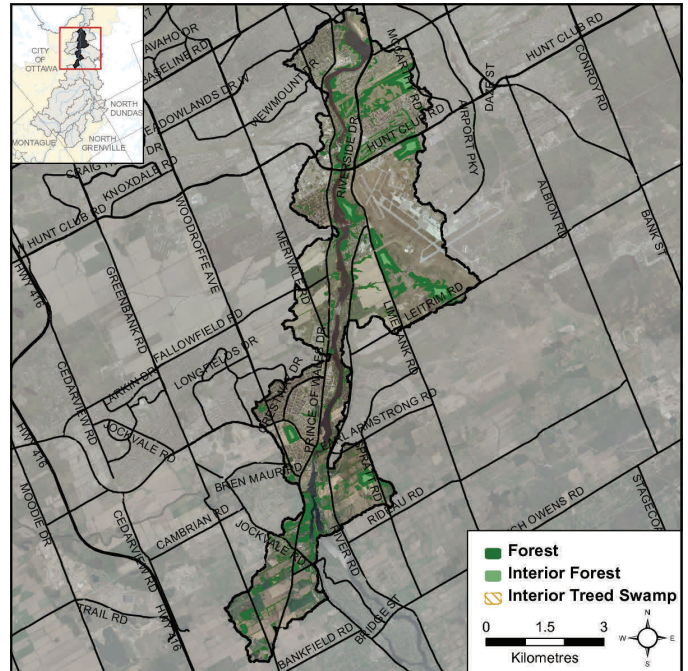
Figure 12. Catchment woodland cover and forest interior

The Rideau River-Hogs Back catchment contains 498 hectares of woodland (Fig.12) that occupies 13 percent of the drainage area. This figure is less than the 30 percent of woodland area required to sustain forest birds, according to Environment Canada’s Guideline: “How much habitat is enough?” When forest cover declines below 30 percent, forest birds tend to disappear as breeders across the landscape.

The same 163 woodlands contain 17 forest interior patches (Fig.12) that occupy one percent (32 ha.) of the catchment land area. This is below the ten percent figure referred to in the Environment Canada Guideline that is considered to be the minimum threshold for supporting edge intolerant bird species and other forest dwelling species in the landscape.

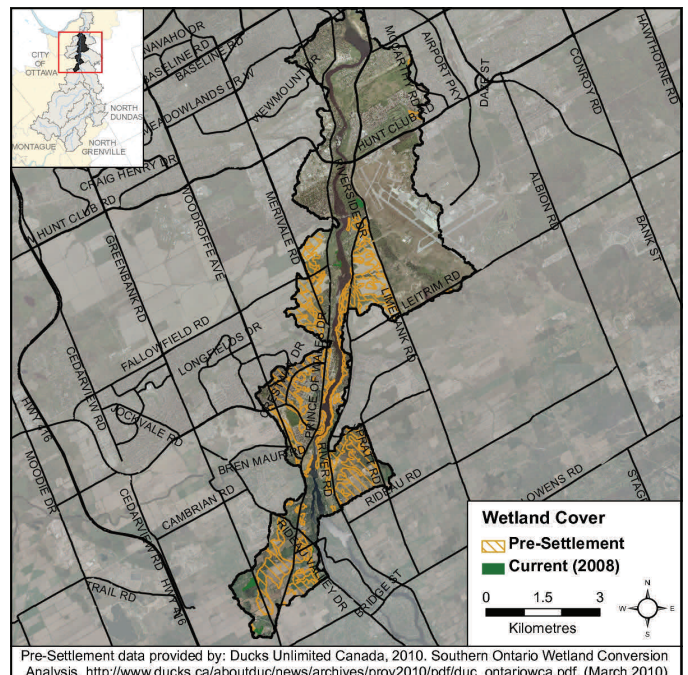
Figure 13. Pre-settlement and present day wetland cover

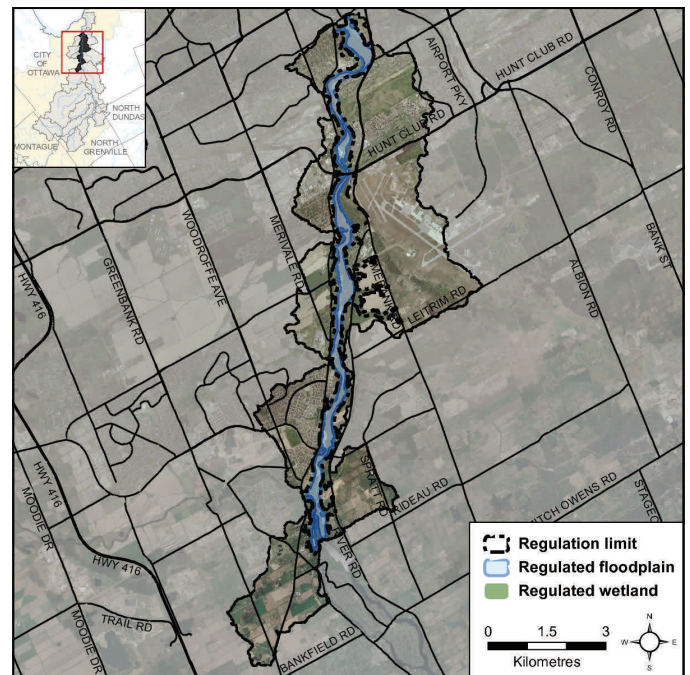
Figure 15. RVCA regulation limits

Six square kilometres or 16 percent of the catchment drainage area is within the regulation limit of Ontario Regulation 174/06 (Fig.15), giving protection to wetland areas and river or stream valleys that are affected by flooding and erosion hazards.
