# RIDEAU RIVER - KARS CATCHMENT

## LOWER RIDEAU RIVER SUBWATERSHED REPORT 2012

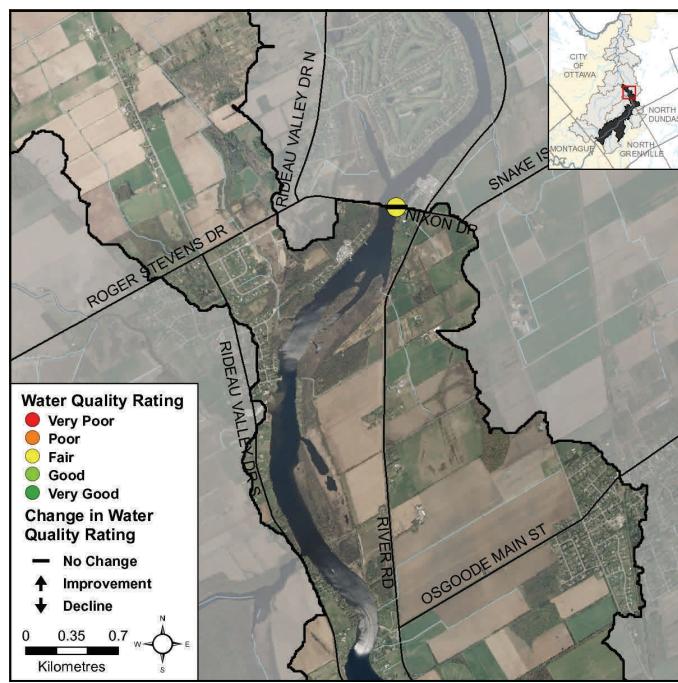
Figure 1. Sampling site on Rideau River-Kars

Surface water quality conditions in Rideau River-Kars are monitored through the City of Ottawa's Baseline Water Quality Program (Site RRS-121C upstream side of Roger Stevens Road bridge, see Fig. 1 for the location).

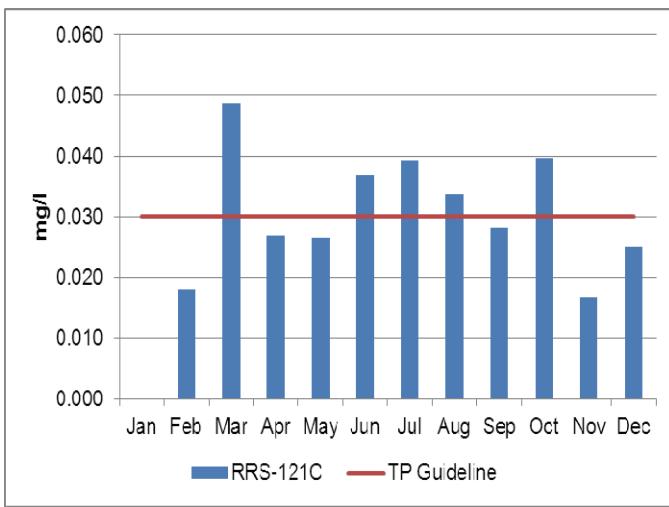
Figure 2a. Total phosphorous concentrations in Rideau River-Kars from 2000-2005

guideline of 0.030 mg/l with little change between the two time periods (Fig. 2a, 2000-2005 and Fig. 2b, 2006-2011). Fifty-five percent of samples were below the guideline in the 2000-2005 period; this declined to forty-nine percent of samples in the 2006-2011 period. There was a slight decrease in average TP concentration from

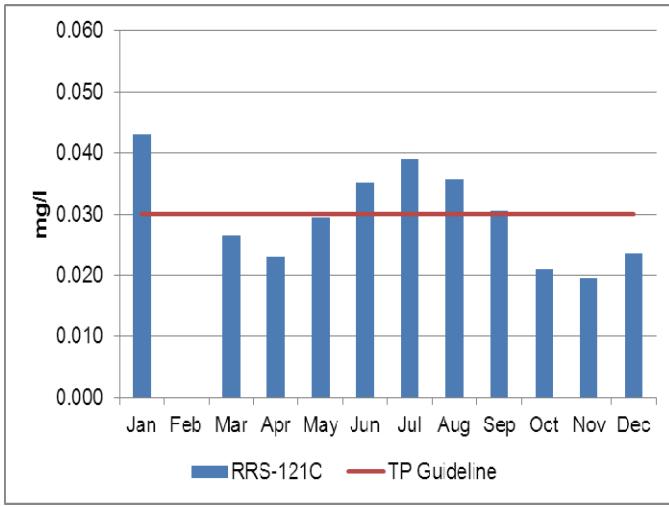
Figure 2b. Total phosphorous concentrations in Rideau River-Kars from 2006-2011

0.032 mg/l (2000-2005) to 0.029 mg/l (2006-2011) which is just below the guideline. The LRWS target of a TP concentration of 0.030 mg/l at the 85<sup>th</sup> percentile has not been achieved at this site, though the concentration at the 85<sup>th</sup> percentile did decrease from 0.042 mg/l (2000-2005, Fig. 3a) to 0.036 mg/l (2006-2011, Fig. 3b).

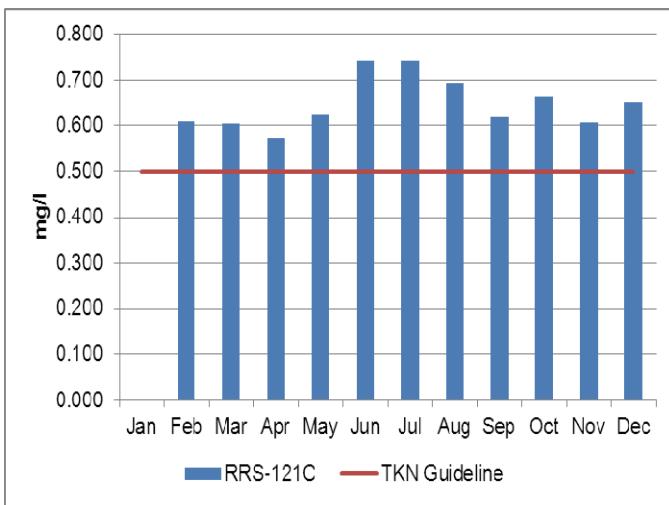
Figure 4a. Total Kjeldahl nitrogen concentrations in Rideau River-Kars from 2000-2005

TKN is used as a secondary indicator of nutrient enrichment. Figures 4a and 4b show that the majority of results exceeded the TKN guideline of 0.500 mg/l; only two percent of samples were below the guideline in 2000-2005, this dropped improved to eleven percent of samples in the 2006-2011 period. The average concentration decreased from 0.650 mg/l to 0.602 mg/l, though exceeding the guideline.

Total Kjeldahl nitrogen (TKN) is used as a secondary indicator of nutrient loading; RVCA uses a guideline of 0.500 mg/l (TKN Guideline) to assess TKN concentrations. Rideau River-Kars TKN results are shown in Figures 4a and 4b.

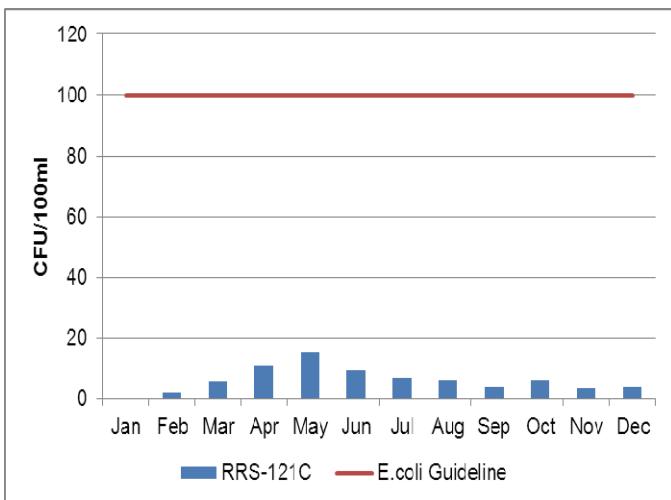
Figure 5a. E. coli counts in the Rideau River-Kars from 2000-2005

E. coli counts above the guideline of 100 colony forming units per 100 mL (CFU/100mL) were rare at the water quality site RRS-121C. In comparing the two time periods the proportion of samples below the guideline remained constant at ninety-five percent, while the count at the geometric mean increased from 6 CFU/100 ml (Fig. 5a, 2000-2005) to 11 CFU/100 ml (Fig. 5b, 2006-2011).

Figure 5 shows the results of the geometric mean with respect to the guideline for the two periods 2000-2005 (Fig. 5a) and 2006-2011 (Fig 5b). Figures 6a and 6b show percentile plots of the data for the two time periods of interest 2000-2005 (Fig. 6a) and 2006-2011 (Fig. 6b). Any point to the left of the 80<sup>th</sup> percentile line (vertical) and above the guideline (horizontal) have failed to reach the LRWS target

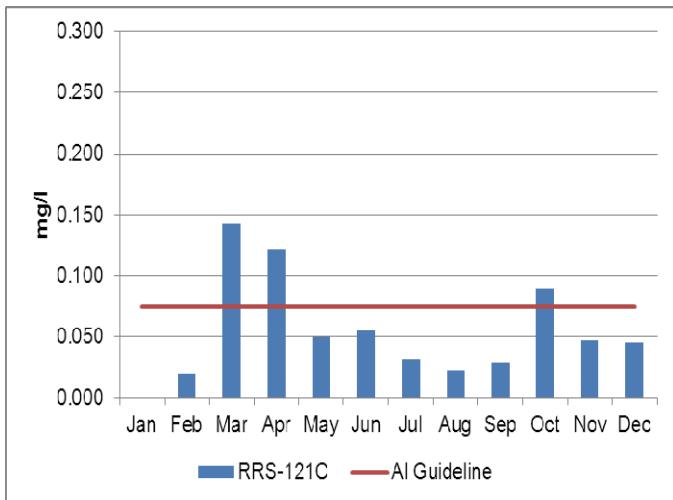
Figure 7a. Aluminum concentrations in Rideau River-Kars from 2000-2005

Results for Al were typically below the guideline of 0.075 mg/l in both time periods (Fig. 7a, 2000-2005 and Fig. 7b, 2006-2011), eighty-one percent of samples were less than the guideline in the 2000-2005 period, this

declined to seventy-six percent in the 2006-2011 period. The average Al concentration remained consistent at 0.062 mg/l.

Figures 7 and 8 show the results for each site with respect to guidelines for the two periods 2000-2005 (figures 7a, and 8a) and 2006-2011 (figures 7b, and 8b). The guidelines for each metal as stated by the PWQO are Al 0.075 mg/l, and Cu 0.005 mg/l. The Lower Rideau Watershed Strategy set a target for Cu concentration of 0.005 mg/l (Cu guideline) at the 75<sup>th</sup> percentile for the main reaches of the Rideau River. Percentile plots of Cu data are shown for the two time periods 2000-2005 (Fig. 9a) and 2006-2011 (Fig. 9b). Any point to the left of the 80<sup>th</sup> percentile line (vertical) and above the guideline (horizontal) have failed to reach the LRWS target.

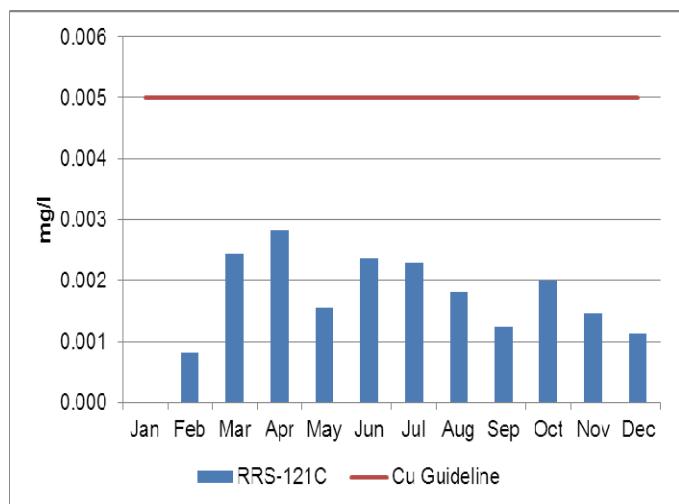
Figure 8a. Copper concentrations in Rideau River-Kars from 2000-2005

Results for Cu concentrations were also occasionally above the guideline of 0.005 mg/l. The proportion of samples below the guideline decreased from ninety-four percent (Fig. 8a, 2000-2005) to eighty percent (Fig. 8b, 2006-2011), the average concentration increased from 0.002 mg/l to 0.004 mg/l. The target of a Cu concentration of 0.005 mg/l at the 75<sup>th</sup> percentile was increased between the time periods to just meet the target in the 2006-2011 period. The concentration at the 75<sup>th</sup> percentile increased from 0.002 mg/l (Fig. 9a, 2000-2005) to 0.0085 mg/l (Fig. 9b, 2006-2011).

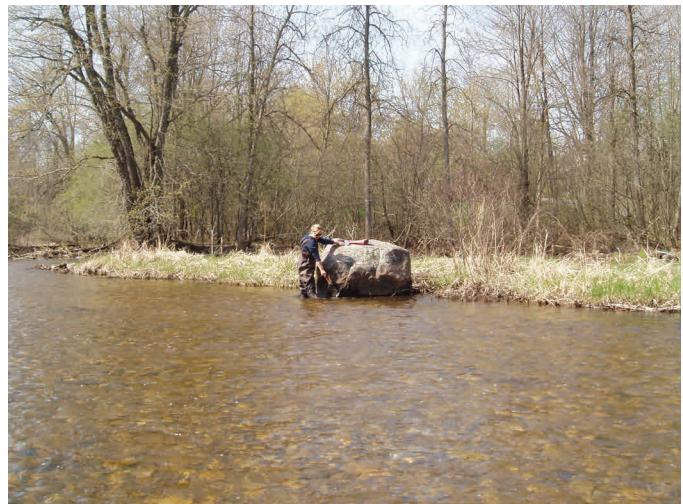
Temperature probes are deployed to determine thermal regime

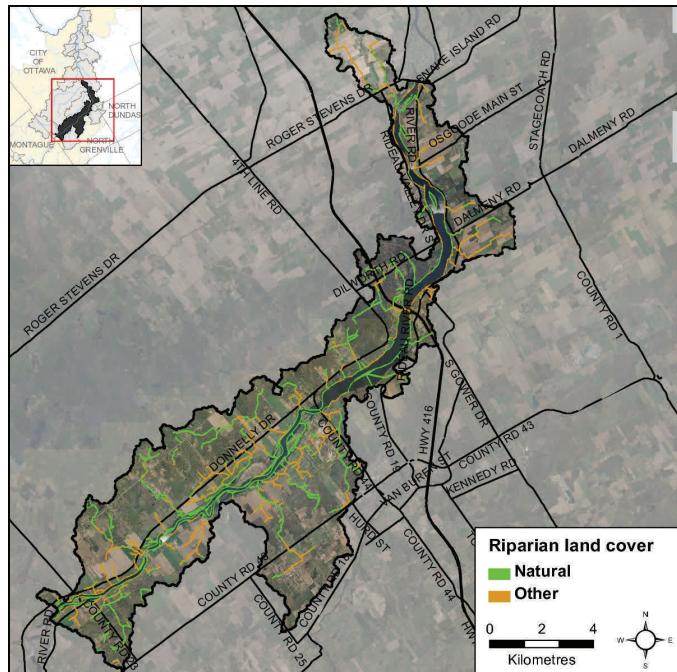
Figure 10. Catchment land cover in the riparian zone

Figure 10 shows the extent of the naturally vegetated riparian zone in the catchment, 30 metres on either side of all waterbodies and watercourses. Results from the RVCA's Land Cover Classification Program show that 56 percent of streams and creeks are buffered with woodland, wetland and grassland; the remaining 44 percent of the riparian buffer is occupied by settlement, crop and pastureland and transportation.

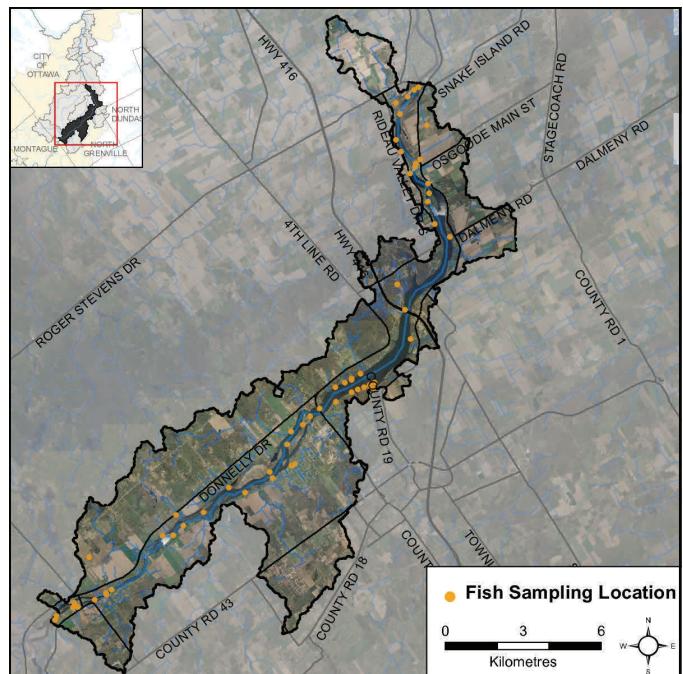
Figure 11. Fish sampling locations along the Kars reach

Fish sampling sites located along the Kars reach are shown in Figure 11. The provincial fish codes shown on the following map are listed (in Table 6) beside the common name of those fish species identified in the Kars reach of the Rideau River.

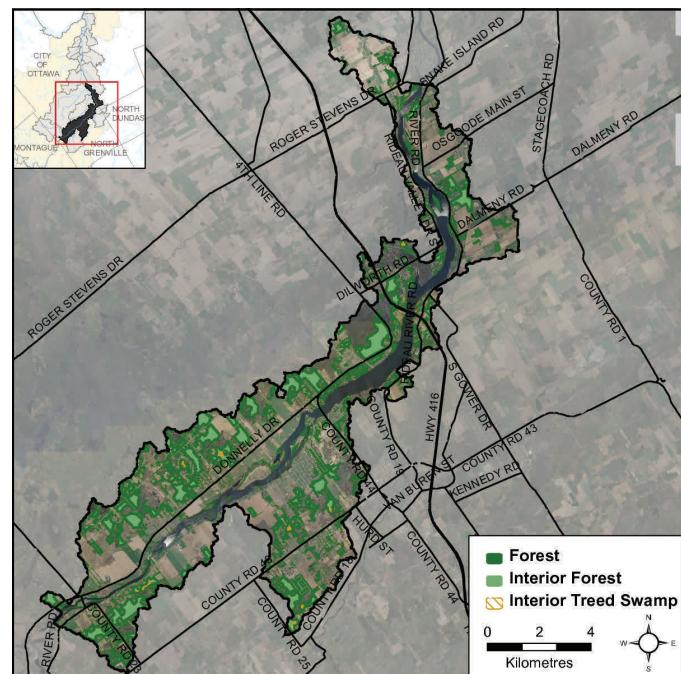
Figure 12. Catchment woodland cover and forest interior

The Rideau River-Kars catchment contains 3166 hectares of woodland (Fig.12) that occupies 29 percent of the drainage area. This figure is less than the 30 percent of woodland area required to sustain forest birds, according to Environment Canada's Guideline: "How much habitat is enough?" When forest cover declines below 30 percent, forest birds tend to disappear as breeders across the landscape.

The same 358 woodlands contain 136 forest interior patches (Fig.12) that occupy four percent (427 ha.) of the catchment land area. This is below the ten percent figure referred to in the Environment Canada Guideline

Most patches (119) have less than 10 hectares of interior forest, 84 of which have small areas of interior forest habitat less than one hectare in size.

Conversely, 17 patches have greater than 10 hectares of interior forest, the largest of which contains more than 50 hectares of interior forest (at 51 ha.).

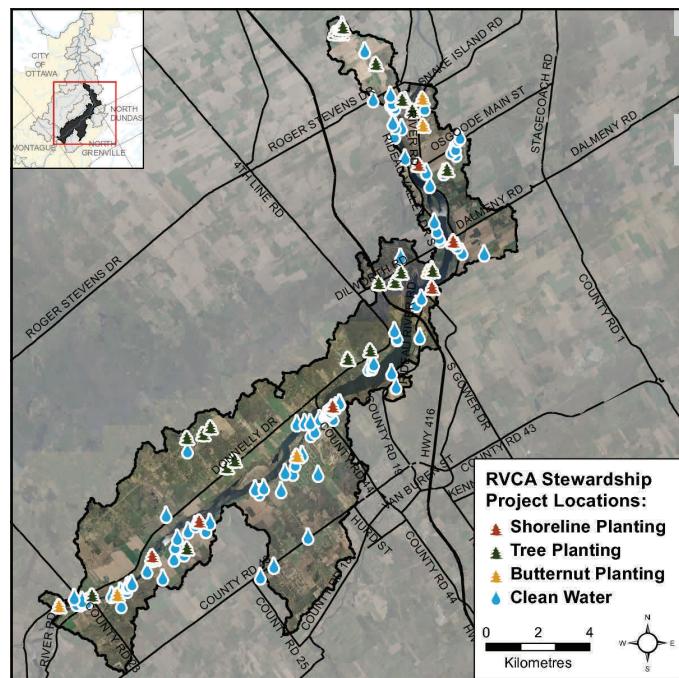
Figure 14. RVCA stewardship program project locations

Figure 14 shows the location of all Rural Clean Water Projects in the Kars drainage area. From 2006 to 2011, landowners completed 71 projects including 29 septic system repair/replacements, 20 well upgrades, 11 well decommissionings, 3 well replacements, 4 erosion control and 4 buffers/windbreaks. In total, RVCA contributed \$94,201 in grant dollars to projects valued \$490,659.

The location of all tree planting and shoreline projects is also shown in Figure 14. From 2006 to 2011, 5400 trees, valued at \$12,324, were planted on 4 sites through the RVCA Tree Planting Program. Before that, from 1984 to 2006, landowners helped plant 100,570 trees, valued at \$145,781, on 18 project sites, using the RVCA Tree Planting Program, on 50.3 hectares of

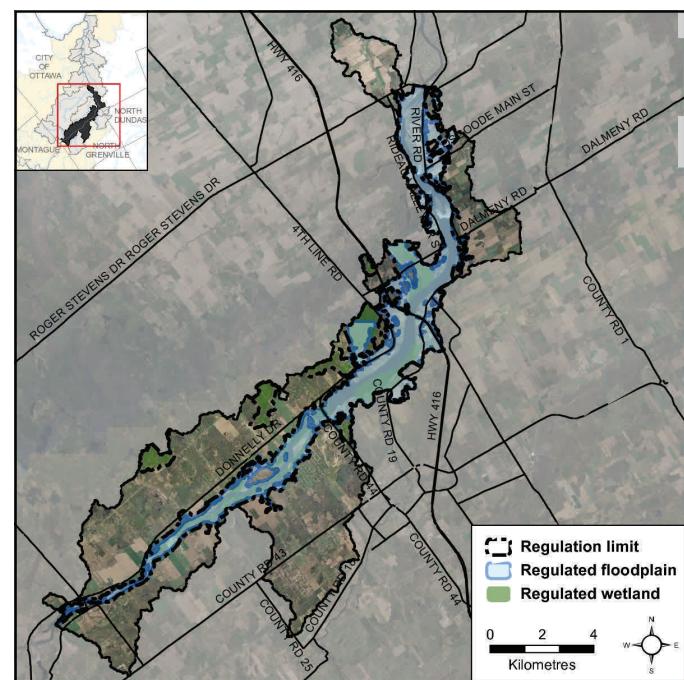
Figure 15. RVCA regulation limits

Thirty-six square kilometre or 33 percent of the catchment drainage area is within the regulation limit of Ontario Regulation 174/06 (Fig.15), giving protection to wetland areas and river or stream valleys that are affected by flooding and erosion hazards.

Natural features within the regulation limit include 8.1 sq. km. of wetland (representing 50 percent of all wetlands in the catchment) and 97.8 kilometres of watercourse (representing 53 percent of all watercourses in the catchment). Many of these regulated watercourses (26 km or 14 percent of streams) flow through regulated wetlands.
