Rideau Lakes Subwatershed Report 2014

BLACK CREEK CATCHMENT

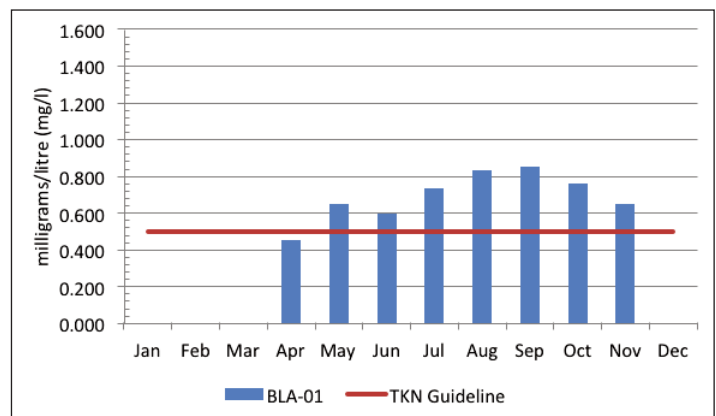
Figure 4 Total Kjeldahl nitrogen concentrations in Black Creek, 2002-2007

TKN results show that the bulk of results exceeded the guideline (Figures 4 and 5); there were few samples (18 percent) below the guideline in the 2002-2007 period and this declined marginally to only 13 percent in the 2008-2013 period. The average concentration was generally elevated and increased from 0.704 mg/l to 0.842 mg/l (Table 4).

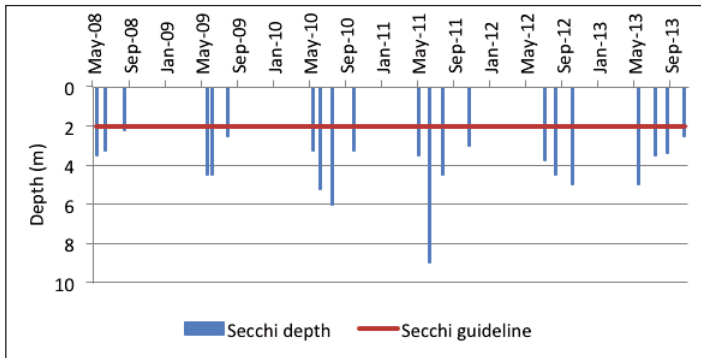
Figure 18 Recorded Secchi depths at the deep point in Hoggs Bay, 2008-2013

Water clarity is measured using a Secchi disk during each deep point sample. Table 9 summarizes the recorded depths and shows that all readings have exceeded the minimum PWQO of 2 metres, indicating good water quality; the average Secchi depth is 4.1 metres. Figure 18 shows that no individual reading has been below the guideline and measured depths range from 2.5 metres to 7.5 metres. It should also be noted that Secchi depths in many waterbodies have been influenced by the colonization of zebra mussels resulting in clearer waters than may have been seen prior to the introduction of this species.

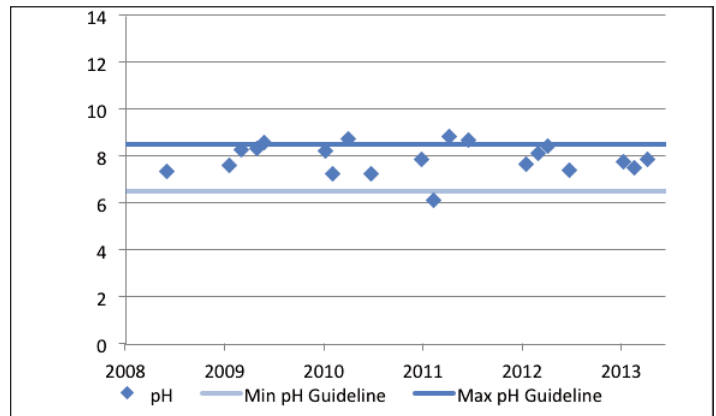
Figure 20 pH concentrations at the deep point in Hoggs Bay, 2008-2013

pH is a basic water quality parameter used to assess the acidity of water, an important factor for aquatic life. Figure 20 shows pH concentrations in Hoggs Bay and Figure 21 summarizes average concentrations by year.

Seventy-six percent of samples (Table 10) were within guidelines established by the PWQO which state that pH should be between 6.5 and 8.5 to protect aquatic life and prevent irritation for anyone using the waters for recreational purposes.

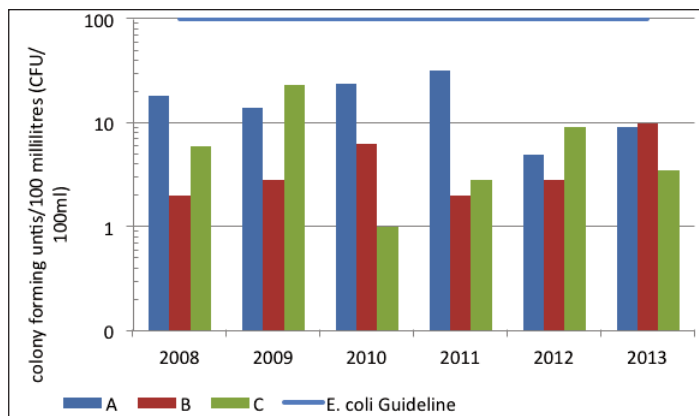
Figure 22 Geometric mean of shoreline sites monitored on Hoggs Bay, 2008-2013

The results presented above provide evidence that bacterial contamination is not a concern in Hoggs Bay and the water should be safe for recreational activities such as swimming and boating.

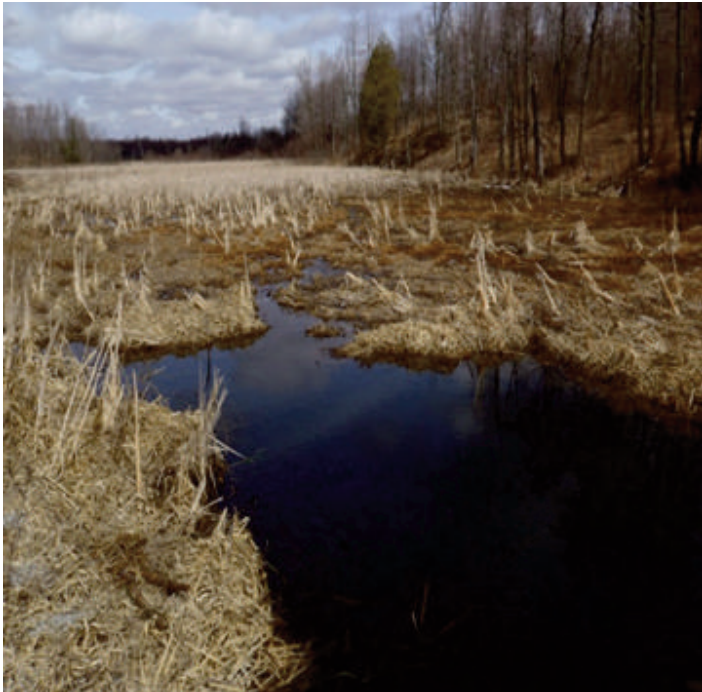
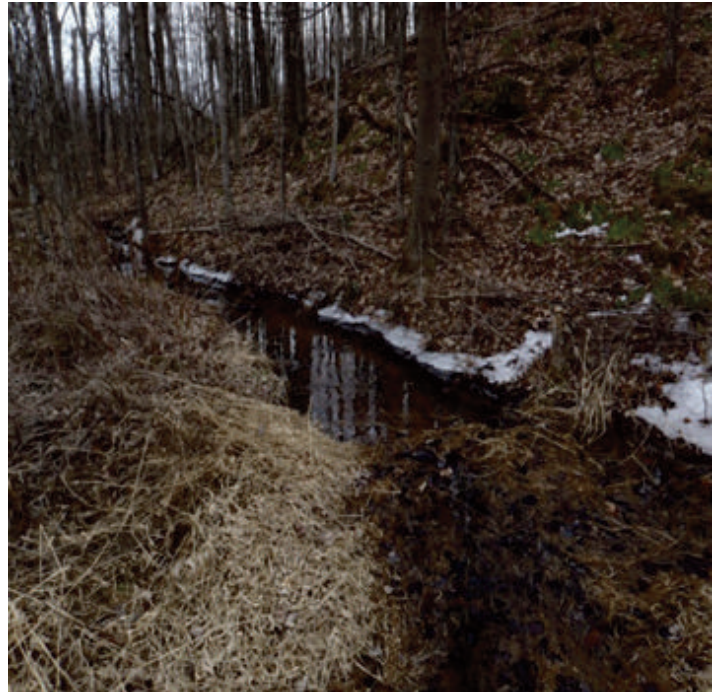
Two headwater drainage features sampled in the Black Creek catchment

The RVCA Stream Characterization program assessed Headwater Drainage Features for the Rideau Lakes subwatershed in 2013. This protocol measures zero, first and second order headwater drainage features (HDF). It is a rapid assessment method characterizing the amount of water, sediment transport, and storage capacity within headwater drainage features (HDF). RVCA is working with TRCA and the MNR to implement the protocol with the goal of providing standard datasets to support science development and monitoring on both the interim guideline for headwater drainage features and existing mitigation strategies. An HDF is a depression in the land that conveys surface flow. Additionally, this module provides a means of characterizing the connectivity, form and unique features associated with each HDF (OSAP Protocol, 2013). An initiative is underway to evaluate how these data can help understand the cumulative contributions of individual headwater drainage features on the downstream watershed state (see Stanfield et al., 2013). In 2013 the program sampled 9 sites in the Black Creek catchment area. Figure 24 shows the headwater drainage features sampling locations in the catchment.
