Rideau Lakes Subwatershed Report 2014

UPPER RIDEAU LAKE CATCHMENT

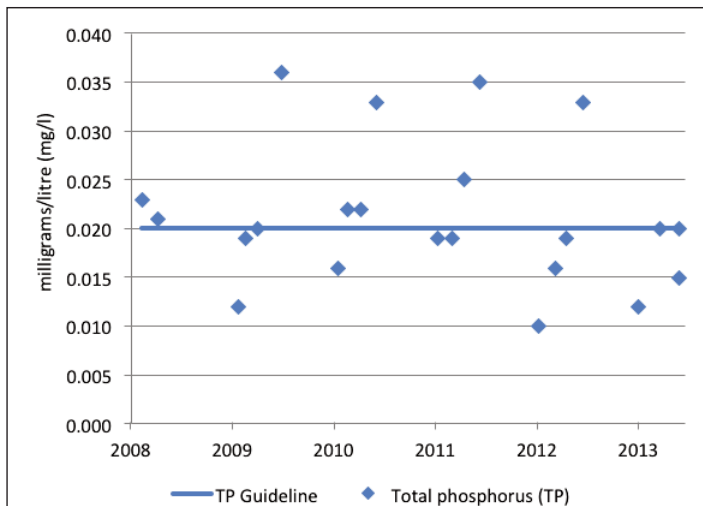
Figure 2 Total phosphorus sampling results at deep point sites in Upper Rideau Lake, 2008-2013

TP and TKN sampling results are presented in Figures 2 and 3. Only 45 percent of samples analyzed for TP were less than the TP guideline and the average concentration was 0.021 mg/l (Table 3). TKN concentration may be considered normal; 91 percent of results were below the TKN guideline and the average concentration was 0.420 mg/l (Table 3). Average year to year concentrations have varied for both TP and TKN

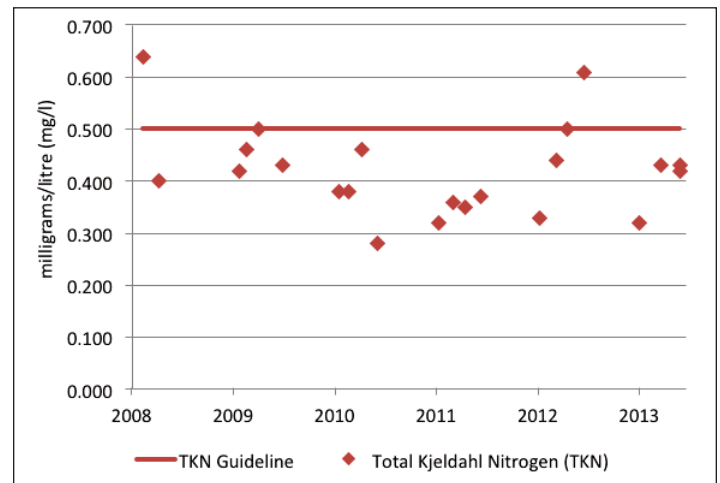
Figure 3 Total Kjeldahl nitrogen sampling results at deep point sites in Upper Rideau Lake, 2008-2013

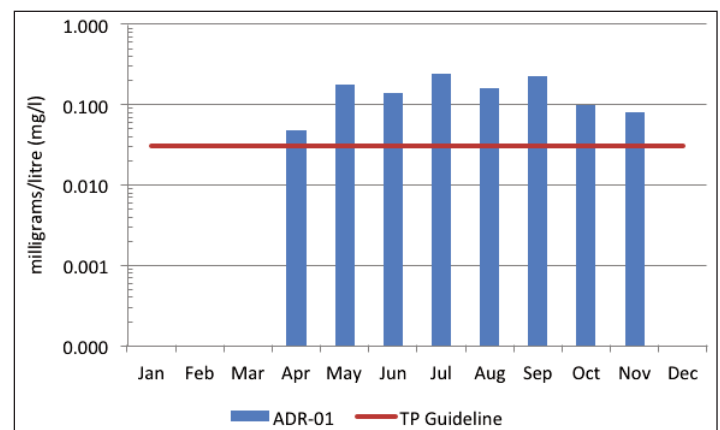
Figure 15 Total phosphorus concentrations in Adrains Creek, 2008-2013

The majority of samples at ADR-01 exceeded the TP guideline; only seven percent of samples were below the guideline in the 2002-2007 period (Figure 14). This declined to only three percent of samples in the 2008-2013 period (Figure 15). The average TP concentration increased from 0.111 mg/l (2002-2007) to 0.146 mg/l (2008-2013).

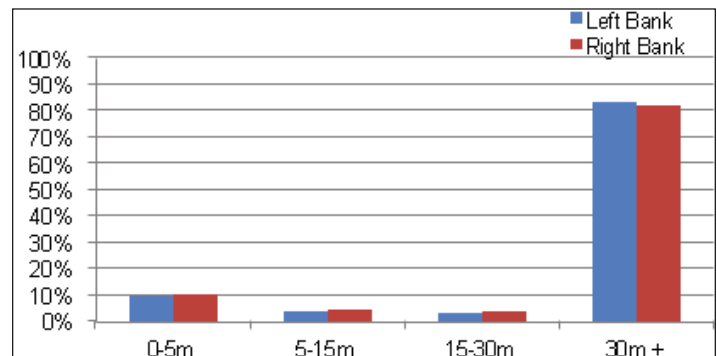
Figure 27 Riparian buffer evaluation along Adrains Creek

Figure 27 shows buffer conditions along the left and right banks of Adrains Creek. Using data from the 2013 Stream Characterization Program, Adrains Creek had a buffer of greater than 30 meters along 82 percent of the right bank and 83 percent along the left bank.
