The RVCA produces individual reports for 16 catchments in the Lower Rideau subwatershed. Using data collected and analysed by the RVCA through its watershed monitoring and land cover classification programs, surface water quality conditions are reported for Brassils Creek along with a summary of environmental conditions for the surrounding countryside every six years.

1) a. Brassils Creek

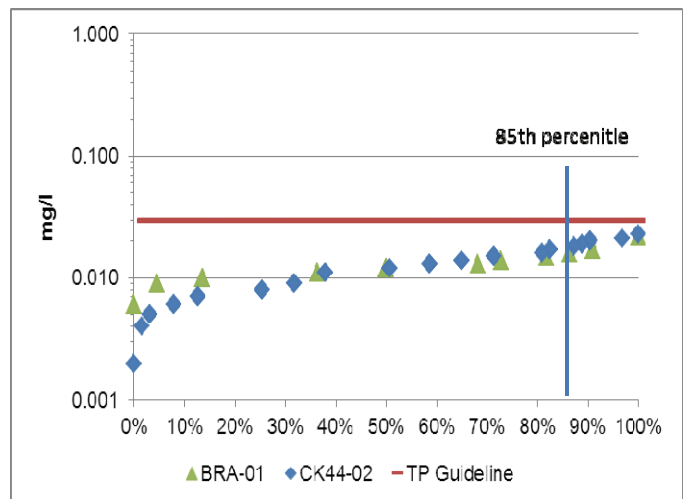
Figure 3a. Percentile plots of total phosphorus in Brassils Creek from 2000-2005

The majority of samples at site CK44-02 were below the TP guideline for both time periods (Fig. 2a, 2000-2005 and Fig. 2b, 2006-2011) and there has been a slight increase in average TP concentration from 0.012 mg/l (2000-2005) to 0.014 mg/l (2006-2011). The LRWS target has been achieved at site CK44-02. Though the target is achieved there has been a slight increase in the concentration at the 85th percentile from 0.017 mg/l (Fig. 3a, 2000-2005) to 0.021 mg/l (Fig. 3b, 2006-2011).

At site BRA-01 samples were below the TP guideline for both time periods (Fig. 2a, 2000-2005 and Fig. 2b, 2006-2011) and there was a slight increase in average TP concentration from 0.012 mg/l (2000-2005) and 0.014 (2006-2011). The LRWS has been achieved at site BRA-01. There is a slight increase in the concentration at the 85th percentile from 0.016 mg/l (2000-2005, Fig 3a) to 0.018 mg/l (2006-2011, Fig. 3b)

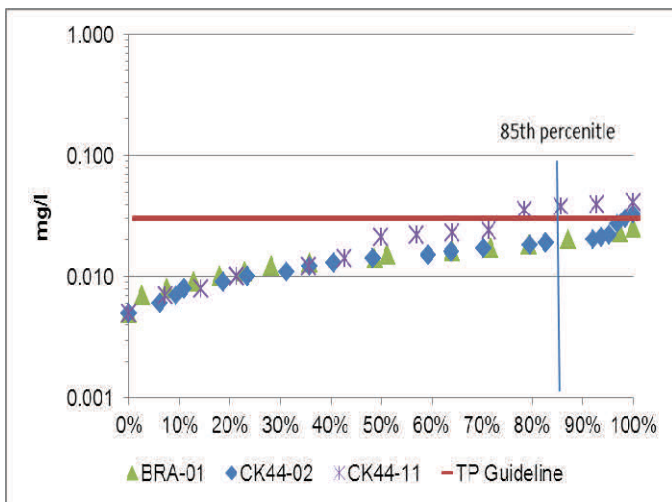
Figure 3b. Percentile plots of total phosphorous in Brassils Creek from 2006-2011

Seventy-three percent of samples are below the TP guideline at site CK44-11, with an average concentration of 0.021 mg/l (Fig. 2b). Please note that data was not available for the time period 2000-2005. The data from 2006-2011 shows that the LRWS target is slightly exceeded at site CK44-11 as the TP concentration at the 85th percentile is 0.034 mg/l.

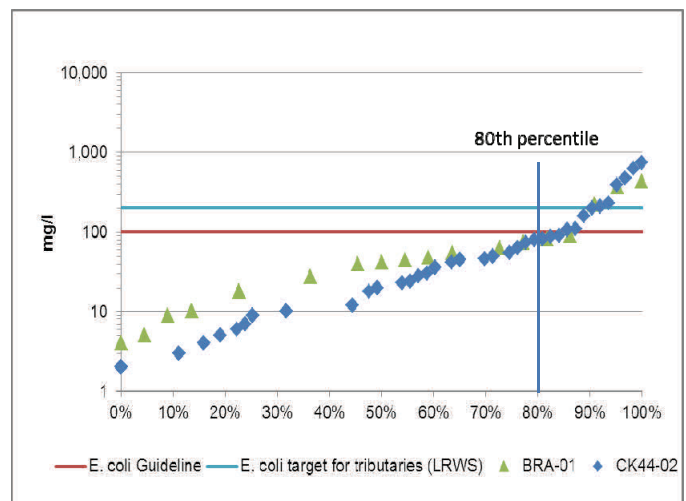
Figure 6a. Percentile plots of *E. coli* in Brassils Creek from 2000-2005

geometric mean increased from 21 CFU/100 ml to 41 CFU/100 ml. *E. coli* counts increased at the 80th percentile over the 2000-2011 monitoring period at site CK44-02. In comparing the two time periods *E. coli* counts at the 80th percentile have increased from 81 CFU/100 ml (Fig. 6a, 2000-2005) to 160 CFU/100 ml (Fig. 6b, 2006-2011).

The proportion of samples below the guideline also decreased from eighty seven percent (Fig. 5a, 2000-2005) to sixty-eight percent (Fig. 5b, 2006-2011), and the count at the geometric mean increased from 37 CFU/100 ml to 51 CFU/100 ml. Similar results were observed at site BRA-01. *E. coli* counts at the 80th percentile increased from 78 CFU/100 ml (Fig. 6a, 2000-2005) to 141 CFU/100 ml (Fig. 6b, 2006-2011).

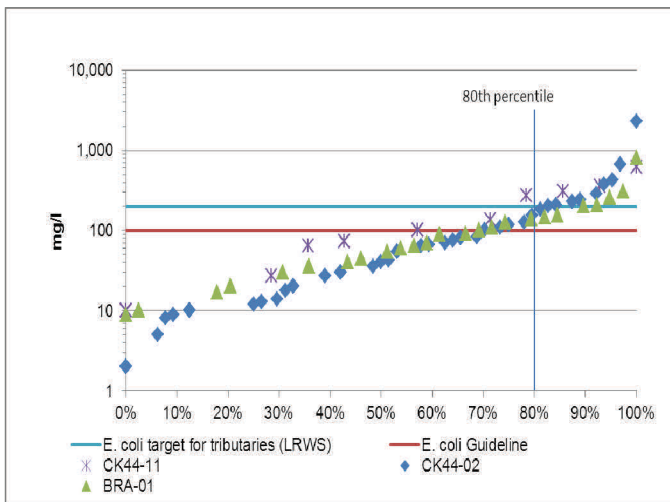
Figure 6b, *E. coli* concentrations in Brassils Creek from 2006-2011

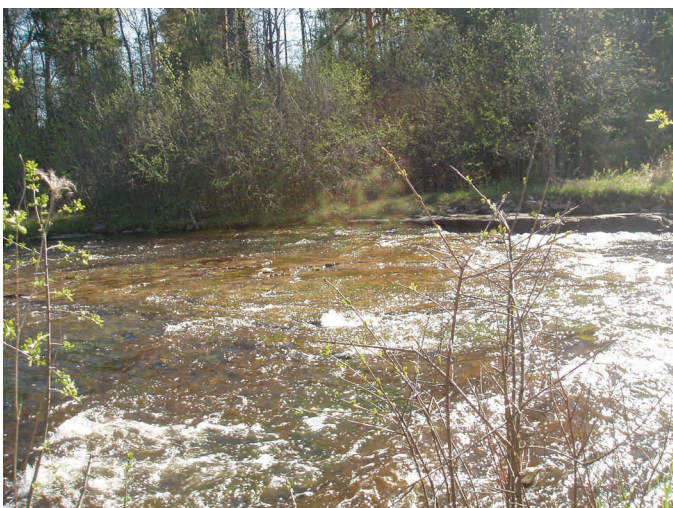
Benthic sampling site replicate one on Brassils Creek at Dwyer Hill Rd in the city of Ottawa, this image was captured in the spring of 2011.

As part of the Ontario Benthic Biomonitoring Network (OBBN), the RVCA has been collecting benthic invertebrates at one location on Brassils Creek at Dwyer Hill Road since 2003. Monitoring data is analyzed and the results are presented using the Family Biotic Index, Family Richness and percent Ephemeroptera, Plecoptera and Trichoptera.
