Rideau Lakes Subwatershed Report 2014

BIG RIDEAU LAKE – PORTLAND CATCHMENT

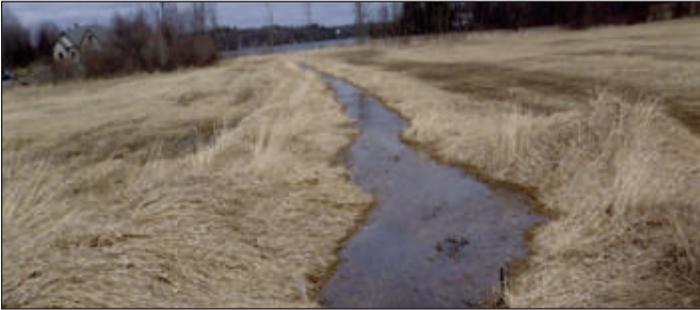
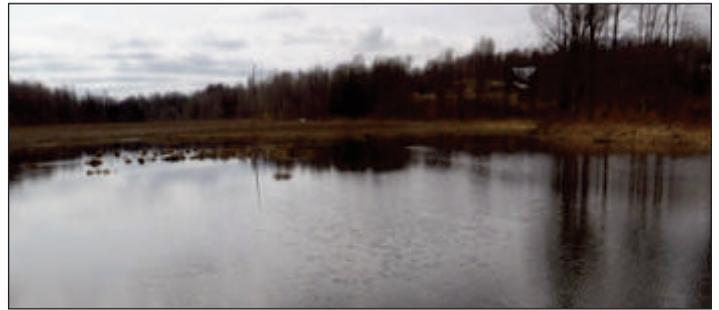
Two headwater drainage features sampled in the Big Rideau Lake-Portland catchment

The RVCA Stream Characterization program assessed Headwater Drainage Features for the Rideau Lakes subwatershed in 2013. This protocol measures zero, first and second order headwater drainage features (HDF). It is a rapid assessment method characterizing the amount of water, sediment transport, and storage capacity within headwater drainage features (HDF). RVCA is working with TRCA and the OMNRF to implement the protocol with the goal of providing standard datasets to support science development and monitoring on both the interim guideline for headwater drainage features and existing mitigation strategies. An HDF is a depression in the land that conveys surface flow. Additionally, this module provides a means of characterizing the connectivity, form and unique features associated with each HDF (OSAP Protocol, 2013). An initiative is underway to evaluate how these data can help understand the cumulative contributions of individual headwater drainage features on the downstream watershed state (see Stanfield et al., 2013). In 2013 the program sampled 20 sites in the Big Rideau Lake-Portland catchment. Figure 24 shows the headwater drainage features sampling locations in the catchment.
