Rideau Lakes Subwatershed Report 2014

WESTPORT SAND LAKE CATCHMENT

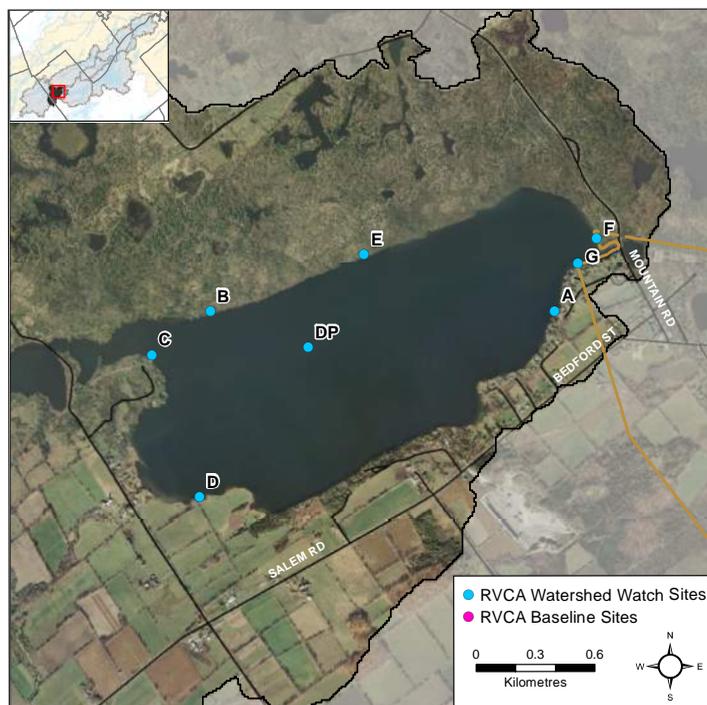
Figure 1 Water quality monitoring sites in the Westport Sand Lake catchment

Surface water quality conditions in the Westport Sand Lake catchment are monitored by the Rideau Valley Conservation Authority's (RVCA) Watershed Watch Program. Watershed Watch monitors watershed lakes to assess nutrient concentrations, water clarity, dissolved oxygen availability and pH. The locations of monitoring sites are shown in Figure 1 and Table 1.

This report also considers data from 7 additional shoreline sites that are regularly monitored around the lake. These sites have not been included in the calculation of the CCME WQI rating as they are not monitored with the same frequency as deep point sites. However, they do provide important information on water quality conditions in the near shore areas. For locations of shoreline sites please see Figure 1.

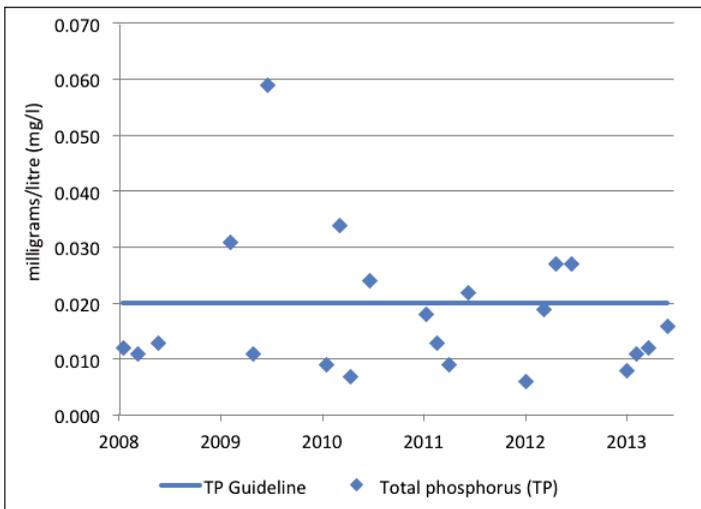
Figure 2 Total phosphorus sampling results at the deep point site in Westport Sand Lake, 2008-2013

TKN concentration were also generally below the guideline; 86 percent of results were below the TKN guideline and the average concentration was 0.374 mg/l (Table 3). Average year to year concentrations have varied for both TP and TKN (Figure 4 and 5). From 2009 to 2011 there appears to be a decline in the average yearly TP concentrations (Figure 4). Average TKN results do not exceed the guideline and have remained generally consistent. Despite the recent decline in average TP concentrations, overall the data presented indicates that often elevated TP concentrations are a concern in the mid-lake, deep water sites of Westport Sand Lake.

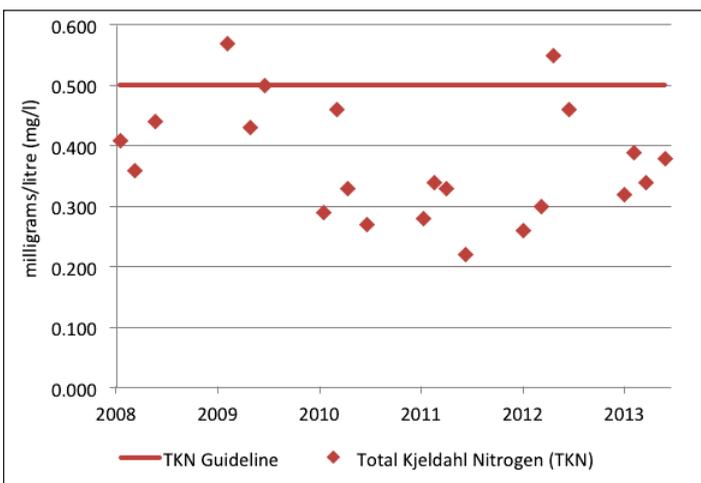
Figure 3 Total Kjeldahl nitrogen sampling results at the deep point site in Westport Sand Lake, 2008-2013

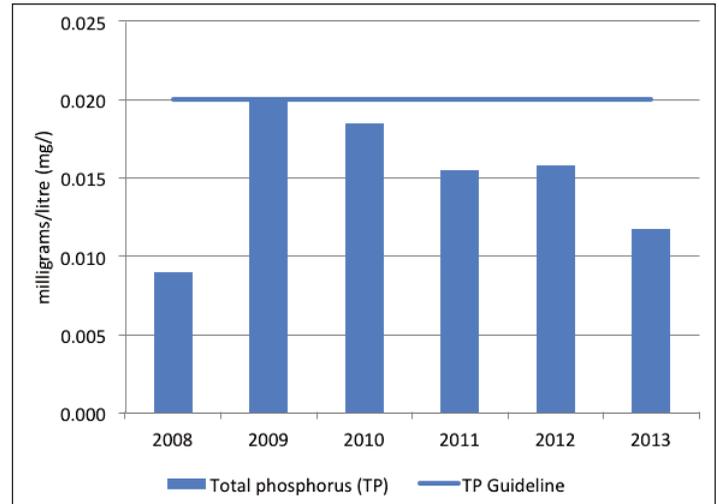
Figure 4 Average total phosphorus at the deep point site in Westport Sand Lake, 2008-2013

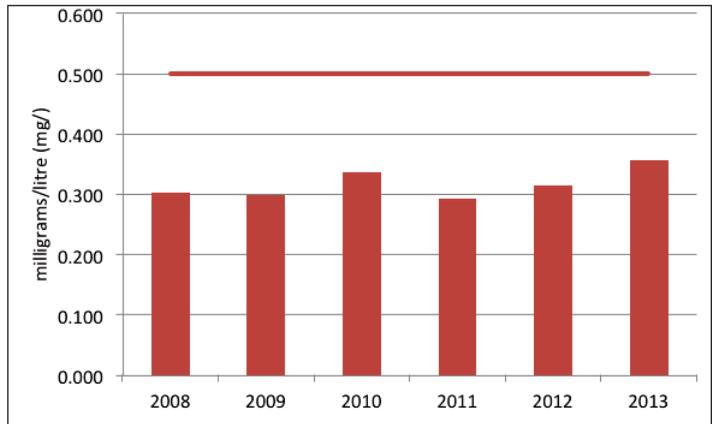
Figure 5 Average total Kjeldahl nitrogen at the deep point site in Westport Sand Lake, 2008-2013

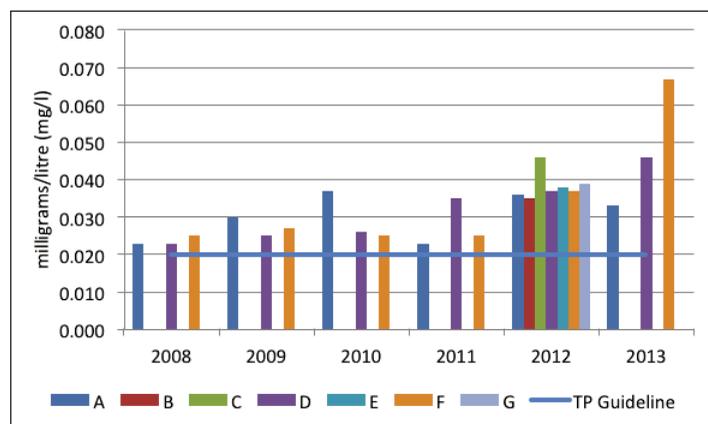
Average total phosphorous concentrations were above the TP guideline at all sites; there is evidence of an increase trend in concentrations at site D (Figure 6). This site is located near agricultural lands and it is possible that animal manure or fertilizer runoff is contributing to elevated concentrations at this site. However, given that all sites regularly exceed the TP guideline, better stewardship practices should be employed around the lake to ensure that phosphorus loading is minimized wherever possible.

Figure 6 Average total phosphorous concentration at shoreline monitoring sites on Westport Sand Lake, 2008-2013

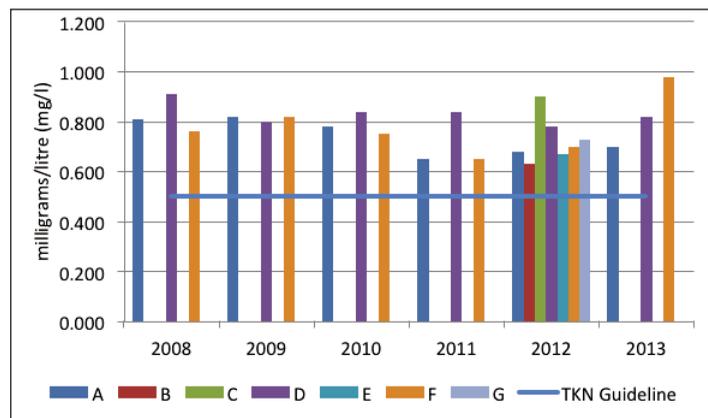
TKN concentrations were also consistently above the guideline at all shoreline sites (Figure 7). These results provide further evidence that nutrient loading is a concern and may result in abundant plant or algal growth and low oxygen levels which may put stress on sensitive aquatic species.

Figure 7 Average total Kjeldahl nitrogen concentration at shoreline monitoring sites on Westport Sand Lake, 2008-2013

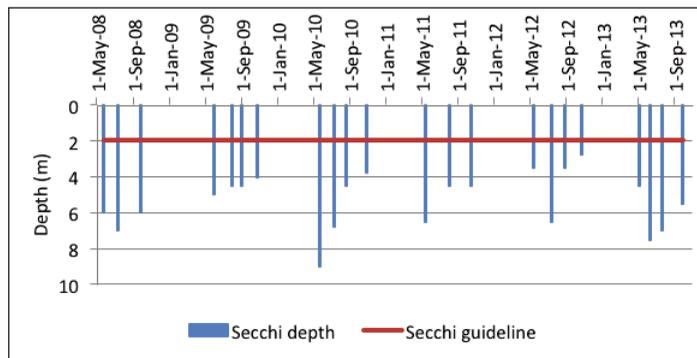
Water clarity is measured using a Secchi disk during each deep point sample. Table 4 summarizes the recorded depths and shows that all readings have exceeded the minimum PWQO of 2 metres, indicating good water quality with an average Secchi depth of 5.3 metres. Figure 8 shows that no individual reading has been below the guideline and measured depths range from 2.75 metres to 9 metres. It should also be noted that Secchi depths in many waterbodies have been influenced by the colonization of zebra mussels resulting in clearer waters than may have been seen prior to the introduction of this species.

Figure 8 Recorded Secchi depths at the deep point site in Westport Sand Lake, 2008-2013

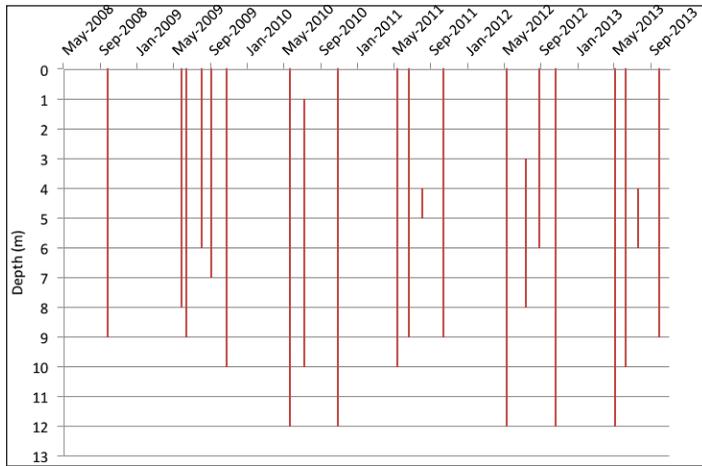
The red bars in Figure 9 shows the depths where suitable conditions exist for warm water fish species (temperature less than 25°C and dissolved oxygen greater than 4 mg/l) at the monitored deep point. The vertical axis represents the total lake depth at each site where the profile is taken. Suitable oxygen temperatures exist over an average depth of 9 metres. Suitable habitat typically becomes limited during the summer months as the upper portion of the water column warms and bottom depths are depleted of oxygen; this is most evident in August 2011, July 2012 and July 2013 (Figure 9).

Figure 9 Depths suitable for warm water fish species at site RVL-14DP in Westport Sand Lake, 2008-2013

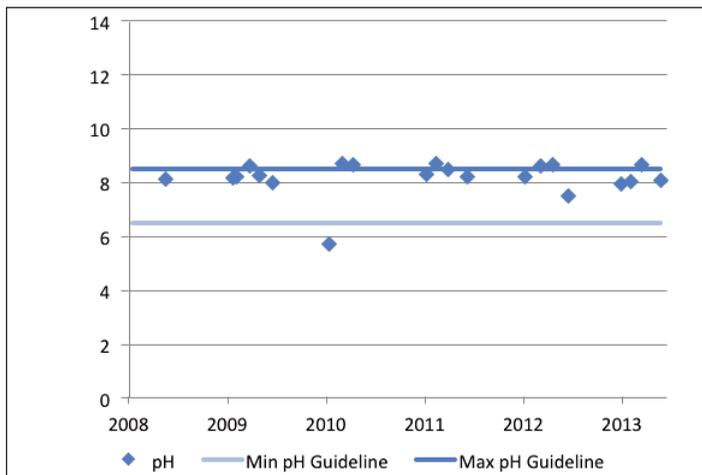
pH is a basic water quality parameter used to assess the acidity of water, an important factor for aquatic life. Figure 10 shows pH concentrations in Westport Sand Lake and Figure 11 summarizes average concentrations by year.

Figure 10 pH concentrations at the deep point in Westport Sand Lake, 2008-2013

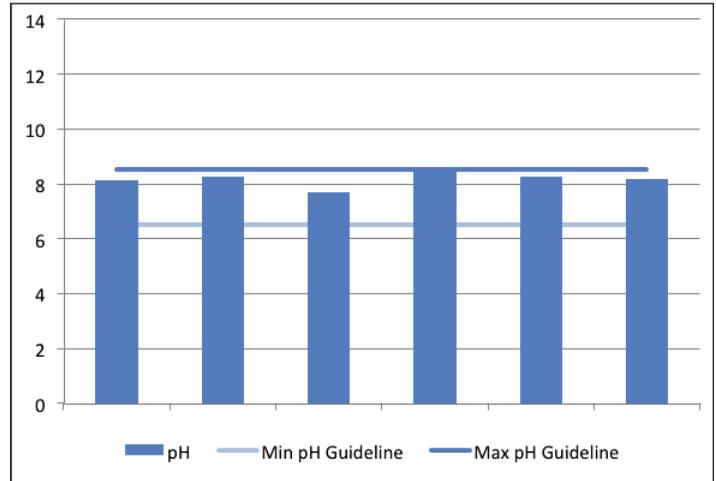
Figure 11 Average pH concentrations at the deep point in Westport Sand Lake, 2008-2013

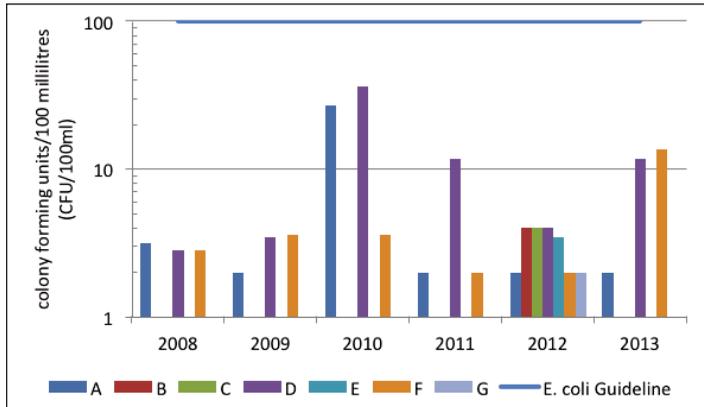
Figure 12 Geometric mean of shoreline sites monitored on Westport Sand Lake

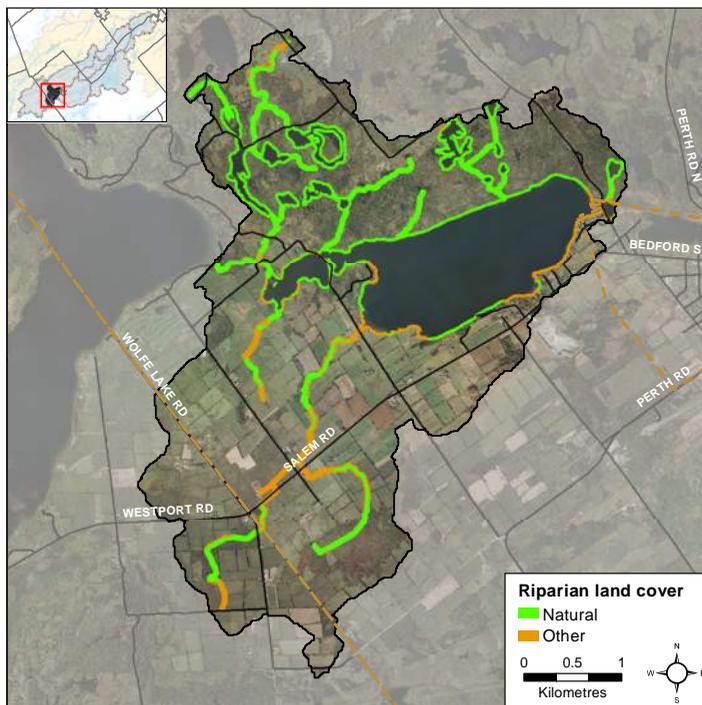
Around **Westport Sand Lake** itself, the shoreline buffer is made up of woodland (56 percent), settlement areas (25 percent), crop and pastureland (11 percent), transportation routes (four percent) and wetland (four percent). This can be further broken down as follows: the **north (on-Shield) shore** is comprised of woodland (73 percent), settlement areas (nine percent), crop and pastureland (eight percent), wetland (five percent) and transportation routes (five percent); in contrast, the **south (off-Shield) shore** is comprised of settlement areas (52 percent), woodland (26 percent), crop and pastureland (18 percent) and transportation routes (four percent).

Figure 13 Natural and other riparian land cover around Westport Sand Lake

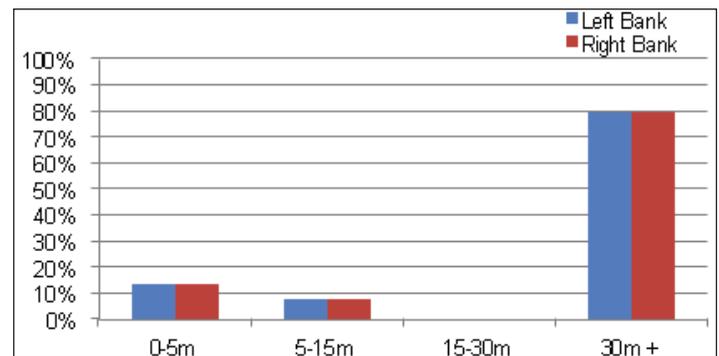
Figure 14 shows buffer conditions along the left and right banks of Sicklers Creek. Using data from the 2013 Stream Characterization Program, Adrains Creek had a buffer of greater than 30 meters along 82 percent of the right bank and 83 percent along the left bank.

Figure 14 Riparian buffer evaluation along Sicklers Creek

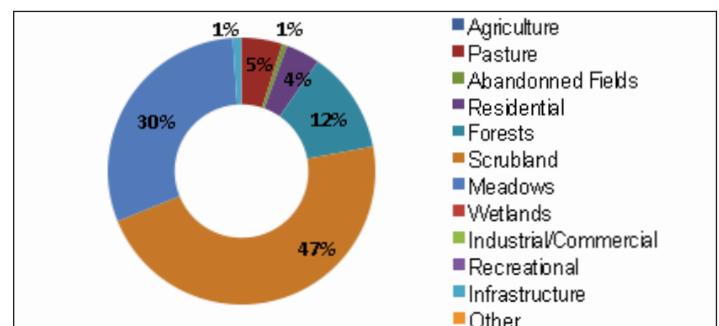
The RVCA's Stream Characterization Program identifies seven different land uses beside Sicklers Creek (Figure 15). Surrounding land use is considered from the beginning to end of the survey section (100 m) and up to 100 metres on each side of the creek. Land use outside of this area is not considered for the surveys but is nonetheless part of the subwatershed and will influence the creek. Natural areas made up 89 percent of the stream, characterized by forest, scrubland and meadow. The remaining land use consisted of pasture, abandoned fields, infrastructure and residential.

Figure 15 Land use along Sicklers Creek

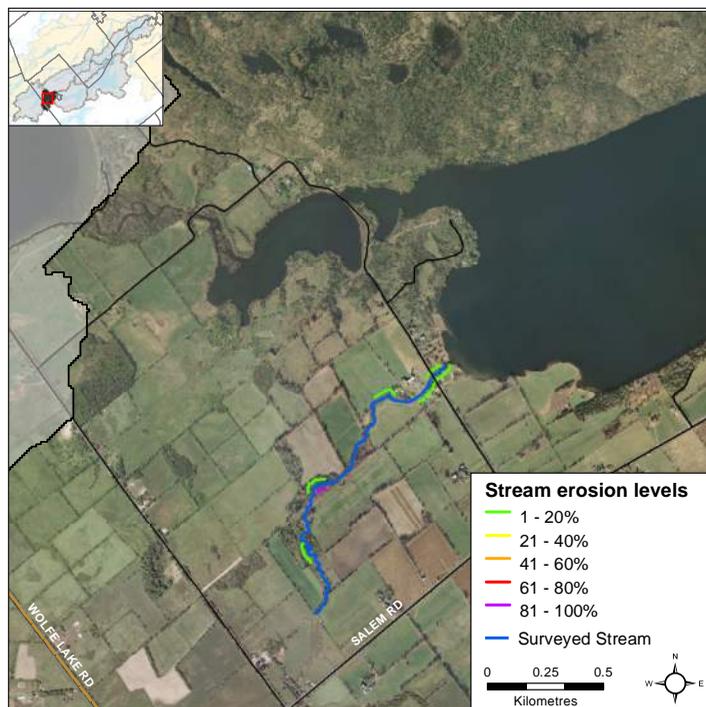
Erosion is a normal, important stream process and may not affect actual bank stability; however, excessive erosion and deposition of sediment within a stream can have a detrimental effect on important fish and wildlife habitat. Poor bank stability can greatly contribute to the amount of sediment carried in a waterbody as well as loss of bank vegetation due to bank failure, resulting in trees falling into the stream and the potential to impact instream migration. Figure 16 shows low levels of erosion along Sicklers Creek with the exception of one section which had high levels of erosion.

Figure 16 Erosion along Sicklers Creek

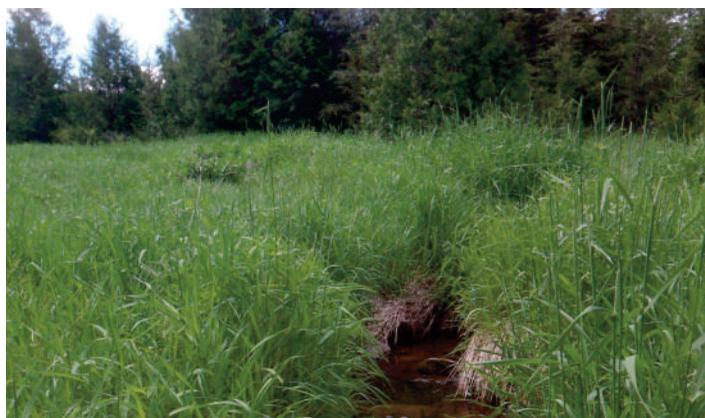
Undercut banks are a normal and natural part of stream function and can provide excellent refuge areas for fish. Figure 17 shows that Sicklers Creek had low levels of undercut banks.

Figure 17 Undercut stream banks along Sicklers Creek

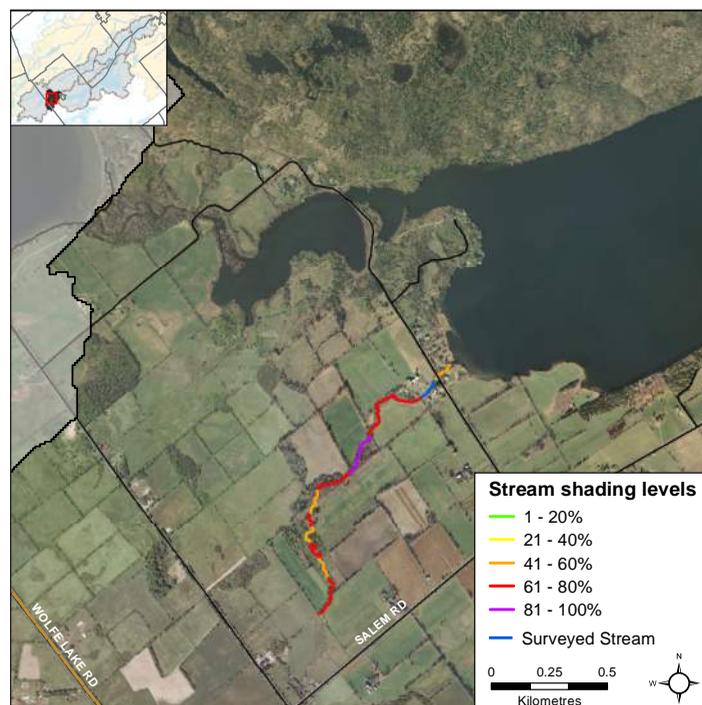
Grasses, shrubs and trees all contribute towards shading a stream. Shade is important in moderating stream temperature, contributing to food supply and helping with nutrient reduction within a stream. Figure 18 shows highly variable stream shading conditions ranging from moderate to high levels along Sicklers Creek.

Figure 18 Stream shading along Sicklers Creek

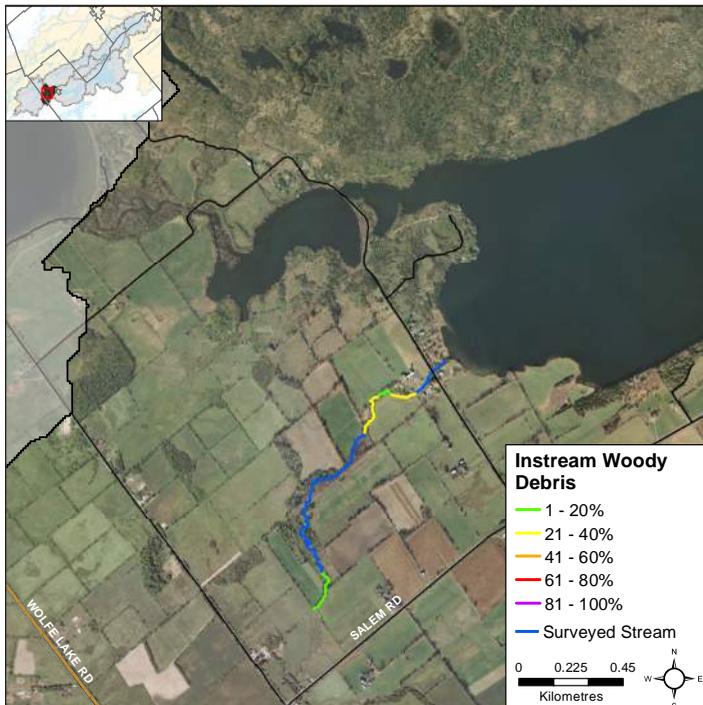
Figure 19 shows that the majority of Sicklers Creek had low levels of instream woody debris in the form of branches and trees. Instream woody debris is important for fish and benthic habitat, by providing refuge and feeding areas.

Figure 19 Instream woody debris along Sicklers Creek

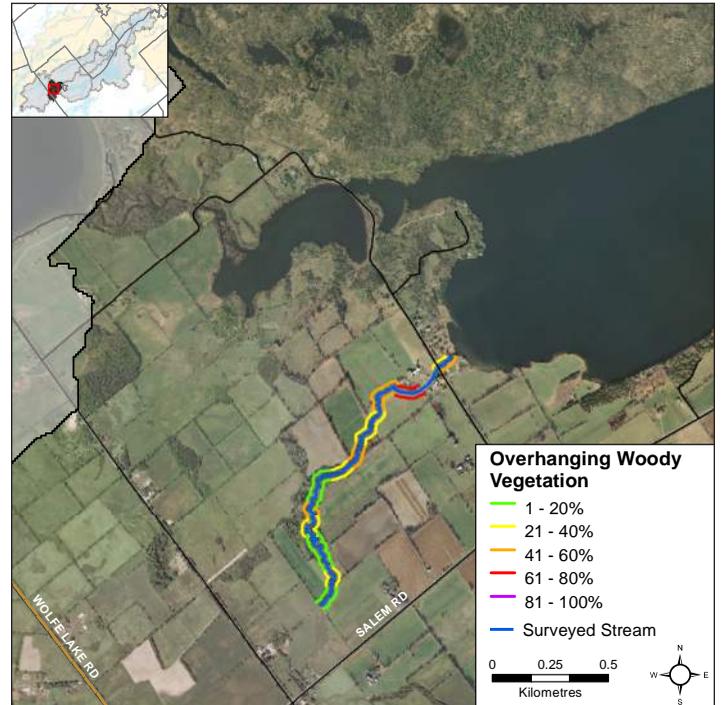
Figure 20 shows highly variable conditions along Sicklers Creek ranging from low to high levels of overhanging branches and trees. Overhanging branches and trees provide a food source, nutrients and shade which helps to moderate instream water temperatures.

Figure 20 Overhanging trees and branches along Sicklers Creek

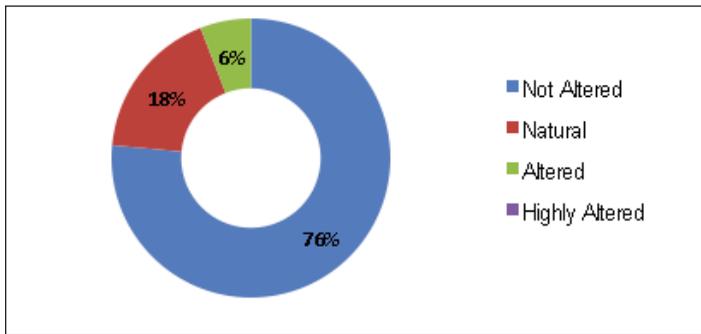
Figure 21 shows 76 percent of Sicklers Creek remains “unaltered” with no anthropogenic alterations. Eighteen percent of Sicklers Creek was classified as natural with minor anthropogenic changes and six percent of its length was considered altered in the form of buffers of less than 15 meters along the banks and road crossings.

Figure 21 Anthropogenic alterations along Sicklers Creek

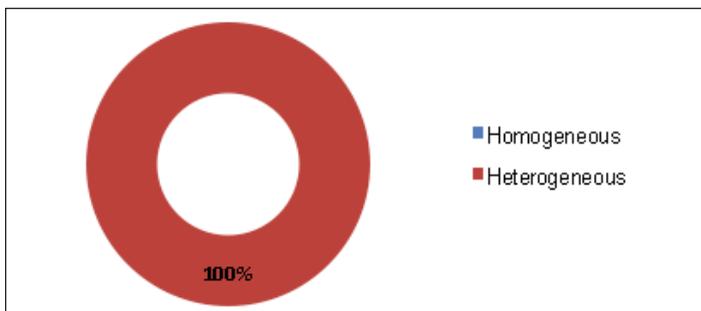
Streams are naturally meandering systems and move over time; there are varying degrees of habitat complexity, depending on the creek. Examples of habitat complexity include variable habitat types such as pools and riffles as well as substrate variability and woody debris structure. A high percentage of habitat complexity (heterogeneity) typically increases the biodiversity of aquatic organisms within a system. One hundred percent of Sicklers Creek was considered heterogeneous, as shown in Figure 22.

Figure 22 Habitat complexity along Sicklers Creek

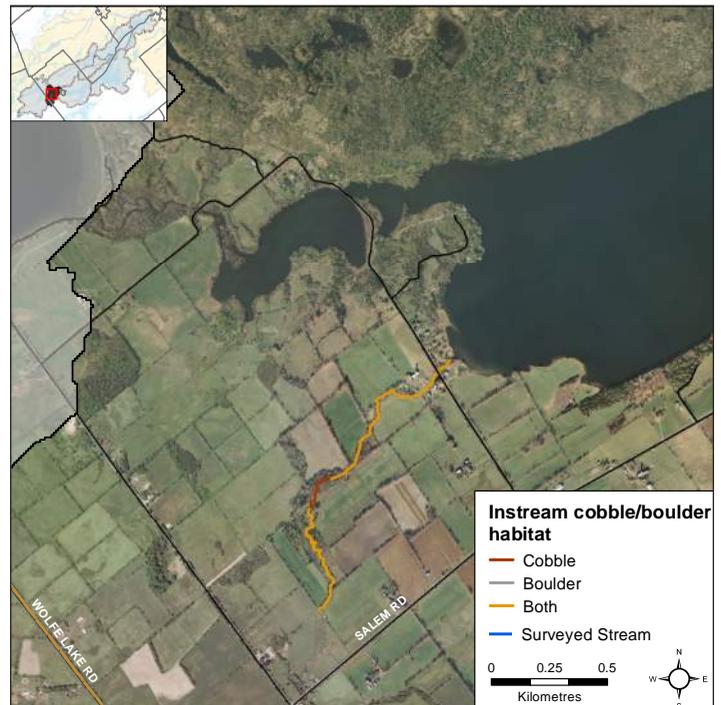
Diverse substrate is important for fish and benthic invertebrate habitat because some species have specific substrate requirements and for example will only reproduce on certain types of substrate. Boulders create instream cover and back eddies for large fish to hide and/or rest out of the current. Cobble provides important spawning habitat for certain fish species like walleye and shiners who are an important food source for larger fish. Cobble can also provide habitat conditions for benthic invertebrates that are a key food source for many fish and wildlife species. Figure 23 shows where cobble and boulder substrate are found in Sicklers Creek.

Figure 23 Instream substrate along Sicklers Creek

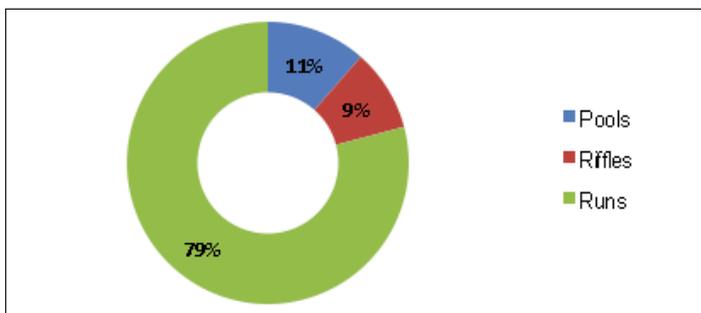
Figure 24 shows that Sicklers Creek is somewhat variable; 79 percent consists of runs, 11 percent pools and 9 percent riffles.

Figure 24 Instream morphology along Sicklers Creek

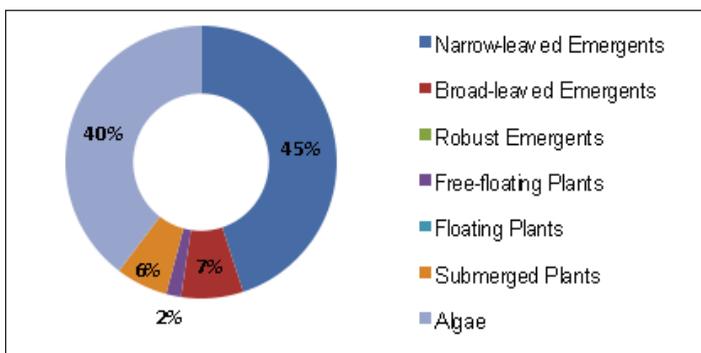
Instream vegetation provides a variety of functions and is a critical component of the aquatic ecosystem. For example emergent plants along the shoreline can provide shoreline protection from wave action and important rearing habitat for species of waterfowl. Submerged plants provide habitat for fish to find shelter from predator fish while they feed. Floating plants such as water lilies shade the water and can keep temperatures cool while reducing algae growth. Sicklers Creek had moderate levels of diversity of instream vegetation. The dominant vegetation type recorded at forty-nine percent consisted of narrow leafed emergents. Figure 25 depicts the plant community structure for Sicklers Creek.

Figure 25 Vegetation type along Sicklers Creek

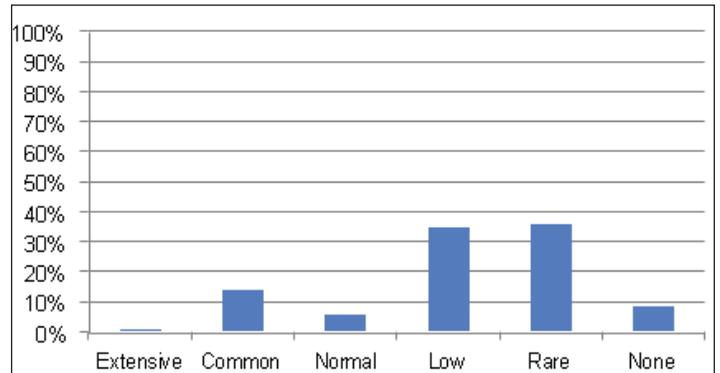
Instream vegetation is an important factor for a healthy stream ecosystem. Vegetation helps to remove contaminants from the water, contributes oxygen to the stream and provides habitat for fish and wildlife. Too much vegetation can also be detrimental. Figure 26 demonstrates that Sicklers Creek had lower levels of instream vegetation for most of its length.

Figure 26 Instream vegetation abundance along Sicklers Creek

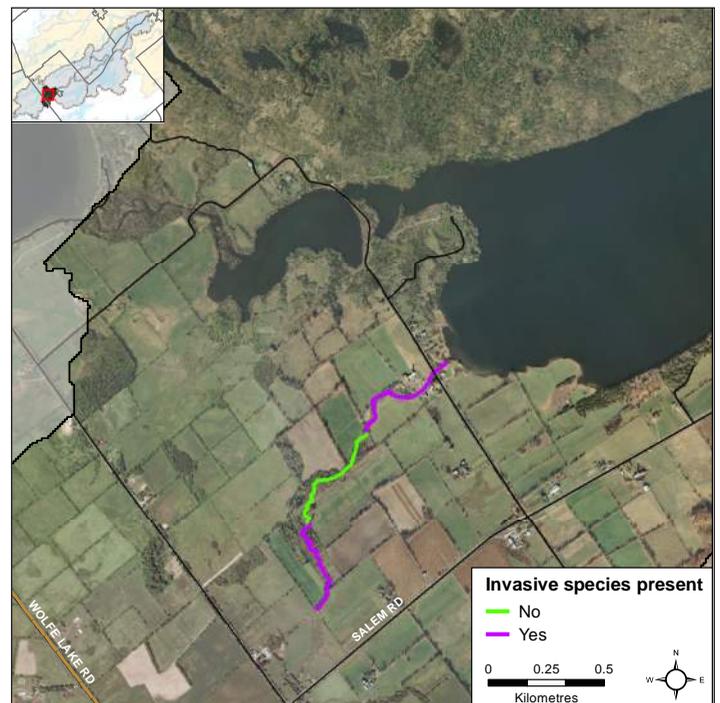
Invasive species can have major implications on streams and species diversity. Invasive species are one of the largest threats to ecosystems throughout Ontario and can out compete native species, having negative effects on local wildlife, fish and plant populations. Sixty three percent of the sections surveyed along Sicklers Creek had invasive species (Figure 27). The invasive species observed in Sicklers Creek were common buckthorn and purple loosestrife.

Figure 27 Invasive species along Sicklers Creek

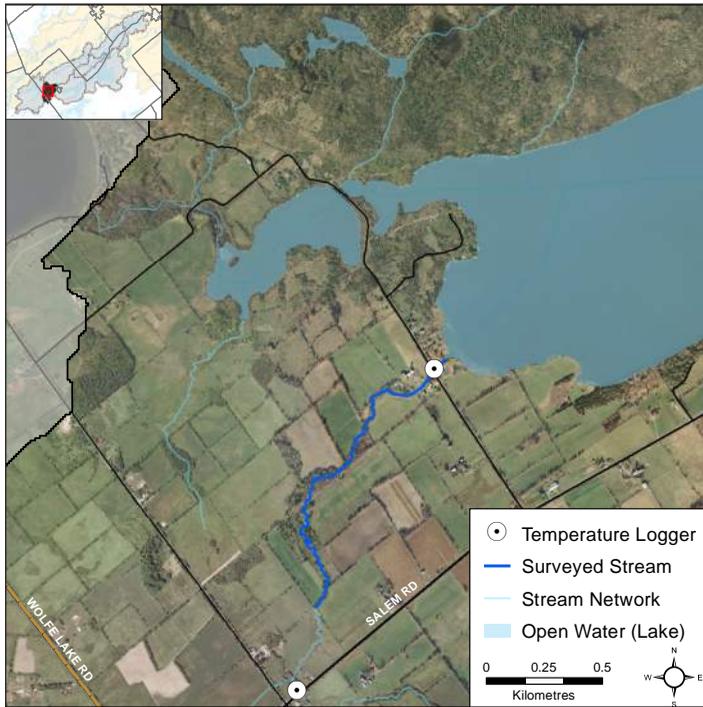
Figure 28 Temperature loggers in Sicklers Creek

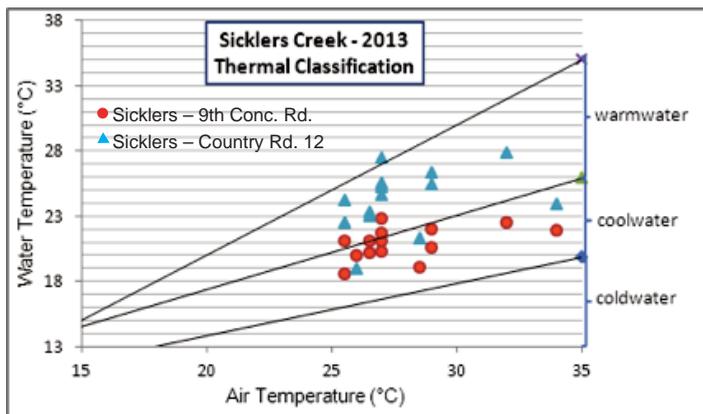
Many factors can influence fluctuations in stream temperature, including springs, tributaries, precipitation runoff, discharge pipes and stream shading from riparian vegetation. Water temperature is used along with the maximum air temperature (using the Stoneman and Jones method) to classify a watercourse as either warm water, cool water or cold water. Figure 28 shows the location of temperature loggers at two sampling locations along Sicklers Creek. Analysis of the data collected indicates that Sicklers Creek is classified as a cool/warm water system (Figure 29).

Figure 29 Temperature logger data for two sites on Sicklers Creek

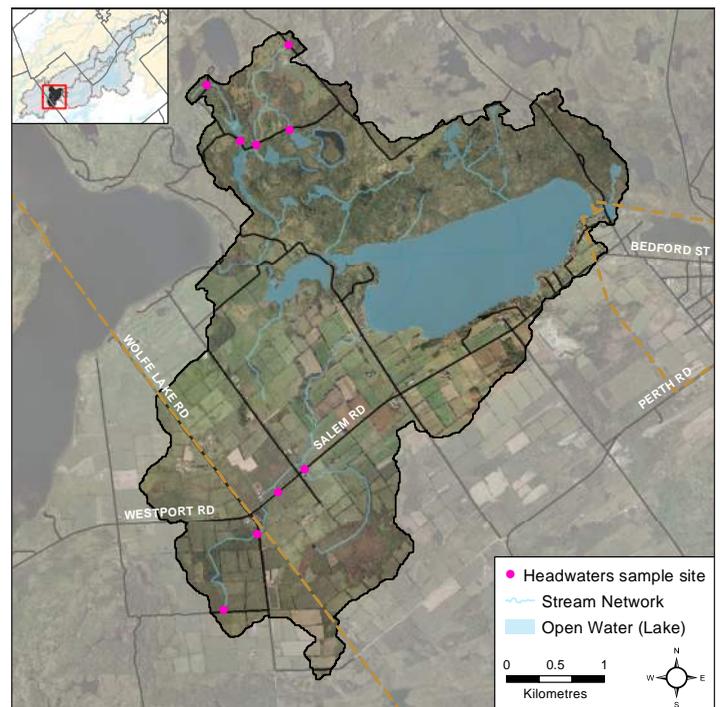
The RVCA Stream Characterization program assessed Headwater Drainage Features for the Rideau Lakes subwatershed in 2013. This protocol measures zero, first and second order headwater drainage features (HDF). It is a rapid assessment method characterizing the amount of water, sediment transport, and storage capacity within headwater drainage features (HDF). RVCA is working with TRCA and the MNR to implement the protocol with the goal of providing standard datasets to support science development and monitoring on both the interim guideline for headwater drainage features and existing mitigation strategies. An HDF is a depression in the land that conveys surface flow. Additionally, this module provides a means of characterizing the connectivity, form and unique features associated with each HDF (OSAP Protocol, 2013). An initiative is underway to evaluate how these data can help understand the cumulative contributions of individual headwater drainage features on the downstream watershed state (see Stanfield et al., 2013). In 2013 the program sampled nine sites in the Westport Sand Lake catchment area. Figure 30 shows the headwater drainage features sampling locations in the catchment.

Figure 30 Headwater drainage feature sampling locations around Westport Sand Lake

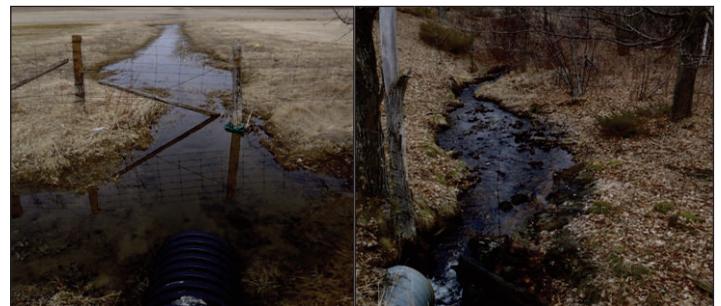
Two headwater sampling sites sampled in the Westport Sand Lake catchment in 2013

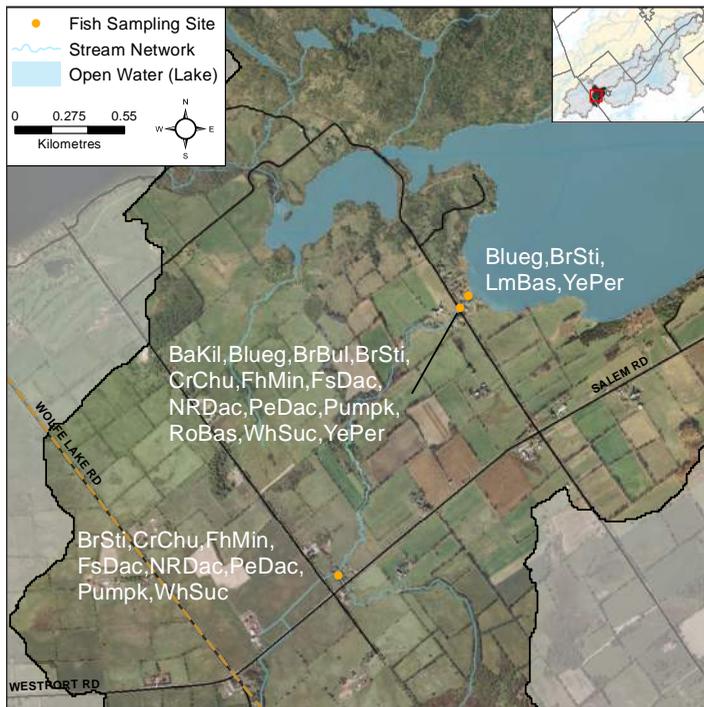
The Westport Sand Lake catchment is classified as a mixed community of warm, cool and cold water recreational and baitfish fishery with 22 species observed. The following is a list of species observed in the watershed (Source: MNR/RVCA). Fish sampling sites are shown in Figure 31.

Figure 31 Fish sampling on Westport Sand Lake

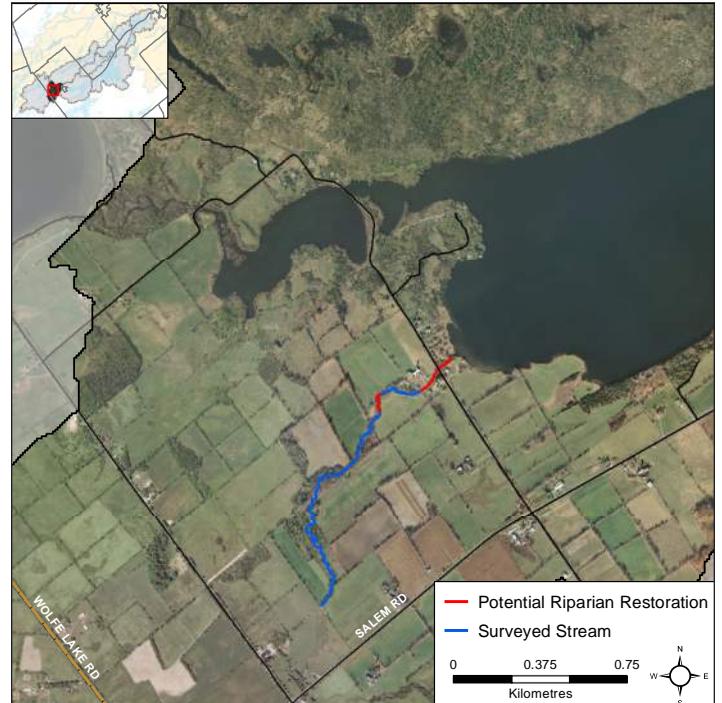
Figure 32 depicts the locations where various riparian restoration activities can be implemented as a result of observations made during the stream assessment survey.

Figure 32 Riparian restoration along Sicklers Creek

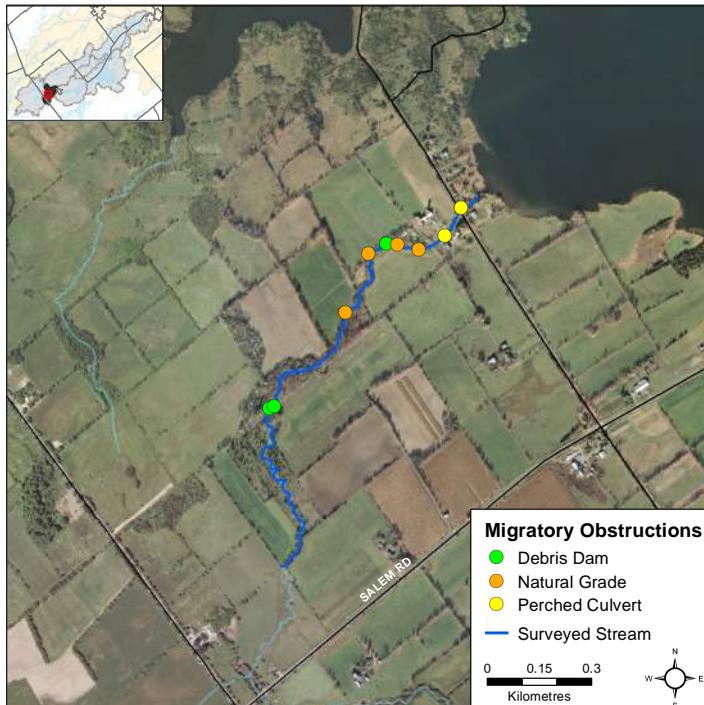
It is important to know the locations of migratory obstructions because they can prevent fish from accessing important spawning and rearing habitat (Figure 33). Migratory obstructions can be natural or manmade, and they can be permanent or seasonal. There were a number of seasonal man-made and natural barriers within the Sicklers Creek catchment at the time of the survey.

Figure 33 Migratory obstructions along Sicklers Creek

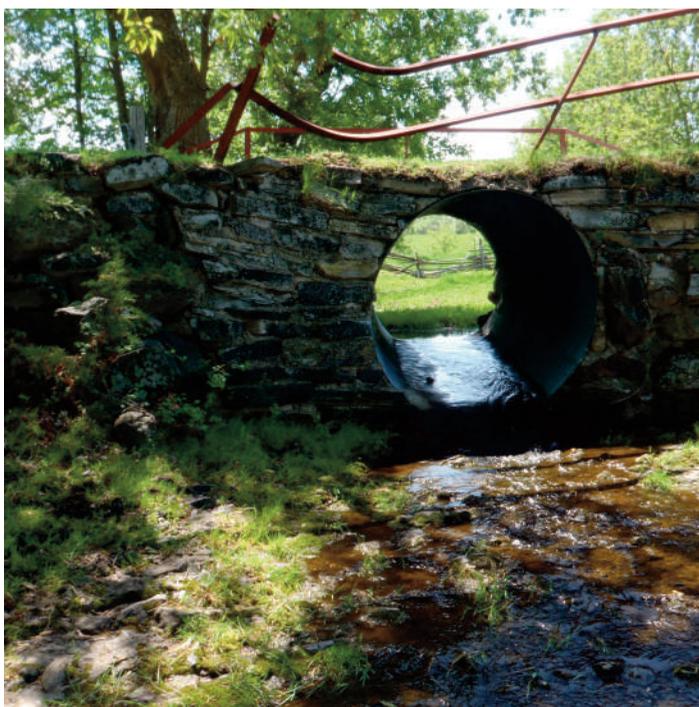
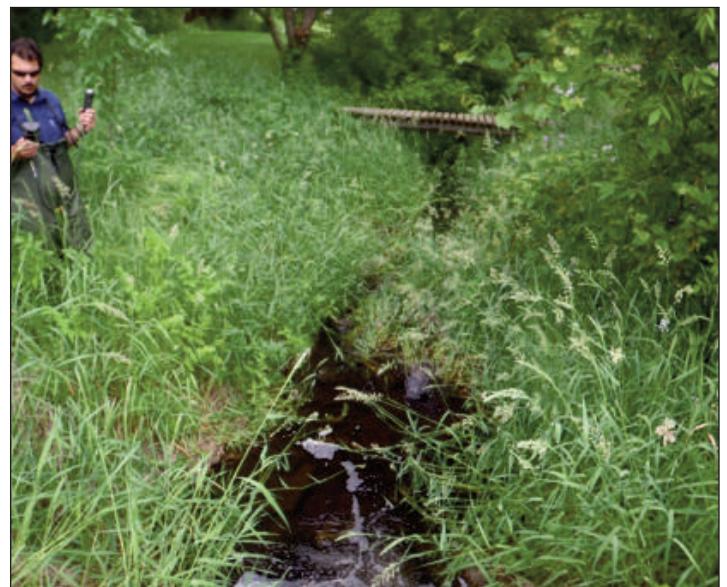
Students measuring water chemistry parameters on Sicklers Creek

Table 7 Water chemistry in Sicklers Creek

Month	Range	DO (mg/L)	DO(%)	Conductivity ($\mu\text{S}/\text{cm}$)	pH
May 2013	Low	11.4	124.9	491	8.0
	High	14.0	153.4	498	8.6
June 2013	Low	7.5	74.2	463	7.5
	High	14.2	140.8	600	8.6

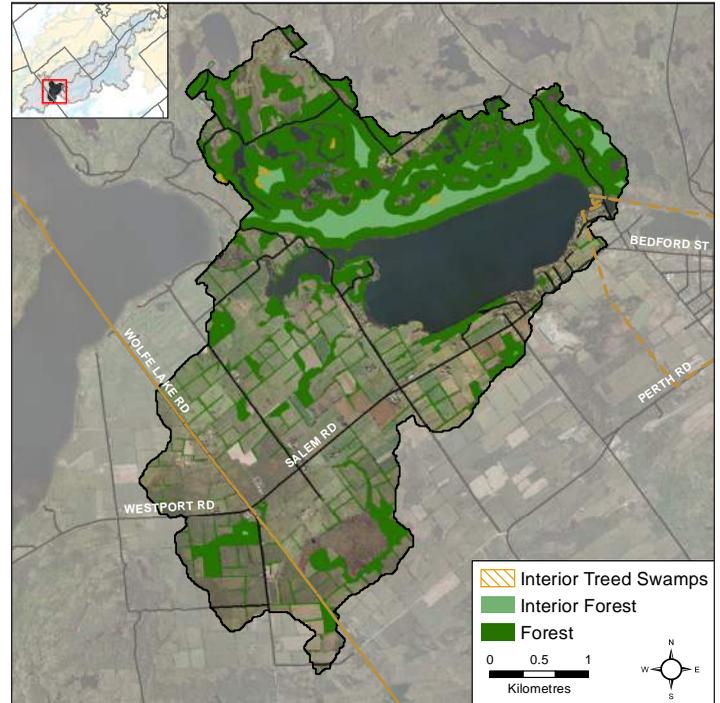
The same 58 woodlands contain 19 forest interior patches (Figure 34) that occupy three percent (63 hectares) of the catchment land area (versus the five percent of interior forest in the Rideau Lakes subwatershed). This is below the ten percent figure referred to in the Environment Canada Guideline that is considered to be the minimum threshold for supporting edge intolerant bird species and other forest dwelling species in the landscape. Most patches (18) have less than 10 hectares of interior forest, 13 of which have small areas of interior forest habitat less than one hectare in size. One other patch contains between 30 and 50 hectares of interior forest (at 45 hectares).

Figure 34 Catchment woodland cover and forest interior

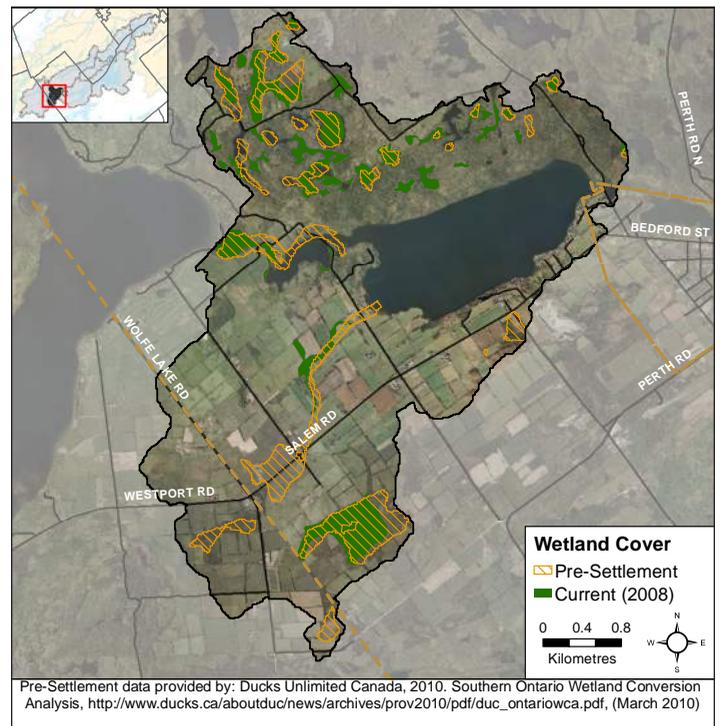
Figure 35 shows pre-settlement wetland cover (Ducks Unlimited Canada 2010) versus current wetland cover (DRAPE 2008) in the catchment.

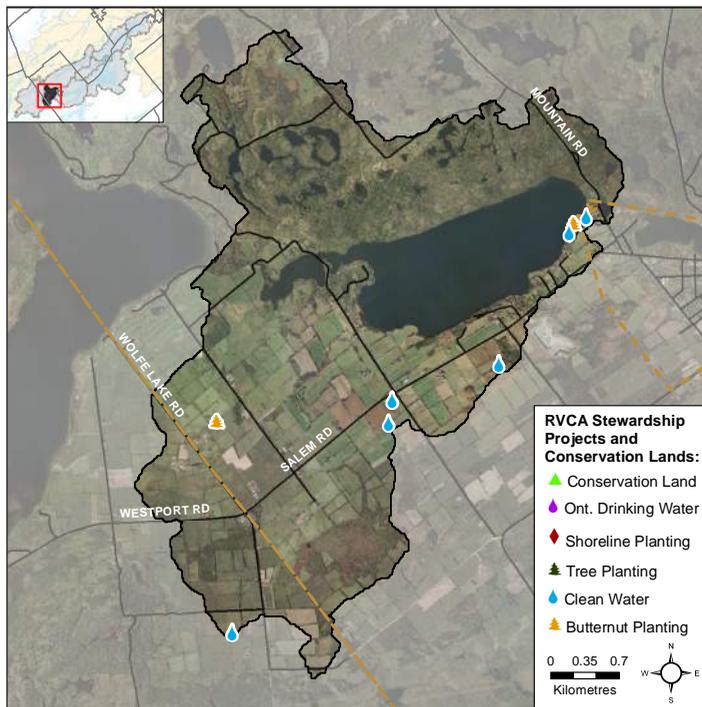
Figure 36 shows the location of all Rural Clean Water Projects in the Westport Sand Lake drainage area. From 2008 to 2013, landowners completed four projects: one nutrient management plan, one erosion control project, one septic system repair and one milkhouse wastewater disposal system. RVCA contributed \$12,500 in grant dollars towards the total project cost of \$40,499.

Figure 36 RVCA stewardship program project locations

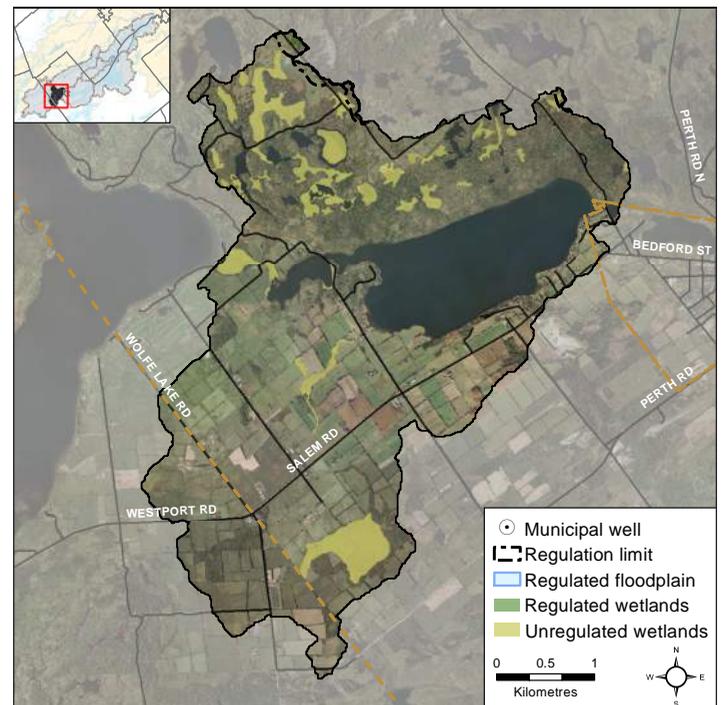
Less than one square kilometre or less than one percent of the catchment drainage area is within the regulation limit of Ontario Regulation 174/06 (Fig.49), leaving most wetland areas and river or stream valleys that are affected by flooding and erosion hazards without any protection. Within the regulation limit, “development” and “site alteration” require RVCA permission. The “alteration to waterways” provision of Ontario Regulation 174/06 applies to all watercourses.

Figure 37 RVCA regulation limits
