The RVCA produces individual reports for 16 catchments in the Lower Rideau subwatershed. Using data collected and analysed by the RVCA through its watershed monitoring and land cover classification programs, surface water quality conditions are reported for Mosquito Creek along with a summary of environmental conditions for the surrounding countryside every six years.

**1) a. Mosquito Creek**

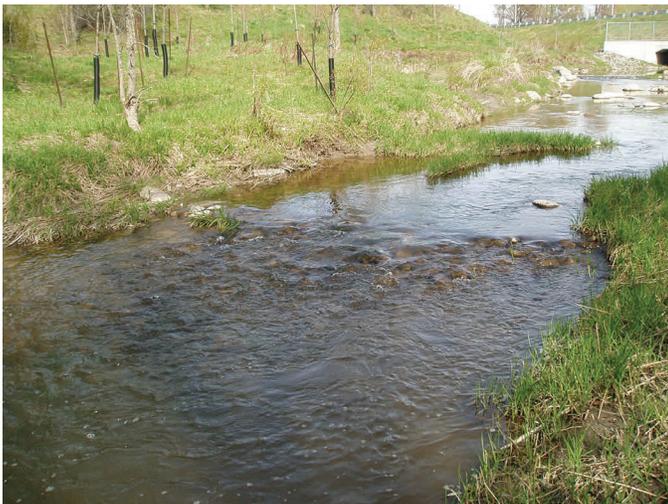
*Benthic sampling site replicate one on Mosquito Creek at Spratt Rd in the City of Ottawa; this image was captured in the spring of 2008.*

As part of the Ontario Benthic Biomonitoring Network (OBBN), the RVCA has been collecting benthic invertebrates at one location on Mosquito Creek at Spratt Road since 2003. Monitoring data is analyzed and the results are presented using the Family Biotic Index, Family Richness and percent Ephemeroptera, Plecoptera and Trichoptera.

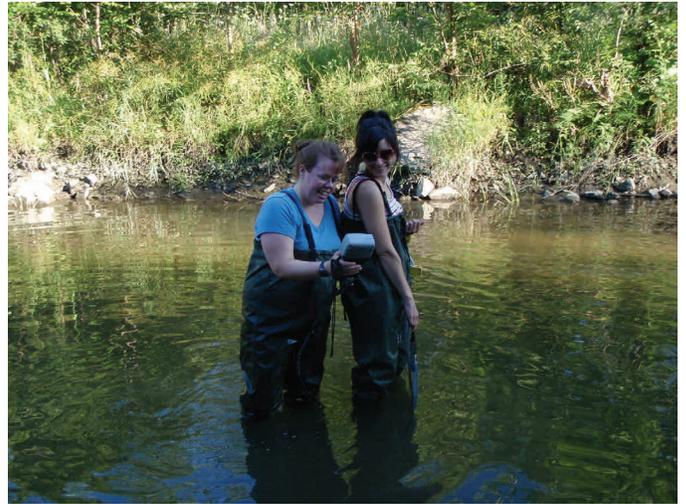
Collecting water quality using a YSI

During the macrostream survey, a YSI probe is used to collect water chemistry, as follows:

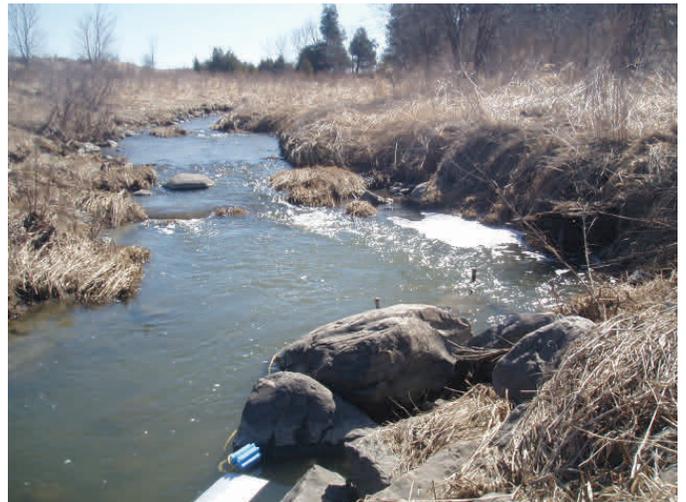
A pool, riffle, run sequence in Mosquito Creek

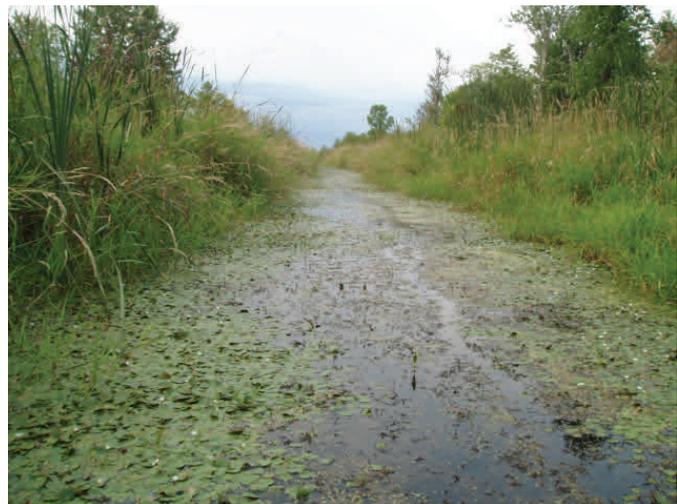
An example of how European frogbit can choke out other native aquatic plant species

Invasive species can have major implications on streams and species diversity. Invasive species are one of the largest threats to ecosystems throughout Ontario and can outcompete native species, having negative effects on local wildlife, fish and plant populations. Forty-five percent of the sections surveyed along Mosquito Creek had invasive species (Figure 30). The species observed in Mosquito Creek were flowering rush, European frogbit, garlic mustard, phragmites, purple loosestrife, poison parsnip.

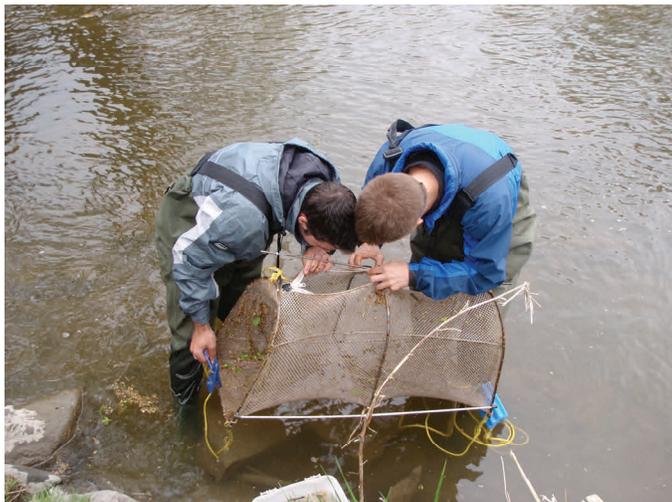
*Students checking a windemere trap for fish*

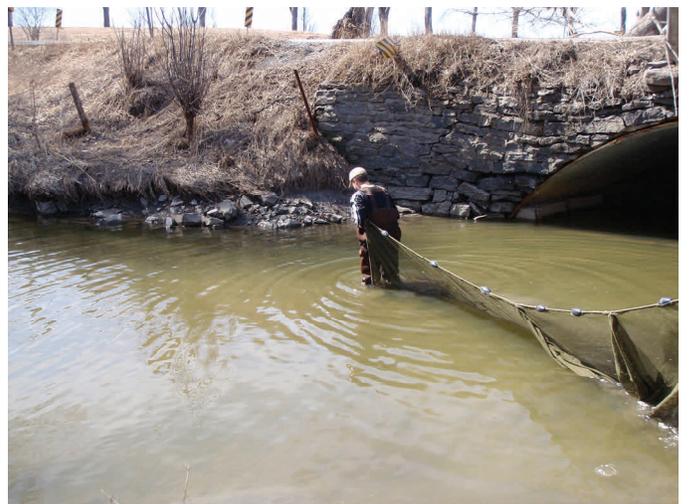
*A seine net is a method used for fish sampling*
