# Rideau Lakes Subwatershed Report 2014

## LOWER RIDEAU LAKE CATCHMENT

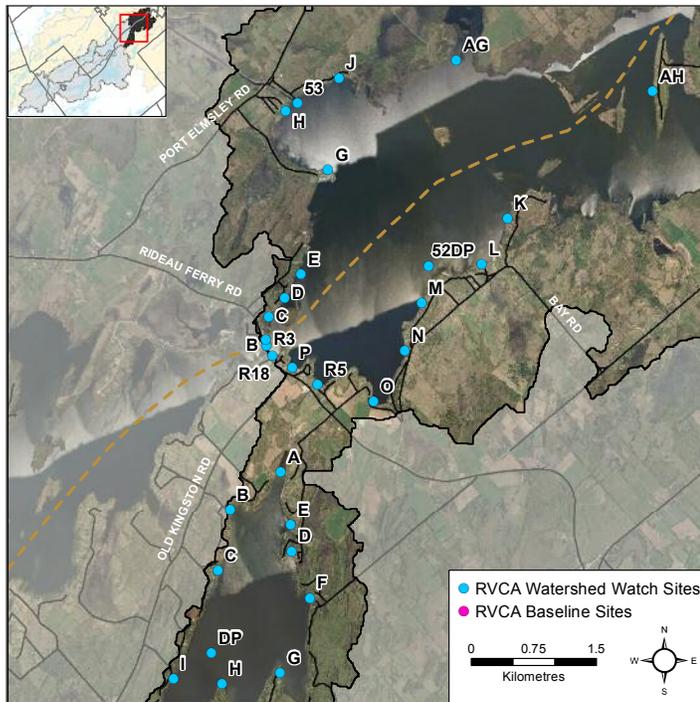
**Figure 1** Water quality monitoring sites on Bass Lake and Lower Rideau Lake

Surface water quality conditions in the Lower Rideau catchment are monitored by the Rideau Valley Conservation Authority's (RVCA) Watershed Watch Program. Watershed Watch monitors watershed lakes to assess nutrient concentrations, water clarity, dissolved oxygen availability and pH. The locations of monitoring sites are shown in Figure 1 and Table 1.

This report also considers data from nine additional sites that are regularly monitored around the lake. These sites have not been included in the calculation of the CCME WQI rating as they are not monitored with the same frequency as deep point sites. However, they do provide important information on water quality conditions in the near shore areas. For locations of shoreline sites please see Figure 1.

This report also considers data from 18 additional sites that are regularly monitored around the lake. These sites have not been included in the calculation of the CCME WQI rating as they are not monitored with the same frequency as deep point sites. However, they do provide important information on water quality conditions in the near shore areas. For locations of shoreline sites please see Figure 1.

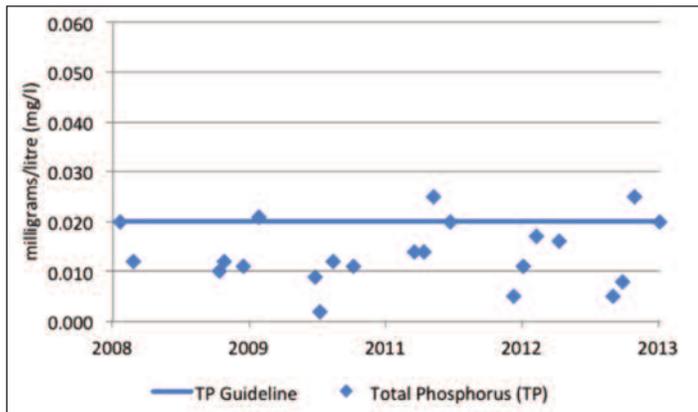
Figure 2 Total phosphorus sampling results at the deep point site in Bass Lake, 2008-2013

TP and TKN sampling results are presented in Figures 2 and 3. Of the samples analyzed for TP, 70 percent were less than the TP guideline with an average concentration of 0.016 mg/l (Table 3). TKN concentrations were less likely to be elevated; 96 percent of results were below the TKN guideline and the average concentration was 0.397 mg/l (Table 3). Average year to year concentrations have varied for both TP and TKN (Figure 4 and 5) but do not indicate a general trend; all results are below the guideline with the exception of results for 2008, which exceeded the guideline for both parameters. Overall, the data presented indicates that phosphorus concentrations are moderate in the mid lake deep waters of Bass Lake which may lead to impairment such as algal blooms and excessive aquatic plant growth.

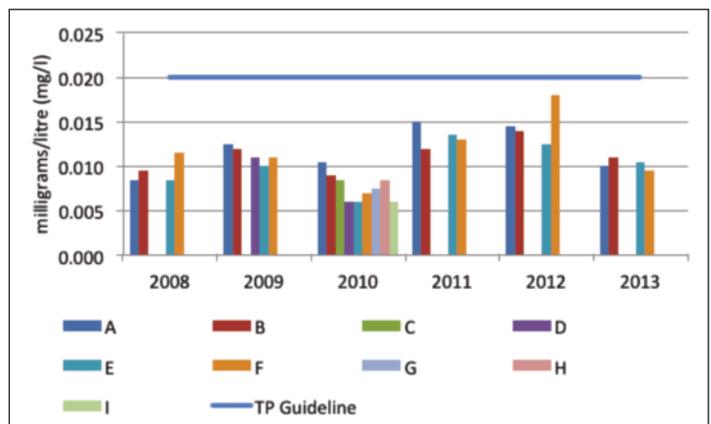
Figure 6 Average total phosphorus concentration at additional monitoring sites on Bass Lake, 2008-2013

The average nutrient concentrations at monitored sites around the lake vary from year to year (Figures 6 and 7). Please note that sites A, B, F and E are monitored each year while other sites are monitored every fifth year.

Average total phosphorous concentrations are below the TP guideline at all shoreline sites and concentrations can generally be considered as moderate across all sites (Figure 6) and that occasionally some problems associated with nutrient enrichment may be observed.

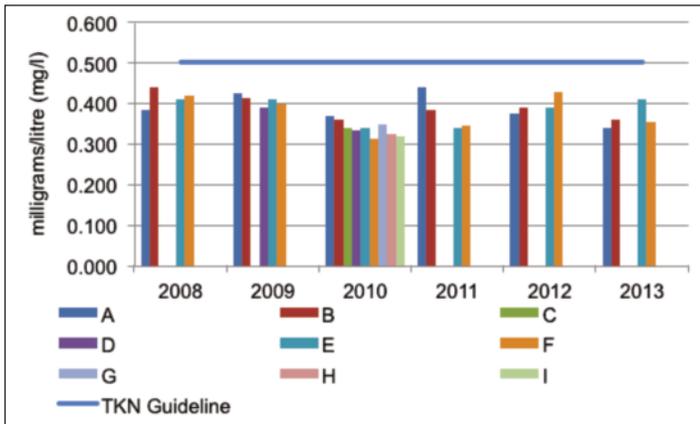
**Figure 7** Average total Kjeldahl nitrogen concentration at additional monitoring sites on Bass Lake, 2008-2013

TKN concentrations were also not elevated above the guideline at any of the sites. These results provide further evidence that nutrient enrichment may not be a problem in some near shore areas. However, if concentrations were to increase it could result in abundant plant or algal growth, particularly in areas where both TP and TKN are persistently elevated.

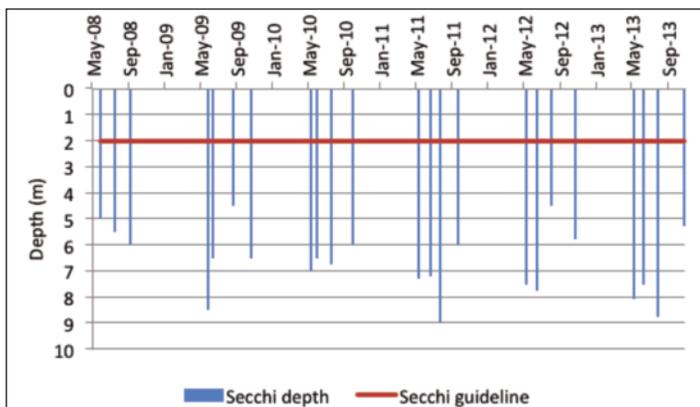
**Figure 8** Recorded Secchi depths at the deep point site in Bass Lake, 2008-2013

Water clarity is measured using a Secchi disk during each deep point sample. Table 4 summarizes the recorded depths and shows that all readings have exceeded the minimum PWQO of 2 metres indicating good water clarity with an average Secchi depth of 6.9 metres. Figure 8 shows that no reading has been below the guideline; measured depths range from 4.5 metres to 9.0 metres. It should also be noted that Secchi depths in many waterbodies have been influenced by the colonization of zebra mussels resulting in clearer waters than may have been seen prior to the introduction of this species in Bass Lake.

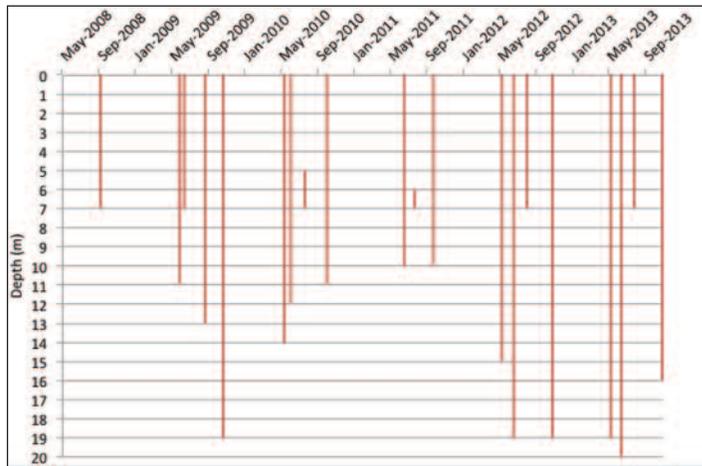
**Figure 9** Depths suitable for warm water fish (red bars) at site RVL-35DP in Bass Lake, 2008-2013

The red bars in Figure 9 show the depths where suitable conditions exist for warm water fish species (temperature less than 25°C and dissolved oxygen greater than 4 mg/l) at the monitored deep point. The vertical axis represents the total lake depth at each site where the profile is taken. Suitable oxygen temperatures exist to an average depth of 12 metres.

Spring and early summer typically have good conditions for fish habitat but as temperatures warm and oxygen becomes limited in the deeper water through the summer, available habitat becomes more limited; this is particularly evident in July 2010 and July 2011.

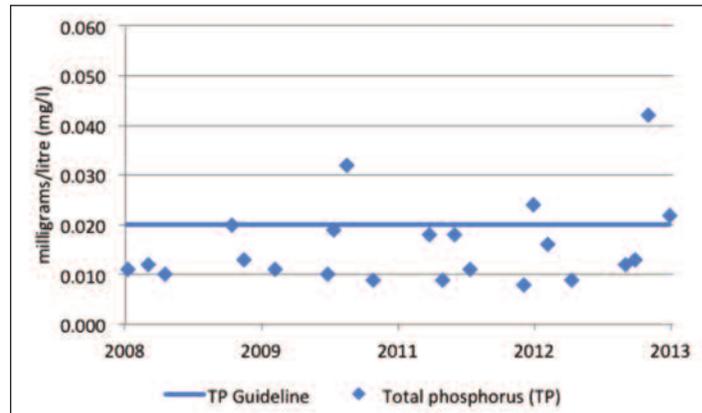
**Figure 13** Total phosphorus sampling results at the deep point site in Lower Rideau Lake, 2008-2013

TP and TKN sampling results are presented in Figures 13 and 14. The majority (74 percent) of samples analyzed for TP were less than the TP guideline and the average concentration exceeded the guideline at 0.025 mg/l (Table 7). TKN concentrations were also elevated; 87 percent of reported results were below the TKN guideline and the average

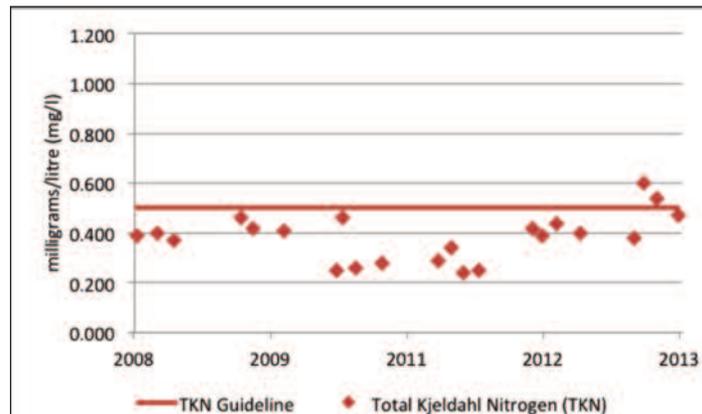
**Figure 14** Total Kjeldahl nitrogen sampling results at the deep point site in Lower Rideau Lake, 2008-2013

concentration was 0.520 mg/l (Table 7). Average year to year concentrations have varied for both TP and TKN (Figure 15 and 16) but do not indicate a general trend; all average results exceed the guidelines in both 2009 and 2013. Overall, the data presented indicates that nutrient enrichment is a concern in the mid-lake, deep water site of Lower Rideau Lake.

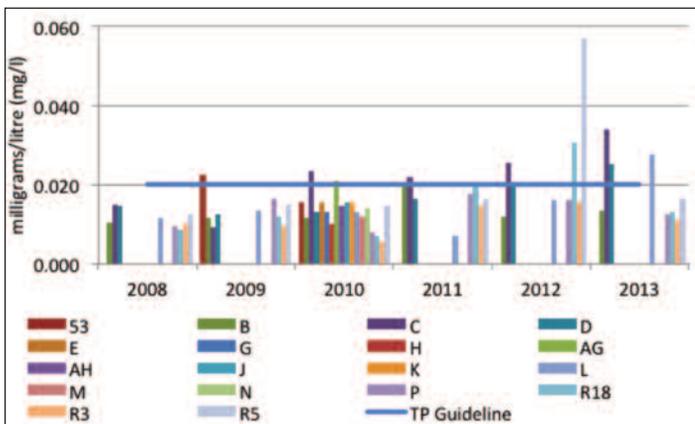
**Figure 17** Average total phosphorus concentration at additional monitoring sites on Lower Rideau Lake, 2008-2013

The average nutrient concentrations at monitored sites around the lake vary from year to year (Figures 17 and 18). Please note that sites B, C, D, L, P, R3, R5, and R18 are monitored each year while other sites are monitored every fifth year.

Total phosphorous concentrations are below the TP guideline at the majority of sites with the exception of site C which exceeded the guideline in more than one year; exceedances were also noted at sites 53, AG, R18, D, and L (Figure 17). Site C is in a very shallow bay behind Hog Island dominated by wetland features. In shallow waters active boating may stir the water column and cause re-suspension of nutrient rich sediment. Site D is close to site C though further downstream and likely impacted by similar circumstances. Sites 53 is located at the outflow of the Tay Canal and site AG at the outflow of the Tay River; the Tay River has been identified as a source of nutrient loading. R18 is near a stormwater outfall to a small shallow bay near the Rideau Ferry Bridge. Site L is in a developed area along the south shore and increased runoff from this area may have contributed to higher results in 2013. Overall the impacts of increased shoreline development, boat traffic and high levels of recreational use in these shallow water areas may contribute to increased loading and re-suspension of sediment resulting in higher TP concentrations.

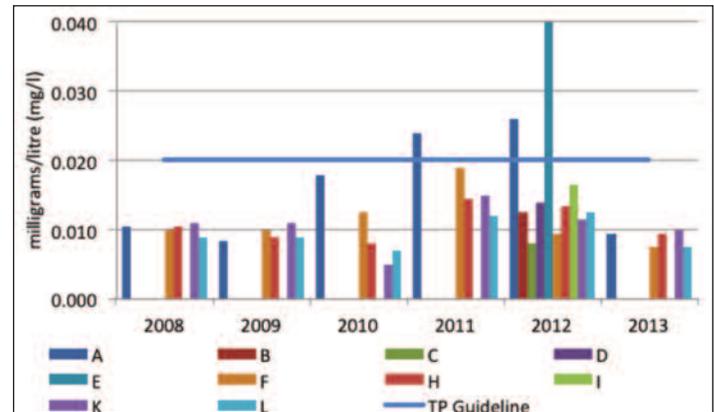
**Figure 18** Average total Kjeldahl nitrogen concentration at additional monitoring sites on Lower Rideau Lake, 2008-2013

TKN concentrations were not elevated above the guideline at the majority of sites. Site R5 is the only site with repeated exceedances in 2012 and 2013; this site is located at the outflow from a small tributary. As with TP, TKN exceedances are also noted at site 53, R5, R18 and L. These results provide further evidence that nutrient enrichment may be a problem in some near shore areas and could result in abundant plant or algal growth, particularly in areas where both TP and TKN are persistently elevated.

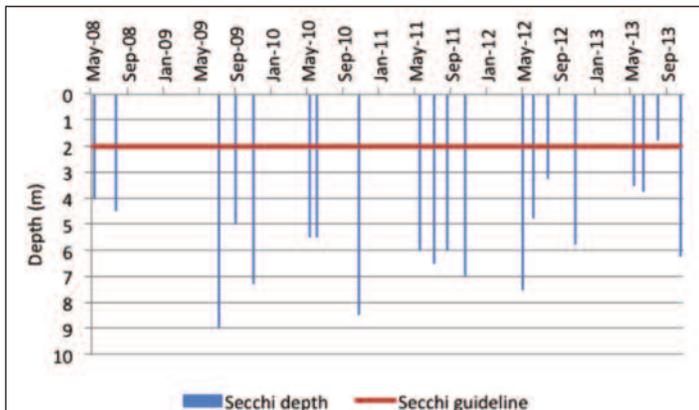
**Figure 19** Recorded Secchi depths at the deep point site in Lower Rideau Lake, 2008-2013

Water clarity is measured using a Secchi disk during each deep point sample. Table 8 summarizes the recorded depths and shows that all readings have exceeded the minimum PWQO of 2 metres indicating good water clarity and the average Secchi depth is 5.6 metres. Figure 19 shows that only one reading has been below the guideline; measured depths range from 1.75 metres to 9.0 metres. It should also be noted that Secchi depths in many waterbodies have been influenced by the colonization of zebra mussels resulting in clearer waters than may have been seen prior to the introduction of this species in Lower Rideau Lake.

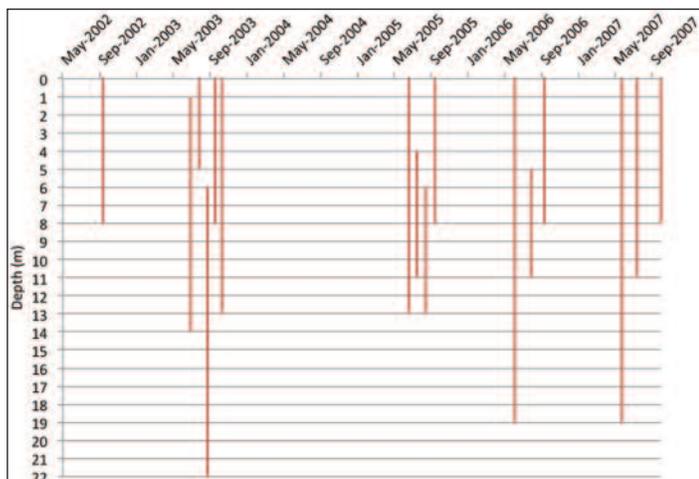
**Figure 20** Depths suitable for warm water fish (red bars) at site RVL-38-52 in Lower Rideau Lake, 2008-2013

The red bars in Figure 20 show the depths where suitable conditions exist for warm water fish species (temperature less than 25°C and dissolved oxygen greater than 4 mg/l) at the monitored deep point. The vertical axis represents the total lake depth at each site where the profile is taken. Suitable oxygen temperatures exist to an average depth of 16 metres.

Spring and early summer typically have good conditions for fish habitat but as temperatures warm and oxygen becomes limited in the deeper waters through the summer, available habitat becomes more limited; this was particularly evident in July 2010.

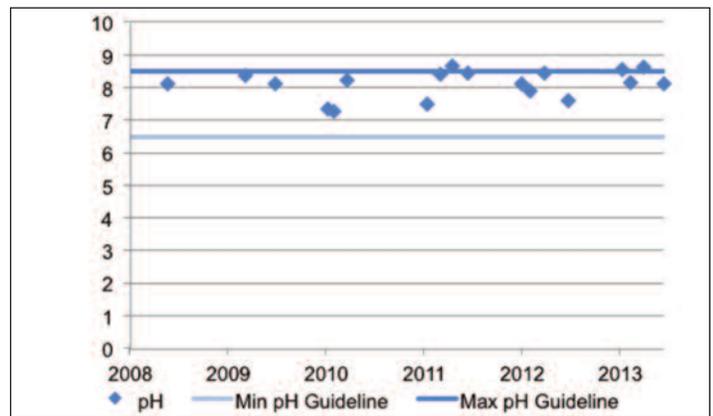
**Figure 21** pH concentrations at the deep point site in Lower Rideau Lake, 2008-2013

pH is a basic water quality parameter used to assess the acidity of water, an important factor for aquatic life. Figure 21 shows pH concentrations in Lower Rideau Lake and Figure 22 summarizes average concentrations by year.

Eighty-three percent of samples (Table 9) were within guidelines established by the PWQO which state that pH should be between 6.5 and 8.5 to protect aquatic life and prevent irritation for anyone using the waters for recreational purposes.

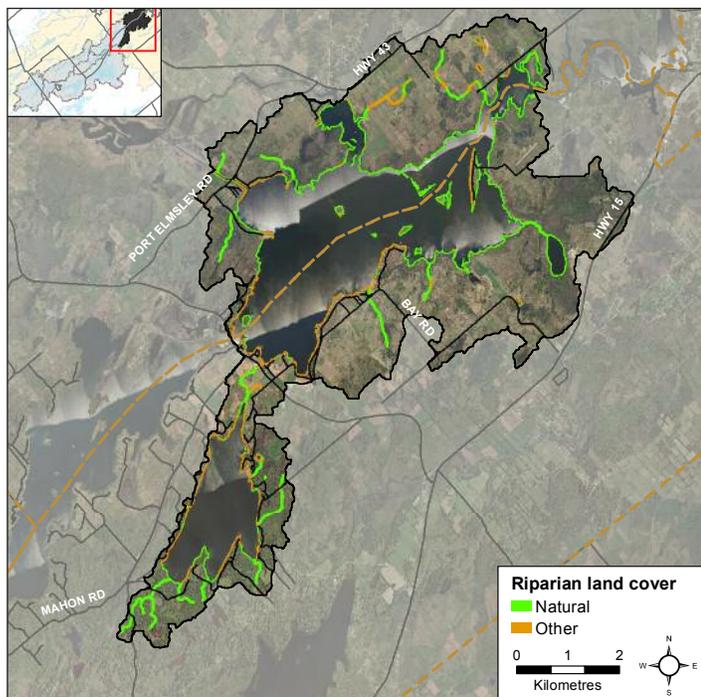
Figure 24 Natural and other riparian land cover around Bass Lake and Lower Rideau Lake

Around **Bass Lake**, the shoreline buffer is made up of settlement areas (65 percent), woodland (16 percent), wetland (15 percent), transportation routes (three percent) and crop and pastureland (one percent).

Along streams, the riparian buffer is comprised of wetland (65 percent), woodland (16 percent), crop and pastureland (14 percent), settlement areas (three percent) and transportation routes (two percent) throughout the whole catchment.

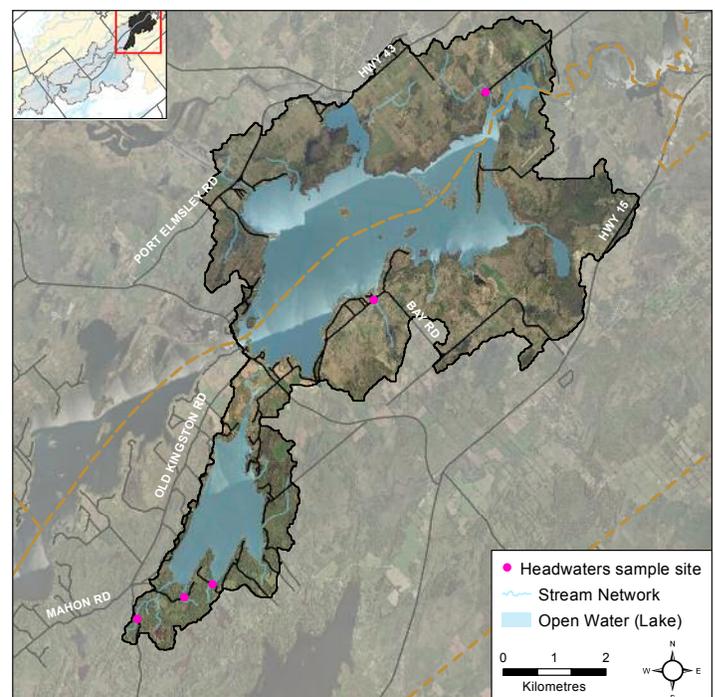
Figure 25 Headwater drainage feature sampling locations around Bass Lake and Lower Rideau Lake

The RVCA Stream Characterization program assessed Headwater Drainage Features for the Rideau Lakes subwatershed in 2013. This protocol measures zero, first and second order headwater drainage features (HDF). It is a rapid assessment method characterizing the amount of water, sediment transport, and storage capacity within headwater drainage features (HDF). RVCA is working with TRCA and the MNR to implement the protocol with the goal of providing standard datasets to support science development and monitoring on both the interim guideline for headwater drainage features and existing mitigation strategies. An HDF is a depression in the land that conveys surface flow. Additionally, this module provides a means of characterizing the connectivity, form and unique features associated with each HDF (OSAP Protocol, 2013). An initiative is underway to evaluate how these data can help understand the cumulative contributions of individual headwater drainage features on the downstream watershed state (see Stanfield *et al.*, 2013). In 2013 the program sampled five sites in the Lower Rideau Lake catchment area. Figure 25 shows the headwater drainage features sampling locations in the catchment.

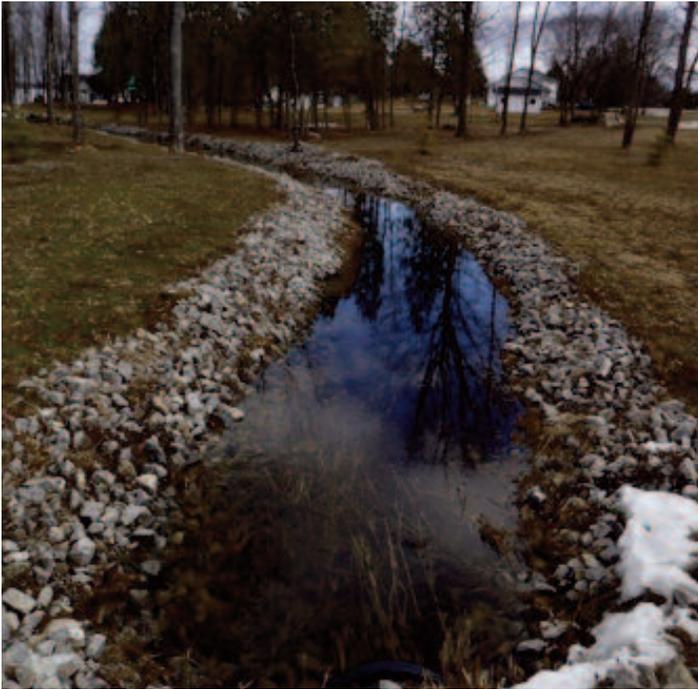
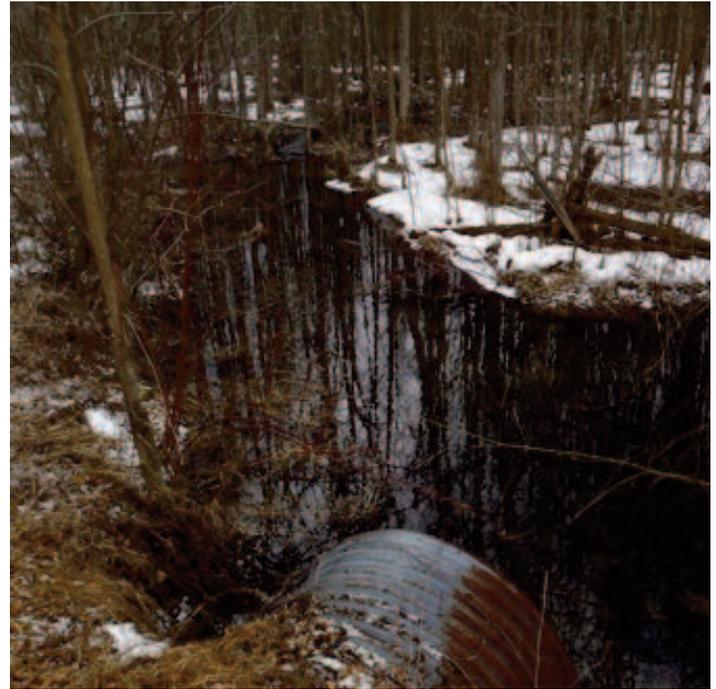
Headwater Drainage Features sampling sites in the Lower Rideau Lake catchment area sampled in 2013

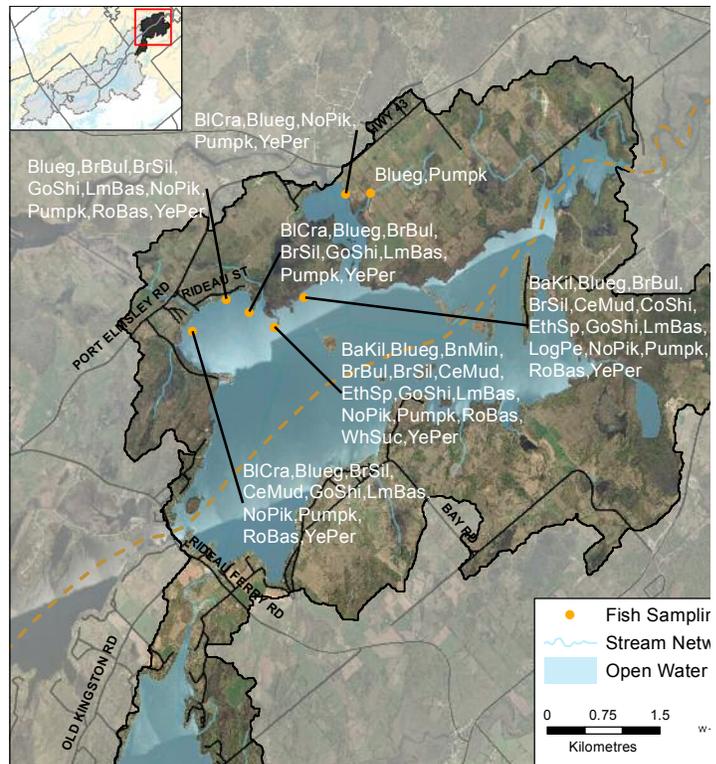
Figure 26 Fish sampling on Lower Rideau Lake

The Lower Rideau Lake catchment is classified as a mixed community of warm, cool and cold water recreational and baitfish fishery with 26 species observed. The following is a list of species in the catchment (Source: MNR/RVCA). Fish sampling sites are shown in Figure 26.

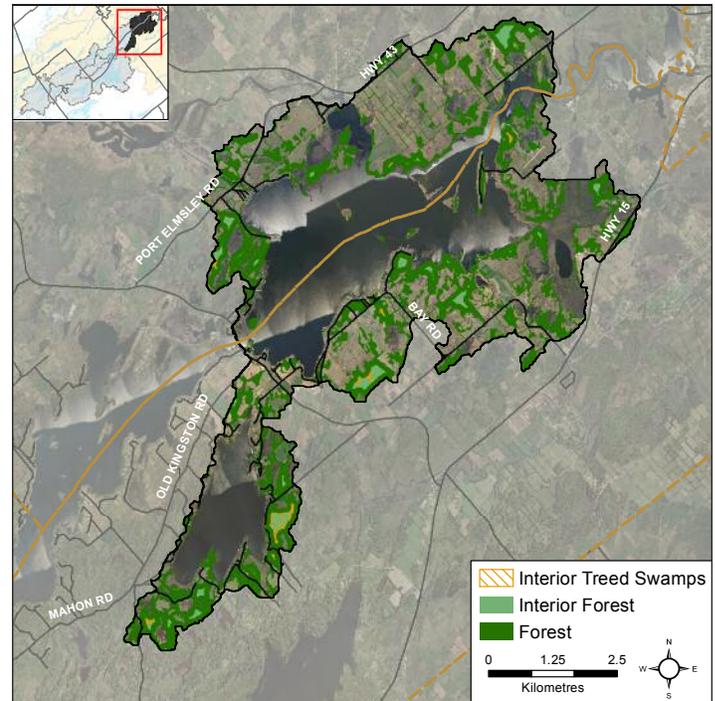
**Figure 27** Catchment woodland cover and forest interior

The same 202 woodlands contain 40 forest interior patches (Figure 27) that occupy one percent (61 hectares) of the catchment land area (versus the five percent of interior forest in the Rideau Lakes subwatershed). This is below the ten percent figure referred to in the Environment Canada Guideline that is considered to be the minimum threshold for supporting edge intolerant bird species and other forest dwelling species in the landscape. Most patches (38) have less than 10 hectares of interior forest, 28 of which have small areas of interior forest habitat less than one hectare in size. The remaining two patches have greater than 10 hectares of interior forest (at 11 and 12 hectares).

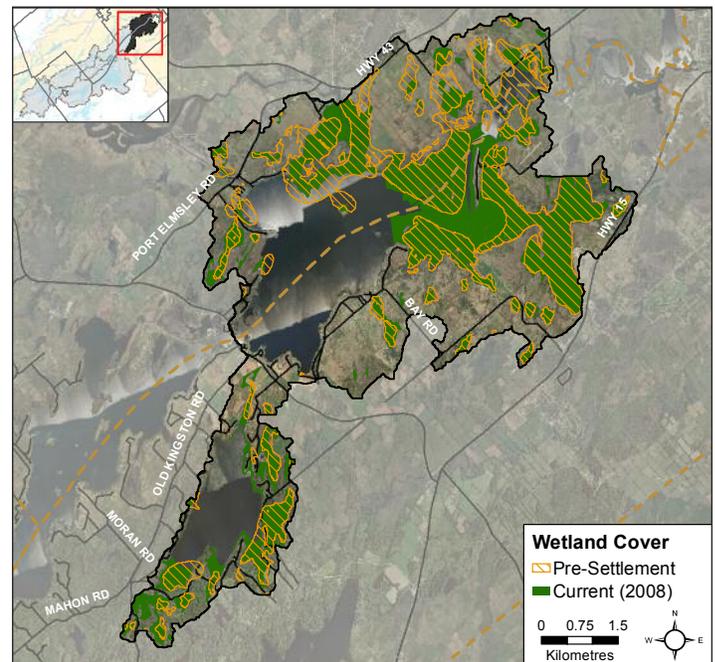
**Figure 28** Catchment wetland cover

Figure 28 shows pre-settlement versus current (2008) wetland cover in the catchment.

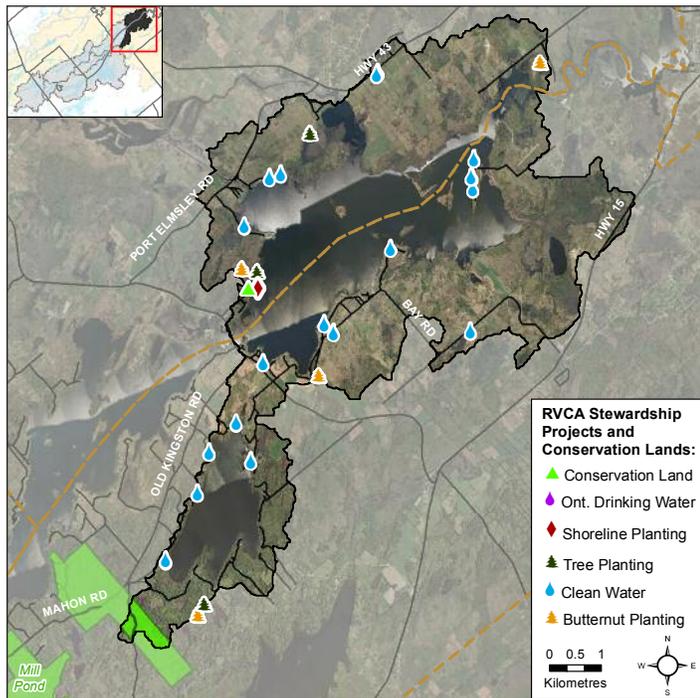
Figure 29 RVCA stewardship program project locations

Figure 29 shows the location of all Rural Clean Water Projects in the Lower Rideau drainage area. From 2008 to 2013, landowners completed 15 projects: nine septic system repairs/replacements, two well decommissionings, two well upgrades, one buffer/windbreak planting and one well replacement. RVCA contributed \$17,529 in grant dollars towards the total project cost of \$ 120,765.

Prior to 2008, the RVCA completed seven projects in the area consisting of three erosion control projects, two septic system repairs/replacements and two well upgrades. In total, RVCA contributed \$9,750 in grant dollars to projects valued at \$51,827.

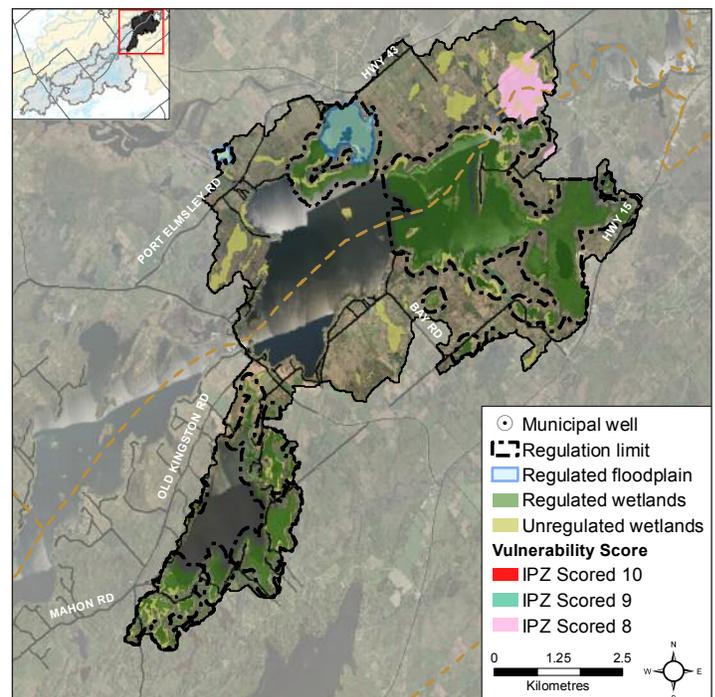
Figure 30 RVCA regulation limits and Smiths Falls Intake Protection Zone

Eighteen square kilometres or 38 percent of the catchment drainage area is within the regulation limit of Ontario Regulation 174/06 (Figure 30), giving protection to wetland areas and river or stream valleys that are affected by flooding and erosion hazards.

Natural features within the regulation limit include 9.5 sq. kilometres of wetlands (representing 77 percent of all wetlands in the catchment) and 22.3 kilometers of streams (representing 45 percent of all streams in the catchment). Some of these regulated watercourses (16.1 kilometres or 33 percent of all streams) flow through regulated wetlands.

Regulation limit mapping has been plotted along 6.2 kilometres (or 28 percent) of the streams that are outside of wetlands. Plotting of the regulation limit on the remaining 87.4 kilometres (or 82 percent) of streams requires identification of flood and erosion hazards and valley systems.
