Kemptville Creek Subwatershed Report 2013

Barnes Creek Catchment

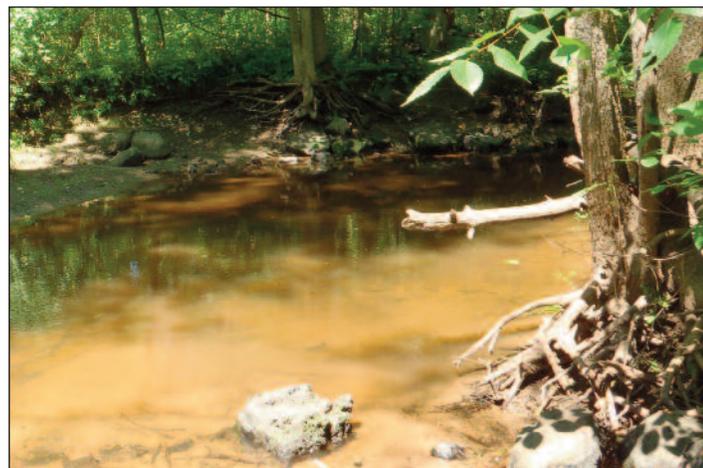
Erosion on Barnes Creek

Erosion is a normal, important stream process and may not affect actual bank stability; however, excessive erosion and deposition of sediment within a stream can have a detrimental effect on important fish and wildlife habitat. Poor bank stability can greatly contribute to the amount of sediment carried in a waterbody as well as loss of bank vegetation due to bank failure, resulting in trees falling into the stream and the potential to impact instream migration. Figure 13 shows high to moderate erosion levels in the lower to middle reaches on the left and right bank along Barnes Creek.

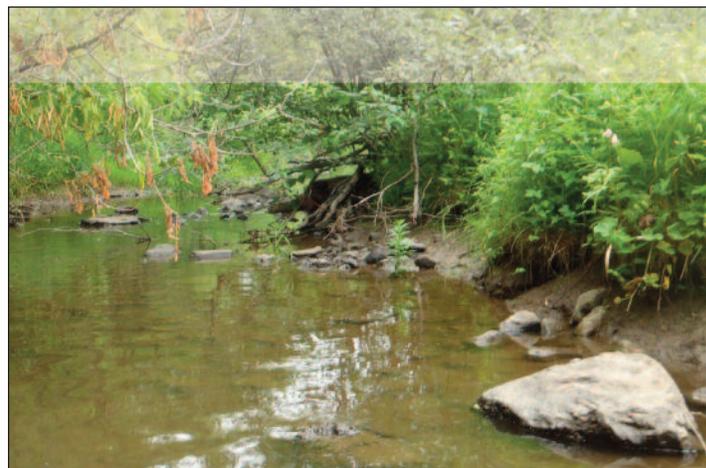
Undercut stream bank along Barnes Creek

Undercut banks are a normal and natural part of stream function and can provide excellent refuge areas for fish. Figure 14 shows that Barnes Creek had moderate to high levels of undercut banks.

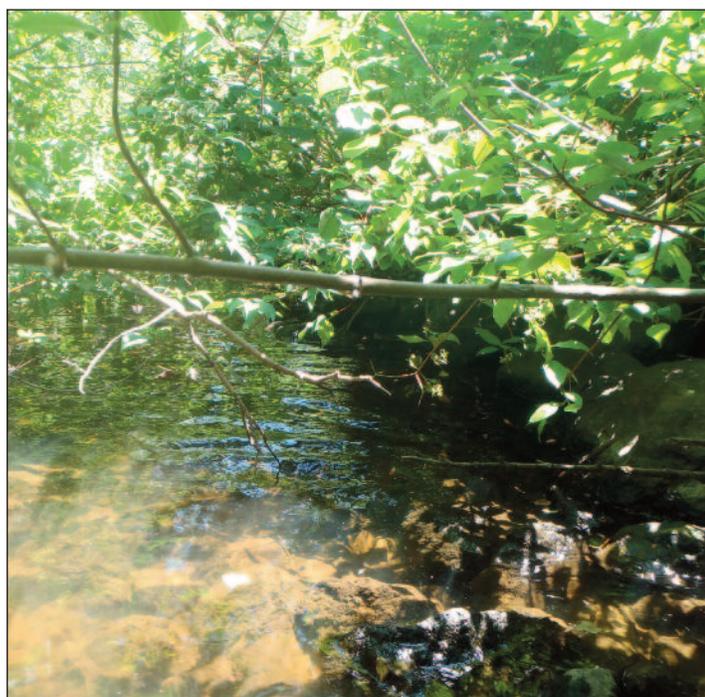
Overhanging trees and branches

Figure 17 shows that the majority of Barnes Creek had varying levels of overhanging branches and trees. Overhanging branches and trees provide a food source, nutrients and shade which helps to moderate instream water temperatures.

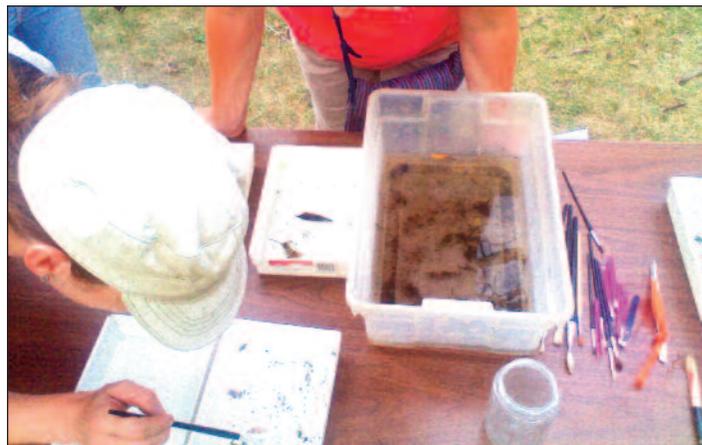
Benthic invertebrate sampling

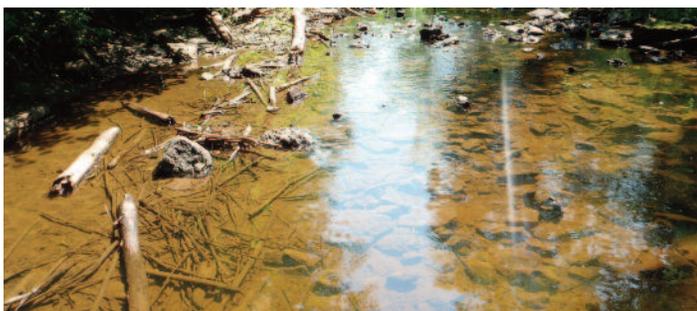
Instream substrate in Barnes Creek

Boulders create instream cover and back eddies for large fish to hide and/or rest out of the current. Cobble provides important over wintering and/or spawning habitat for small or juvenile fish. Cobble can also provide habitat conditions for benthic invertebrates that are a key food source for many fish and wildlife species. Figure 24 shows where cobble and boulder substrate is found in Barnes Creek. Diverse substrate is important for fish

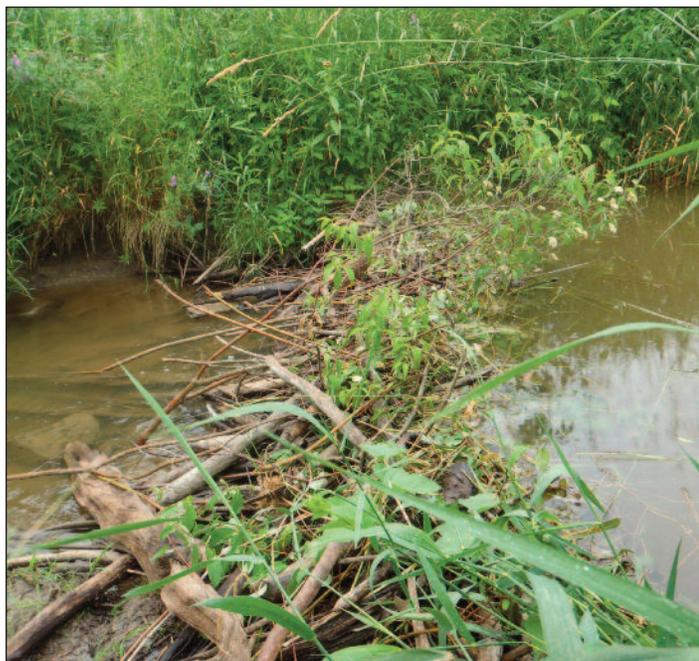
Beaver dam — a migratory obstruction on Barnes Creek

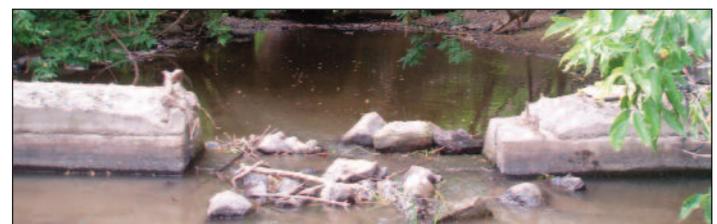
Small weir on Barnes Creek

- Investigate the purpose of the weir and consider its removal to restore natural stream processes along Barnes Creek
- As part of the normal life cycle process for the replacement of municipal infrastructure, implement mitigation measures to lower the invert at the perched culvert located downstream of Van Buren Street along Barnes Creek, to allow for low flow seasonal fish migration

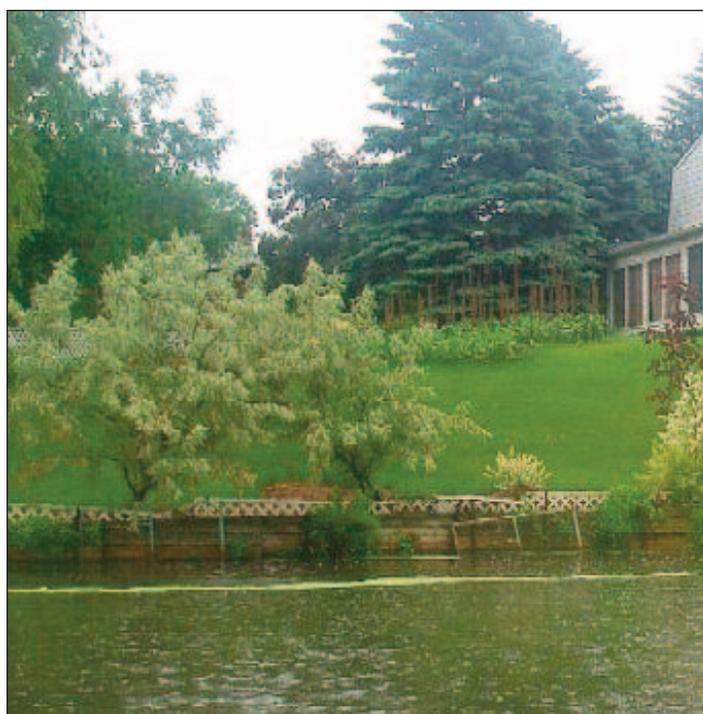
Opportunities for riparian restoration on Barnes Creek

Figure 33 depicts the locations where various riparian restoration activities can be implemented as a result of observations made during the stream survey assessments.
