# Kemptville Creek Subwatershed Report 2013

## Oxford Mills Catchment

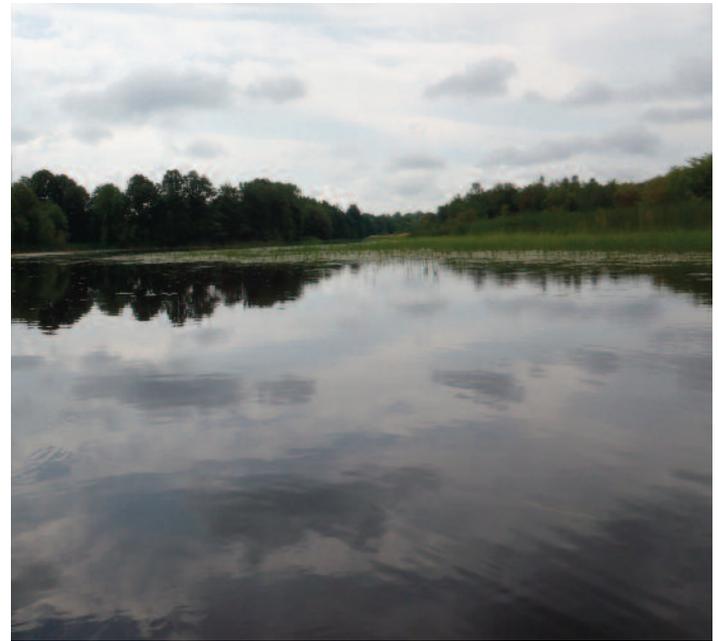
Figure 26 Temperature loggers in Kemptville Creek Oxford Mills catchment

Figure 26 shows the location of temperature loggers at one sampling location on Kemptville Creek in the Oxford Mills catchment.

Kemptville Creek Oxford Mills catchment is a warm water system

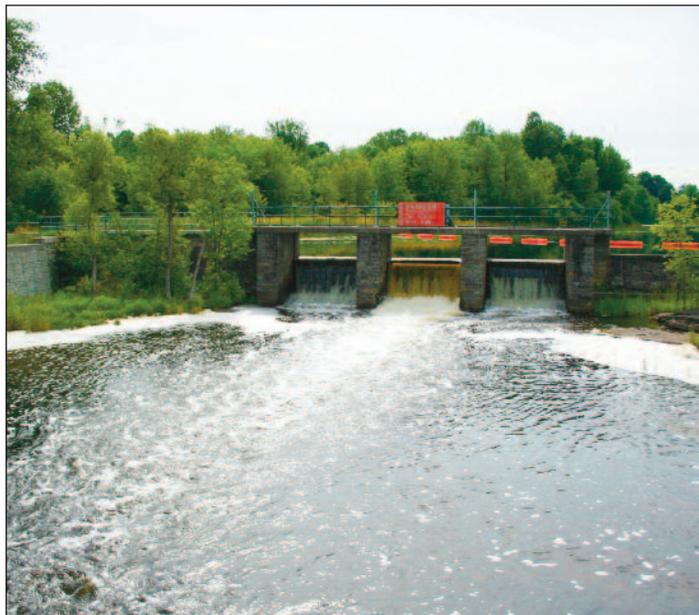
The Oxford Mills dam is a migratory obstruction
