Kemptville Creek Subwatershed Report 2013 South Branch Catchment

1. South Branch Surface Water Quality Conditions

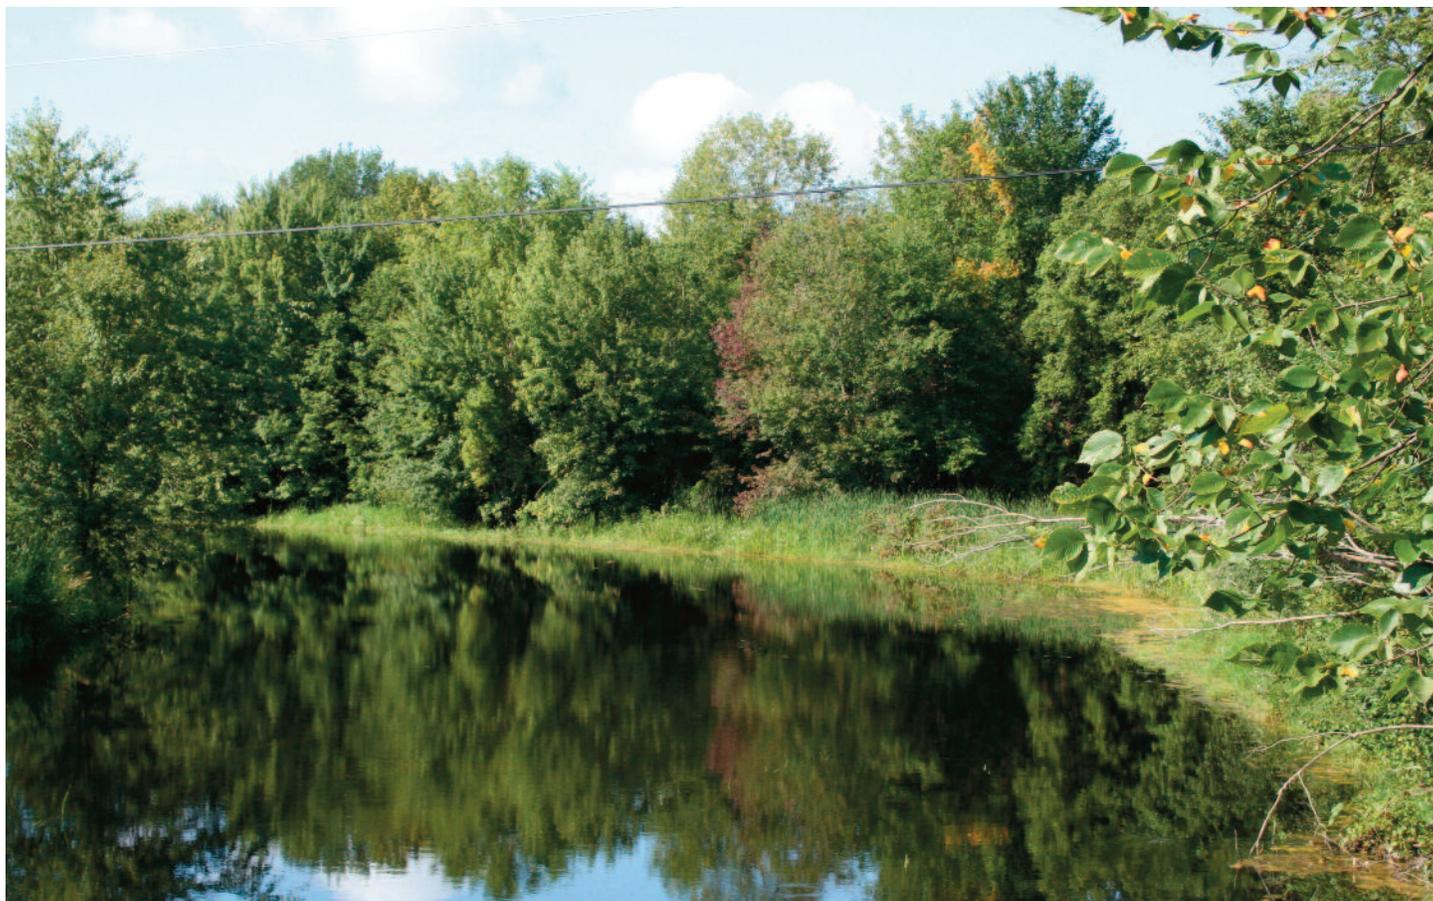
Figure 6b Percentile plots of *E. coli* in South Branch for 2007–2012

Figure 5 shows the results of the geometric mean with respect to the guideline for the two periods 2001–2006 and 2007–2012. Figure 6 shows percentile plots of the data for the same two time periods. Any point to the left of the 70th percentile line (vertical) and above the guideline (horizontal line) has failed to reach the KCWP target.

E. coli counts at site KEM-14 show improvement with regard to bacterial contamination. Counts at the 70th percentile decreased from 102 CFU/100 ml (Figure 6a) to 96 CFU/100 ml (Figure 6b). The proportion of samples below the guideline remained consistent at 69 percent (Figures 5a and 5b), and the count at the geometric mean increased from 51 CFU/100 ml (2001-2006) to 73 CFU/100 ml (2007-2012).

At site KEM-11 *E. coli* counts at the 70th percentile increased from 76 CFU/100 ml (Figure 6a) to 120 CFU/100 ml (Figure 6b). The proportion of samples below the guideline declined from 87 percent (Figure 5a) to 64 percent (Figure 5b) and the count at the geometric mean increased from 43 CFU/100 ml (2001-2006) to 63 CFU/100 ml (2007-2012).

E. coli counts increased at the 70th percentile over the 2001–2012 monitoring period at site KEM-10. In comparing the two time periods *E. coli* counts at the 70th percentile have increased from 48 CFU/100 ml (Figure 6a) to 60 CFU/100 ml (Figure 6b). The proportion of samples below the guideline decreased from 97 percent (Figure 5a) to 92 percent (Figure 5b), and the geometric mean increased from 25 CFU/100 ml (2001–2006) to 35 CFU/100 ml (2007–2012).

Percentile plots of *E. coli* data at site KEM-09 show counts at the 70th percentile increased to exceed the KCWP target, from 38 CFU/100 ml (Figure 5a) to 112 CFU/100 ml (Figure 5b). The proportion of samples below the guideline decreased from 90 percent (Figure 6a) to 67 percent (Figure 6b), indicating higher counts occur more frequently. The count at the geometric mean increased from 25 CFU/100 ml to 74 CFU/100 ml.
