# Kemptville Creek Subwatershed Report 2013 Mud Creek Catchment

The RVCA produces individual reports for six catchments in the Kemptville Creek Subwatershed. Using data collected and analysed by the RVCA through its watershed monitoring and land cover classification programs, surface water quality conditions are reported for Mud Creek along with a summary of environmental conditions for the surrounding countryside every six years.

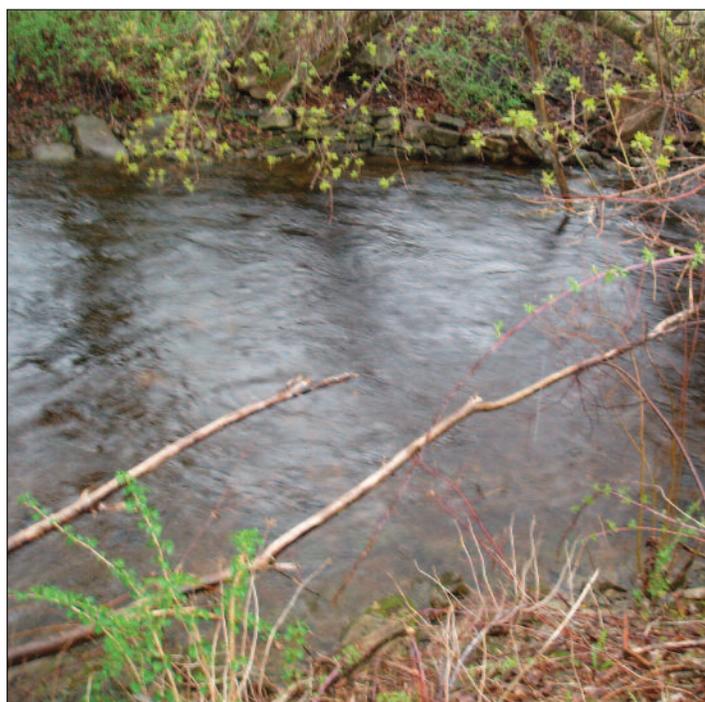
Mud Creek has low to moderate levels of overhanging branches

Figure 17 shows that Mud Creek had low to moderate levels of overhanging branches and trees. Overhanging branches and trees provide a food source, nutrients and shade which helps to moderate instream water temperatures.
