The RVCA produces individual reports for 16 catchments in the Lower Rideau subwatershed. Using data collected and analysed by the RVCA through its watershed monitoring and land cover classification programs, surface water quality conditions are reported for Barrhaven Creek along with a summary of environmental conditions for the surrounding countryside every six years.

**1) a. Barrhaven Creek**

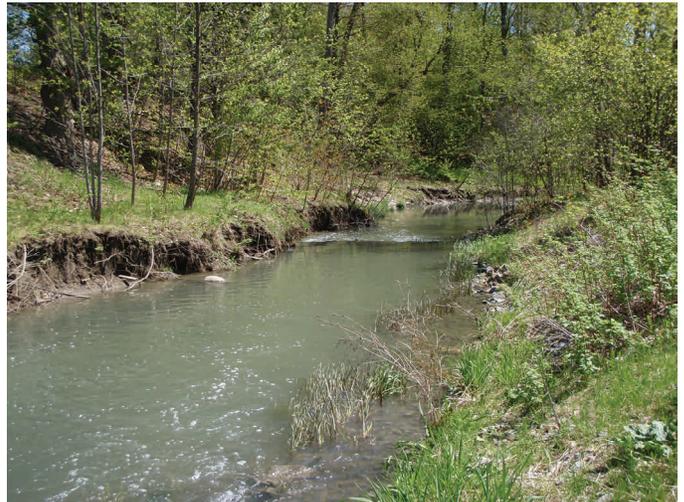
A riffle pool riffle sequence along Barrhaven Creek

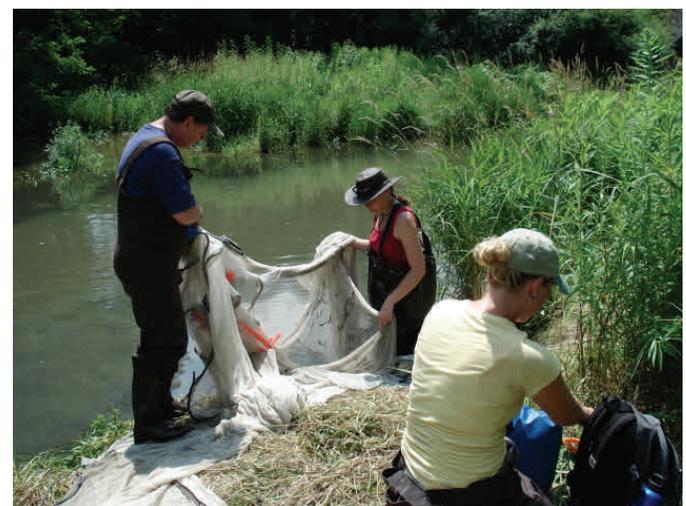
A seine net being retrieved and fish identified on Barrhaven Creek
