BLACKS RAPIDS CREEK CATCHMENT

LOWER RIDEAU RIVER SUBWATERSHED REPORT 2012

1a. Black Rapids Creek

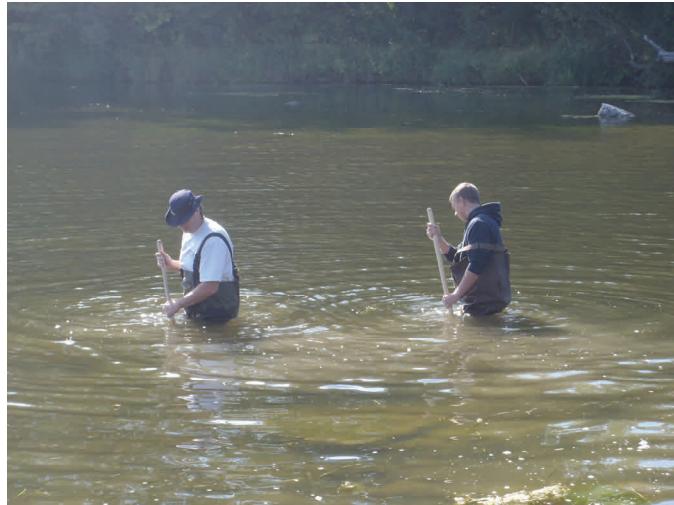
The kick and sweep method to collect benthic invertebrates
