The RVCA produces individual reports for 16 catchments in the Lower Rideau subwatershed. Using data collected and analysed by the RVCA through its watershed monitoring and land cover classification programs, surface water quality conditions are reported for Stevens Creek along with a summary of environmental conditions for the surrounding countryside every six years.

1) Surface Water Quality

1) a. Stevens Creek

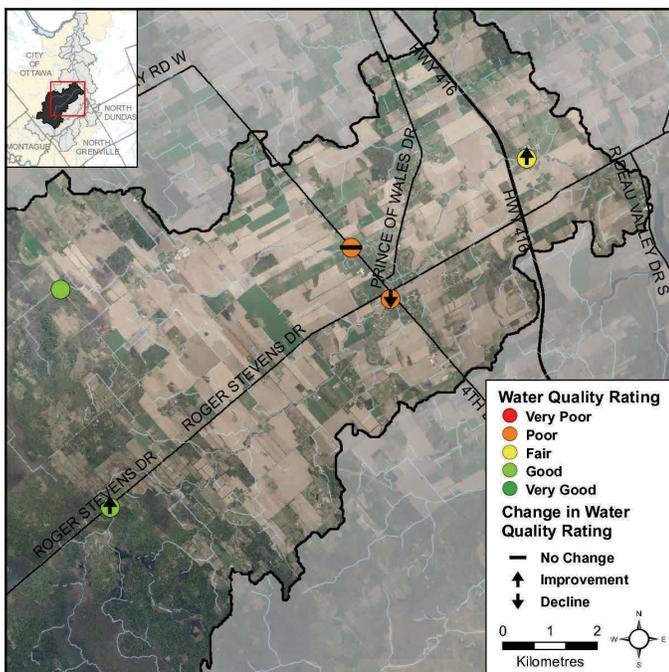
Figure 1. Sampling sites on Stevens Creek and Taylor Drain

Surface water quality conditions in Stevens Creek are monitored through the City of Ottawa's Baseline Water Quality Program. See Fig. 1 and Table 2 for their locations.

Surface water quality conditions in Taylor Drain are monitored through the City of Ottawa’s Baseline Water Quality Program. (Ck42-05-03 downstream side of 4th Line Road bridge and CK42-05-07 Proven Line Road) (See Fig. 1, on page 2 for their location)
