# Kemptville Creek Subwatershed Report 2013 North Branch Catchment

The RVCA produces individual reports for six catchments in the Kemptville Creek Subwatershed. Using data collected and analysed by the RVCA through its watershed monitoring and land cover classification programs, surface water quality conditions are reported for the North Branch of Kemptville Creek along with a summary of environmental conditions for the surrounding countryside every six years.

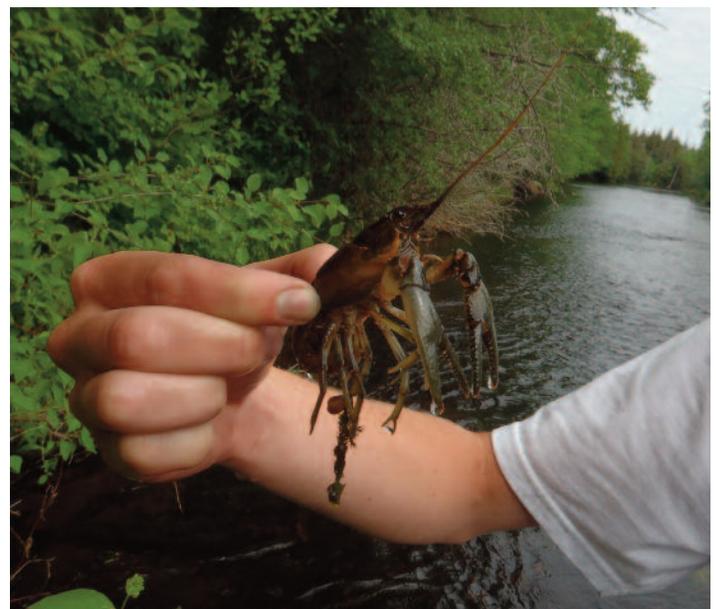
Invasive rusty crayfish found in North Branch

Invasive species can have major implications on streams and species diversity. Invasive species are one of the largest threats to ecosystems throughout Ontario and can outcompete native species, having negative effects on local wildlife, fish and plant populations. Forty-six percent of the sections surveyed along the North Branch had invasive species (Figure 25). The invasive species observed in the North Branch were curly leaf pondweed, European frogbit, Eurasian milfoil, purple loosestrife, rusty crayfish and dog strangling vine.

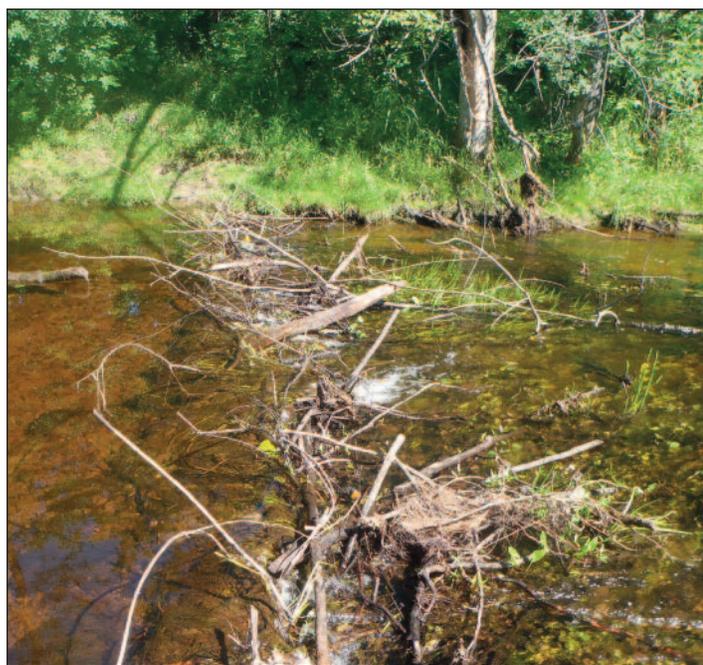
Beaver dam — a migratory obstruction on North Branch
